### ON-SITE AIR BAG INVESTIGATION

CASE NUMBER - IN98-018  
LOCATION - TEXAS  
VEHICLE - 1988 MERCEDES BENZ 190E  
CRASH DATE - September, 1997

1. <i>Report No.</i> IN98-018	2. <i>Government Accession No.</i>	3. <i>Recipient's Catalog No.</i>	
4. <i>Title and Subtitle</i> On-Site Air Bag Fatality Investigation Vehicle - 1988 Mercedes Benz 190E Location - Texas		5. <i>Report Date:</i> 2/27/02; 4/25/02; 5/12/02; 11/15/02

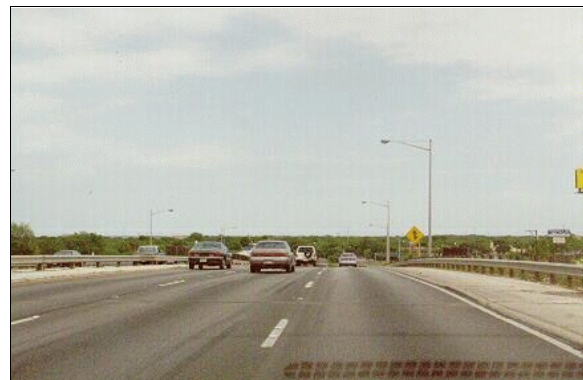
**Figure 1:** Case vehicle's travel path as it attempted to change lanes from outside eastbound lane to center eastbound lane just prior to impact; Note: impact occurred on upgrade just prior to hill crest (case photo #03)

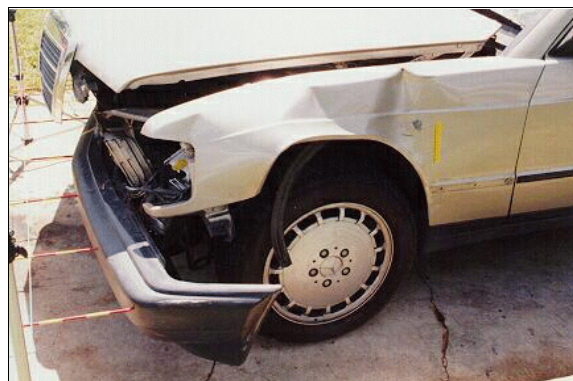
**Figure 2:** Damage to case vehicle's left fender from initial sideswipe impact with Nissan's right quarter panel (case photo #18)

The case vehicle's first event was a sideswiping impact with the Nissan that involved the left fender (**Figure 2** above). Direct damage began 29 centimeters (11.4 inches) behind the left front axle and extended, a measured distance of 91 centimeters (35.8 inches), forward along the left front wheel well. Maximum crush was measured as 4 centimeters (1.6 inches). The field "L" began 58 centimeters (22.8 inches) behind the left front axle (i.e., just forward of the left "A"-pillar) and extended, a measured distance of 119 centimeters (45.7 inches), forward along the left fender. The case vehicle's second event (first impact with the guardrail) involved the front right corner (**Figure 6** above). Direct damage began 21 centimeters (8.3 inches) to the right of the case vehicle's center and extended, a measured distance of 57 centimeters (22.4 inches), to the front right bumper corner. Residual maximum crush was measured as 25 centimeters (9.8 inches) at C<sub>6</sub>. The field "L" went from bumper corner to bumper corner, a measured distance of 149 centimeters (58.7 inches). The third event (second impact with the guardrail) involved almost the entire right side (**Figures 7** and **8** above). Direct damage began 82 centimeters (32.3 inches) behind the right rear axle and extended, a measured distance of 355 centimeters (139.8 inches), forward along the right side. Maximum crush was near the right "B"-pillar and was measured as 14 centimeters (5.5 inches). The fourth and final event (third guardrail impact) involved the case vehicle's back right (**Figure 8** above). Direct damage began 37 centimeters (14.6 inches) inward from the back right bumper corner and extended, a measured distance of 151 centimeters (59.4 inches), leftward along the back bumper. Maximum crush was measured as 20 centimeters (7.9 inches) at the back right bumper corner. The wheelbase on the case vehicle's left side was shortened 3 centimeters (1.2 inches) while the right side was shortened 5 centimeters (2.0 inches). The case vehicle's front and back bumpers, front and back bumper fascia, grille, radiator, right and left fenders, right quarter panel, front right headlight and turn signal assemblies, back right brake light and turn signal assemblies, and right front and right rear doors were directly damaged and crushed inward. Both of the case vehicle's right side tires were physically restricted, and the right front tire was deflated and rotated outward from the case vehicle's first impact with the median's guardrail. There was induced damage to the case vehicle's windshield (i.e., stress fracture), hood, trunk lid, left quarter panel, and left front headlight and turn signal assemblies.

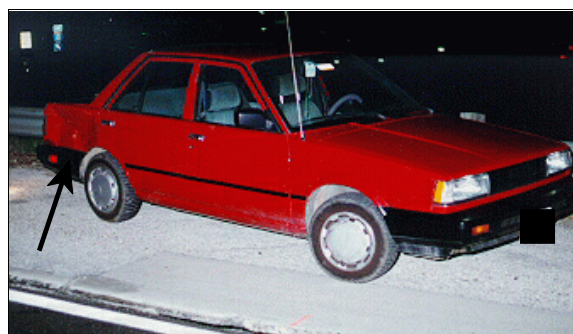
**Figure 3:** On-scene photo looking south-southeast at Nissan's final rest position on south shoulder; Note: sideswipe damage to right quarter panel from impact with case vehicle's left front fender (case photo #13)

The Nissan’s right rear impact from the case vehicle caused the right quarter panel to be crushed inward (**Figure 3** above). Based on the photograph, the direct damage started at the right rear bumper corner and continued forward to the right rear axle. The Nissan’s left rear side impact with the guardrail caused minor damage to the left quarter panel and rear bumper corner (**Figure 20** above). Based on the available police photographs, the CDCs for the Nissan are estimated as: **01-RBEW-1 (40)**-1<sup>st</sup> event, and **06-LBMS-1 (180)**-5<sup>th</sup> event. The Nissan was towed due to damage.

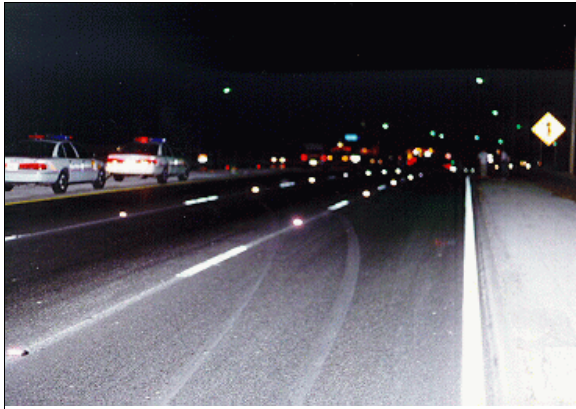
**Figure 4:** On-scene photo showing case vehicle's counterclockwise rotation across all three eastbound lanes when driver overcorrected following initial impact with Nissan; Note: scuffs on roadway (case photo #05a)

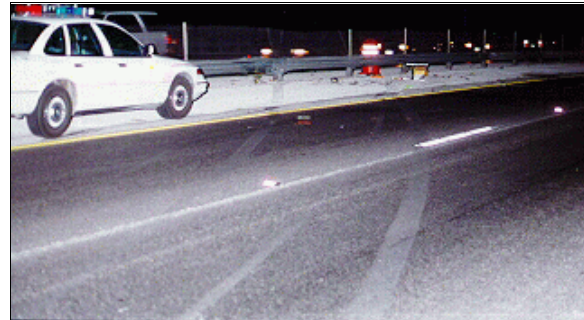
**Figure 5:** On-scene photo showing case vehicle's travel path into median's guardrail on north roadside during counterclockwise rotation; Note: tire scuffs and damaged guardrail (case photo #05b)

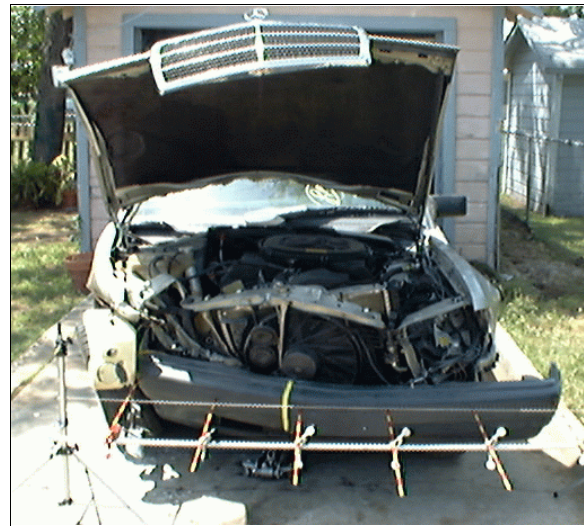
The case vehicle's front right corner (**Figure 6**) impacted the median guardrail, causing the case vehicle's driver air bag to deploy. The case vehicle rotated rapidly counterclockwise and impacted (i.e., first slapping and then sliding along) the guardrail with its right side and right quarter panel (**Figures 7 and 8** below). Because the trafficway, and thus the median's longitudinal barrier (i.e., guardrail) was curving to the right, the case vehicle's back right corner dug into and snagged on the guardrail (**Figure 8** below). As a result, the case vehicle rebounded off the guardrail, rotated counterclockwise back out into the eastbound roadway of the interstate, crossed the inside and center eastbound through lanes, and came to rest in the outside eastbound lane, with its left front wheel straddling the lane line, heading northeastward (**Figures 9 and 10** below).

**Figure 6:** Case vehicle's frontal damage with contour gauge present; Note: yellow tape marks leftward end of direct damage and leftward shift of front bumper (case photo #15)

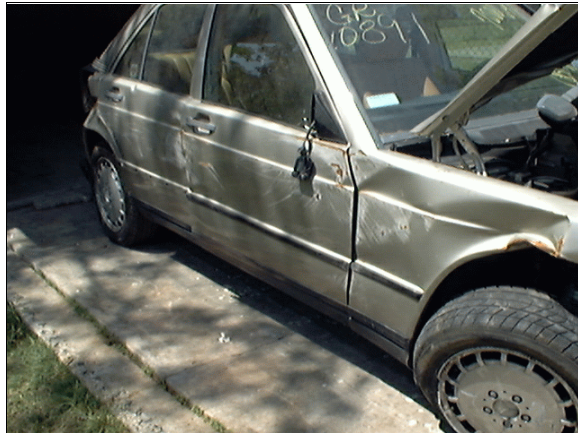
**Figure 7:** Case vehicle’s right side damage from slapping impact with median guardrail (case photo #24)

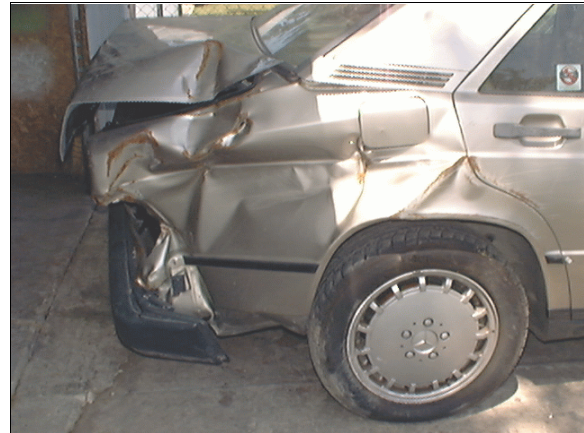
**Figure 8:** Multiple impact damage to case vehicle’s right quarter panel and back right corner from median guardrail; Note: outline of top of guardrail can be seen along right quarter panel and right rear door and inward crush through back, with restriction of right rear tire, from snagging impact with guardrail (case photo #23)

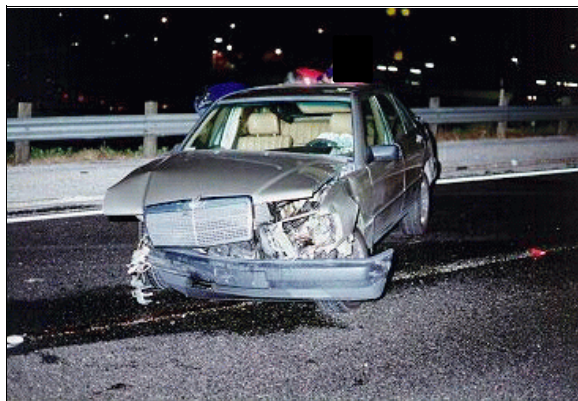
**Figure 9:** On-scene photo looking southwestward at case vehicle’s final rest position straddling lane line between inside and center eastbound lanes; Note: left shift to case vehicle’s bumper from impact with median guardrail (case photo #08)

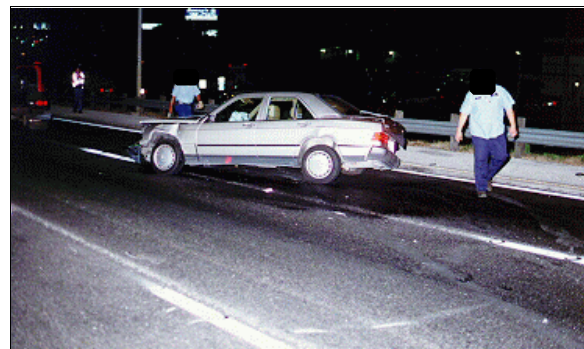
**Figure 10:** On-scene photo looking east-southeast at case vehicle’s final rest position straddling inside and center eastbound lanes (case photo #09)

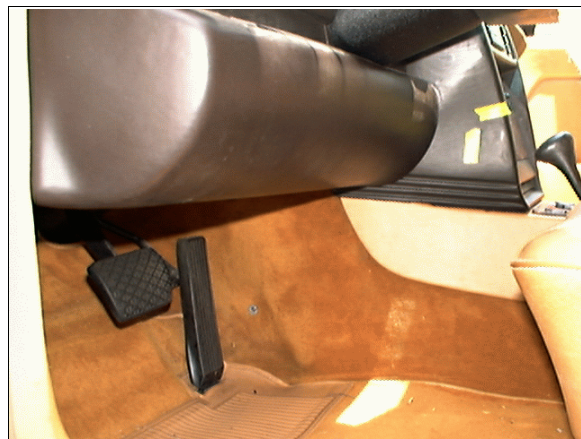
Inspection of the case vehicle's interior revealed only a scuff mark on the left side of the center instrument panel, most likely from contact by the driver's right knee (**Figure 11**). The contractor was not allowed access to the case

**Figure 11:** Case vehicle's driver knee bolster and left side of center instrument panel showing no contact evidence on knee bolster and driver's right knee contact to instrument panel (case photo #32)

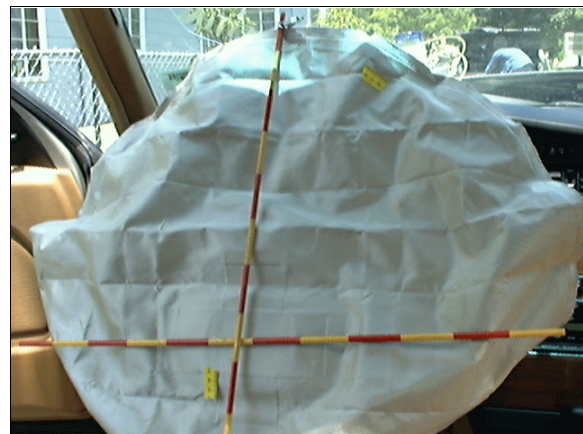
**Figure 12:** Case vehicle's deployed driver air bag with yellow tape indicating blood spot near 1 o'clock position blue ink transfer just left and below center (case photo #34)

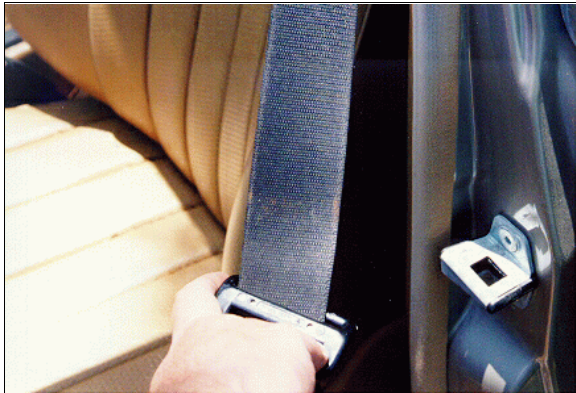
**Figure 13:** Case vehicle’s driver safety belt showing heat abrasion indicating at least previous usage (case photo #38)

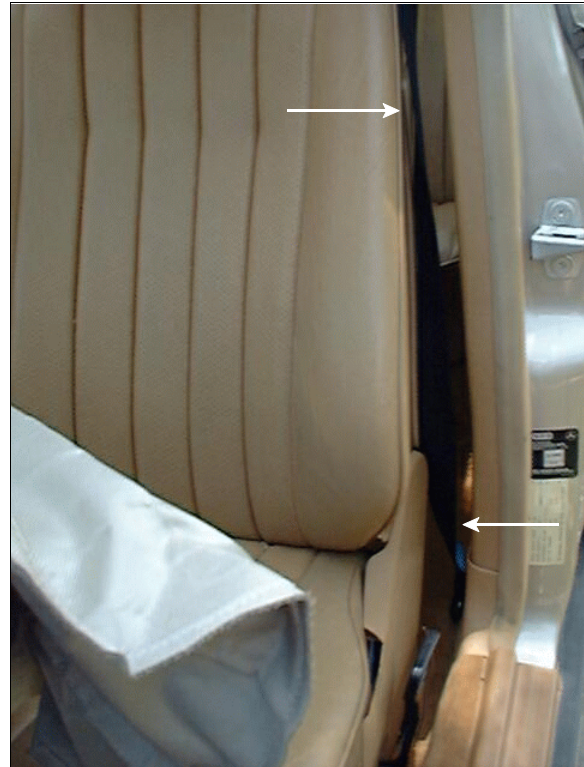
**Figure 14:** Case vehicle’s driver safety belt system shown along “B”-pillar with belt webbing free to reel in and out; Note: emergency tension retractor did not actuated when air bag deployed because safety belt was not buckled (case photo #44)

extended, preventing the belts movement (**Figure 15**). The **ETR** on the driver's belt system had not actuated when the air bag deployed, allowing the belt webbing to reel in and out (**Figure 14** above).

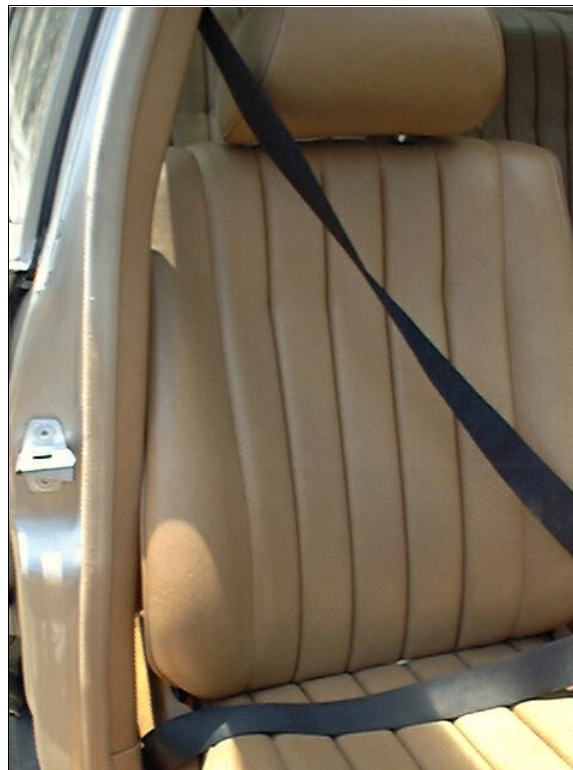
In comparison, the inspection of the front right passenger’s seat belt showed evidence of loading (**Figure 15** below) on the plastic free sliding latch plate (heat abrasion markings) and a related heat abrasion on the webbing (**Figure 16** below). This contractor would have expected to have found some type of loading evidence on the driver’s seat belt system. Furthermore, it should be noted that the **ETR** on the front right belt system was still locked in place with the belt webbing

**Figure 15:** Case vehicle's front right safety belt system showing belt fully extend and not retractable because pretensioner had actuated accompanying deployment of driver's air bag (case photo #43)

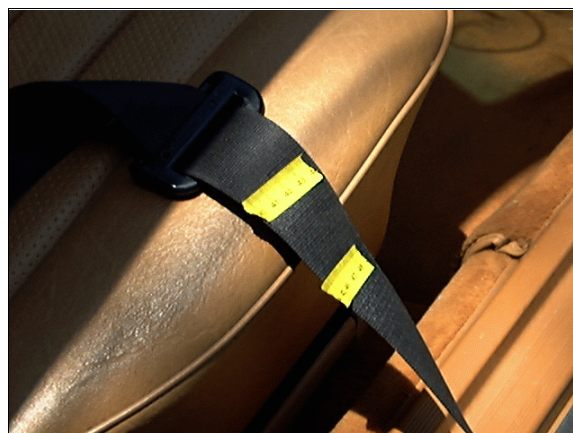
**Figure 16:** Case vehicle's front right safety belt showing heat abrasion mark on belt's webbing (case photo #42)

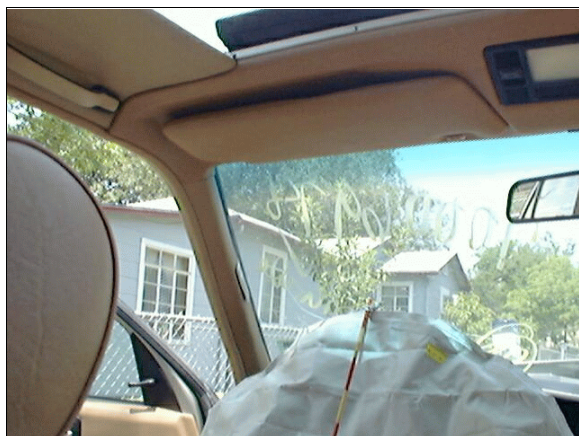
**Figure 17:** Case vehicle's deployed driver air bag and driver's greenhouse area showing no obvious occupant contact evidence (case photo #30)

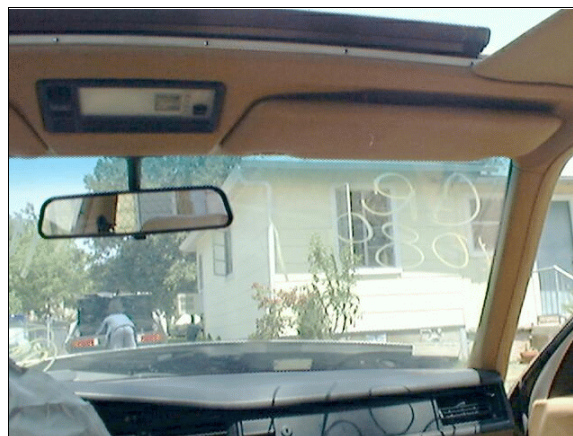
**Figure 18:** Case vehicle's center and front right greenhouse areas showing no obvious occupant contact evidence (case photo #31)

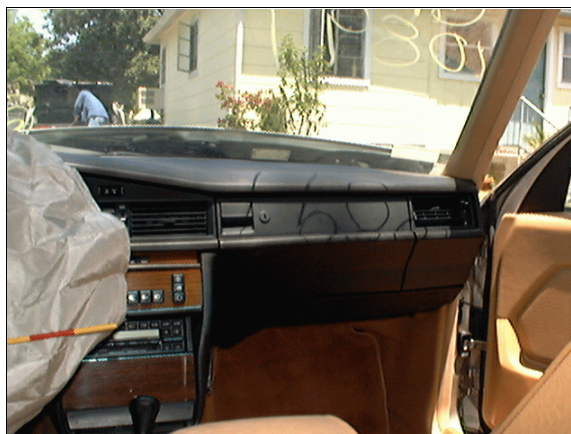
**Figure 19:** Case vehicle’s front right instrument panel and windshield’s glazing showing no obvious occupant contact evidence (case photo #40)

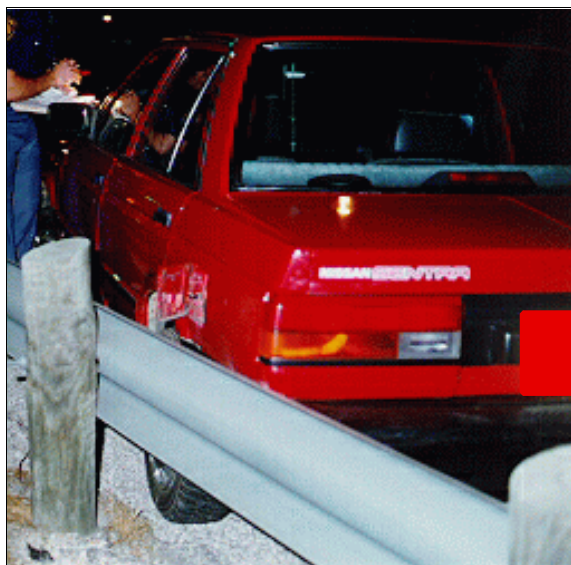
**Figure 20:** On-scene photo looking west at Nissan’s final rest position with left rear corner against guardrail on south roadside (case photo #14)
