TRANSPORTATION RESEARCH CENTER

ON-SITE AIR BAG INVESTIGATION

CASE NUMBER - IN98-023
LOCATION - INDIANA
VEHICLE - 1995 MITSUBISHI ECLIPSE GS
CRASH DATE - October, 1998

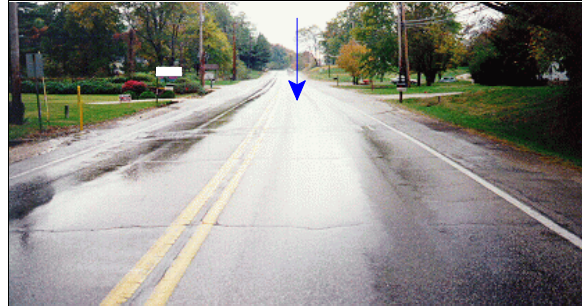
The case vehicle was traveling west in a slight left-hand curve (**Figure 1**), in the westbound lane of a two-lane, undivided, state roadway, and intended to continue its westerly travel path. The Pontiac was also traveling west in the westbound lane of the same state roadway and was slowing with the intention of making a left-hand turn into a residential driveway (**Figure 2**). The case vehicle's driver applied her brakes [depositing 3.6 meters (11.8 feet) of skid marks] in an attempt to avoid the crash. The crash occurred in the westbound lane of the roadway; see **CRASH DIAGRAM**.

Figure 1: Case vehicle's westward travel path in westbound lane of slight left-hand curve, approaching Pontiac which was stopped (arrow) waiting to make a left-hand turn (case photo #01)

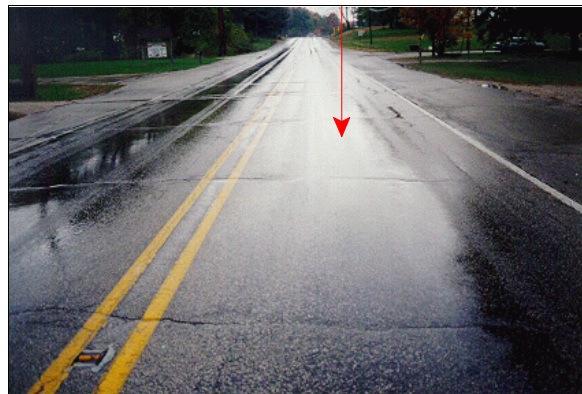
Figure 2: Case vehicle's and Pontiac's westward travel path in westbound lane showing approximate (arrow) point of impact (case photo #04)

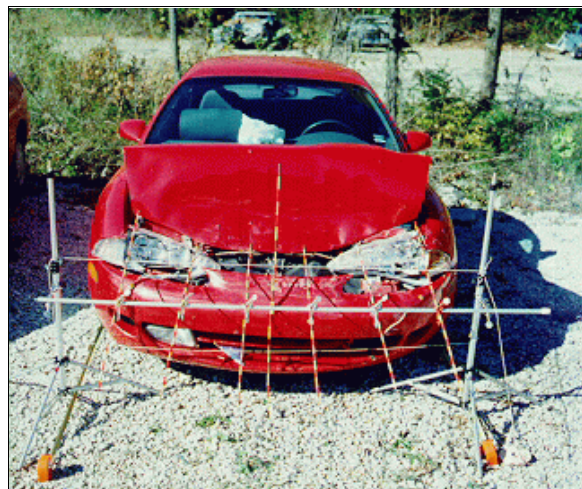
Figure 3: Underride damage to case vehicle's front with contour gauge showing above bumper damage (case photo #10)

The front of the case vehicle (**Figure 3** above and **Figure 4**) impacted the back of the Pontiac (**Figure 5**), causing the case vehicle's driver and front right passenger supplemental restraints (air bags) to deploy. The case vehicle rotated approximately 15 degrees counterclockwise while continuing forward a short distance. The case vehicle came to rest essentially in the westbound lane (i.e., its left front tire was on the center line) heading west. The Pontiac was pushed forward approximately 15.8 meters (51.8 feet) and came to rest straddling the westbound lane and the north (right) shoulder, heading west-northwest.

The upper half of the case vehicle’s front bumper impacted the lower half of the Pontiac’s back bumper. This vertical mismatch of bumpers resulted in a classic underride of the Pontiac. Direct damage to the case vehicle extended across the entire frontal surface and included: rearward displacement of the front bumper and fascia, a cracked plastic grille, a shattered front left fog light, a front right fog light that was knocked askew, front headlamp assemblies that were pushed rearward and upward, cracked and splintered glass covers to the front headlamp assemblies, a shattered front left turn light lens, indentation to the forward edge of the left fender, white paint transfers on the forward edge of the right fender, **and** rearward displacement of the forward edge of the hood with buckling approximately a third of the way to its rear edge. Induced damage included: buckling of the left fender at its rear seam, rearward displacement of the left front door such that the door latch became inoperable, and a slight displacement of the right fender rearward, reducing the space between the fender’s rear seam and the forward seam of the right front door. In addition, there was no evidence of intrusion to the case vehicle. The case vehicle was towed due to disabling damage.

Based on the vehicle inspection, the CDC was determined to be: **12-FDEW-3 (0)** for the case vehicle [maximum crush, which was located above the bumper, was 43 centimeters (16.9 inches)]. The WinSMASH reconstruction program, damage only algorithm, was used on the case vehicle’s highest severity impact. The Total, Longitudinal, and Lateral Delta Vs are, respectively: 21.2 km.p.h. (13.2 m.p.h.), -21.2 km.p.h. (-13.2 m.p.h.), and 0.0 km.p.h. (0.0 m.p.h.).

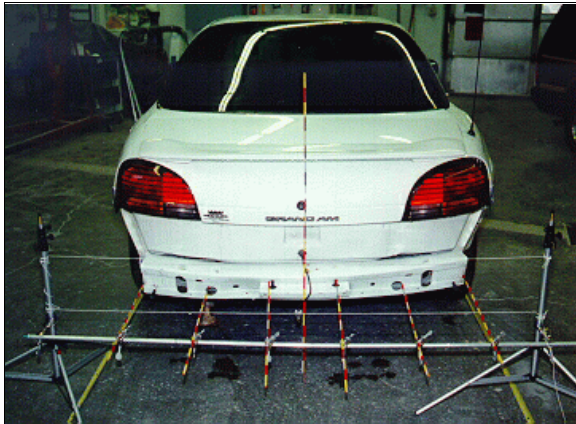
Figure 5: Pontiac's damaged back with contour gauge present; Note: bumper and reinforcement bar were knocked off (case photo #66)

The lower half of the back bumper of the Pontiac was impacted by the top half of the case vehicle’s front bumper. This vertical mismatch of the bumpers resulted in a classic underride of the Pontiac. The low contact to the Pontiac's back bumper, combined with the 180 Direction of Principal Force, torqued the back bumper off its

mounts. The back bumper corners were cracked. The bumper backing bracket was torqued downward. Both the right and left quarter panels were displaced forward and buckled, both rearward and forward of the rear axle (**Figure 16** above and **Figure 17**). The back panel above the bumper and below the trunk lid shows back-to-front contact damage.

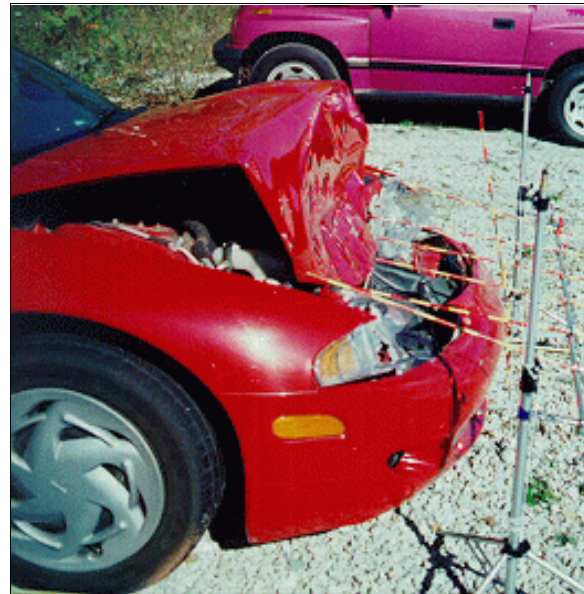
Figure 4: Case vehicle's front underride damage viewed from right along front reference line (case photo #22)

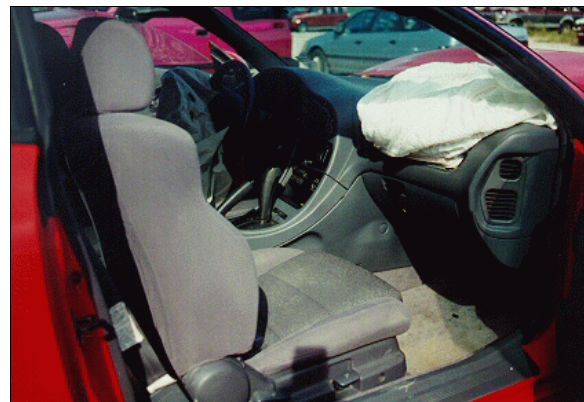
Figure 6: Case vehicle's front right seating area showing deployed front right passenger air bag and center console with floor-mounted, transmission selector lever (case photo #31)

The interior of the case vehicle had front bucket seats with folding backs and adjustable head restraints (**Figure 6**). The back seat was a bench seat without head restraints. The case vehicle's front seat was equipped with manual, three-point, lap-and-shoulder, safety belt systems in the outboard seating positions. The case vehicle was equipped with manually operated height adjusters

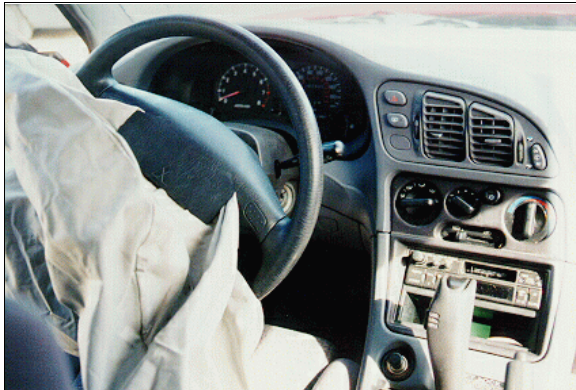
Figure 7: Case vehicle’s front seating area showing deployed driver air bag, center instrument panel, and automatic transmission selector lever (case photo #28)

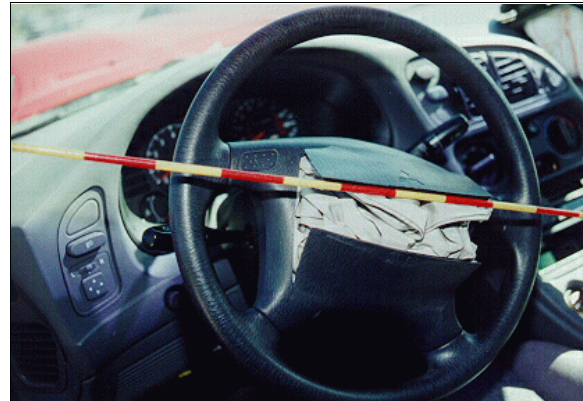
Figure 8: Case vehicle’s steering wheel showing driver air bag module’s top and bottom cover flaps and refolded air bag (case photo #32)

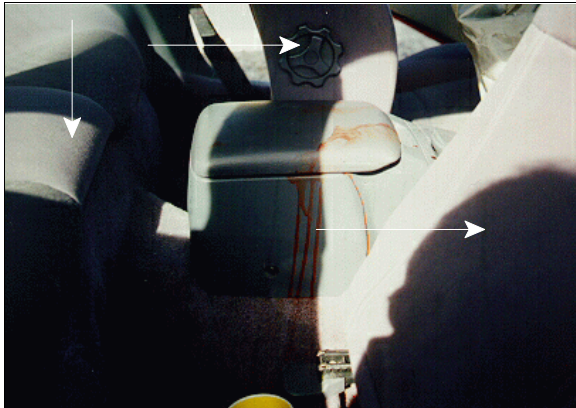
An inspection of the case vehicle's interior revealed that there were scuff marks on: the rim and on one of the spokes of the steering wheel, to the left of the steering column on the left lower instrument panel, and on the glove box door. There was a bloodstain on the front header above the front right seating area and a soda splash mark on the roof. In addition, there was a large bloodstain on the center console storage area, including inside the center console's storage area cover (Figures 9, 10, 11 and 12). There were bloodstains on the forward side of the front right seat back. Finally, there were body oil smudges on the backside of the front right seat back.

Figure 9: Case vehicle's bloodstained console storage area cover; Note: arrows indicate (left-to-right) back bench seat and driver and front right passenger bucket seats (case photo #42)

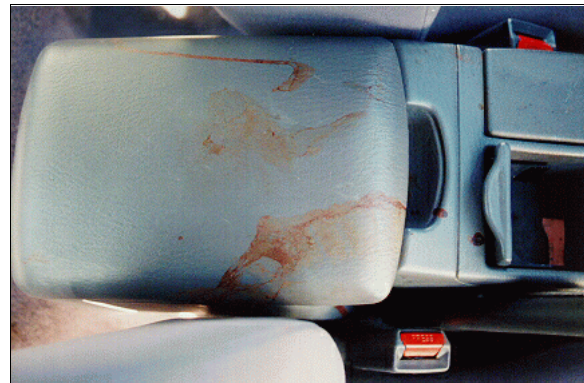
Figure 10: Overhead view of case vehicle's bloodstained console storage area cover; Note: driver's seat is further forward than front right passenger's seat (case photo #43)

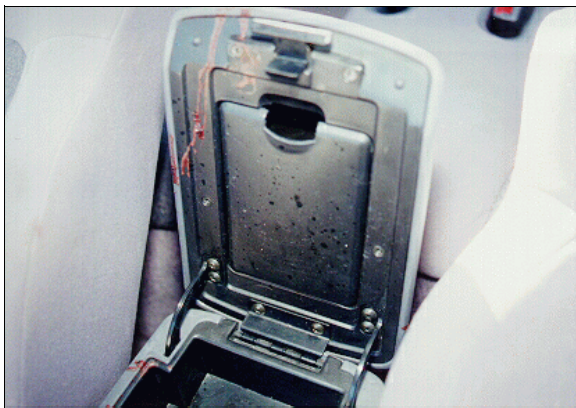
Figure 11: Inside surface of case vehicle's console storage area cover showing bloodstains, indicating that cover was raised at time of crash (case photo #44)

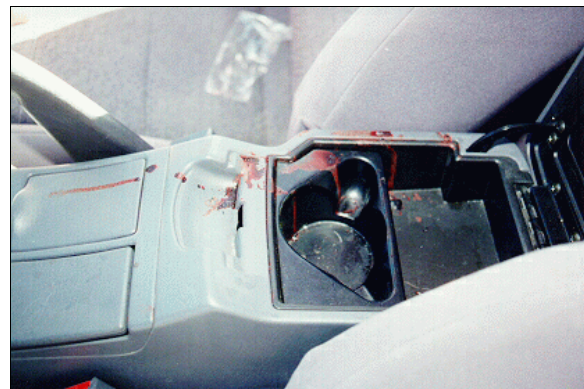
Figure 12: Bloodstains on inside of case vehicle's console storage area; Note: console storage area is viewed from driver's seat (case photo #45)

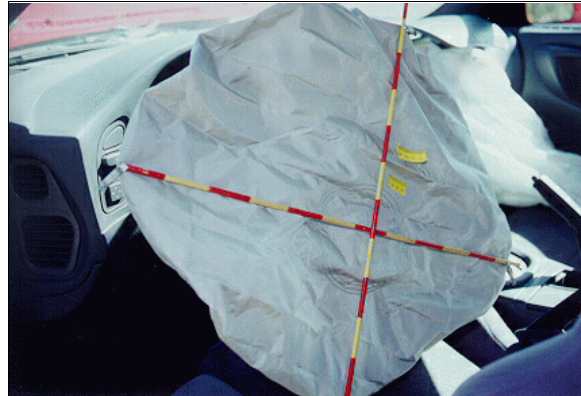
and 6 centimeters (2.4 inches) high. An inspection of the air bag module's cover flaps and air bag fabric revealed that the cover flaps opened at the designated tear points, and there was no evidence of damage during the deployment to the air bag or the cover flaps. The driver's air bag was designed with two tethers, each 8 centimeters (3.1 inches) wide. The driver's air bag had two vent ports, approximately 3 centimeters (1.2 inches) in diameter, located at the 11:30 and 12:30 o'clock positions. The deployed driver's air bag was elliptical with a height of approximately 52 centimeters (20.5 inches) and a width of approximately 60 centimeters (23.6 inches). There was a lipstick smear on the driver's air bag, located in the upper right quadrant near the center of the air bag (**Figure 13**). The smear was located 10 centimeters (3.9 inches) above a line laterally through the middle of the air bag and 9 centimeters (3.5 inches) to the right of a line vertically through the center of the air bag.

Figure 13: Case vehicle's deployed driver air bag showing probable occupant contact evidence in upper right quadrant (case photo #39)

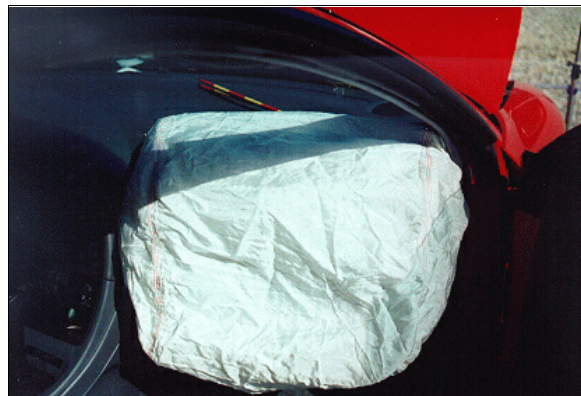
The front right passenger's air bag was located in the middle of the instrument panel. There was a single, rectangular, modular cover flap. The cover flap was made of a thick vinyl over a thick cardboard type frame. The flap's dimensions were: 53 centimeters (20.9) at the horizontal seam and 23 centimeters (9.1 inches) along the vertical seam. The profile of the case vehicle's instrument panel/dash resulted in a 2 centimeter (0.8 inch) setback of the leading edge of the cover flap relative to the protruding right instrument panel. An inspection of the front right air bag module's cover flaps and air bag fabric revealed that the cover flaps opened at the designated tear points, and there was no evidence of damage during the deployment to the air bag or the cover flaps. The front right passenger's air bag was designed without any tethers. The front right air bag had two vent ports, approximately 6 centimeters (2.4 inches) in diameter, located at the 10 and 2 o'clock positions. The deployed front right air bag was rectangular with a height of approximately 66 centimeters (26.0 inches) and a width of approximately 44 centimeters (17.3 inches). There was no contact evidence readily apparent on the front right air bag (**Figure 14**). The distance from the forward surface of the front right seat back to the approximate maximum excursion point of the front right air bag was measured as 34 centimeters (13.4 inches).

Figure 14: Case vehicle's deployed front right passenger air bag; Note: no visible contact evidence was found on this air bag (case photo #49)

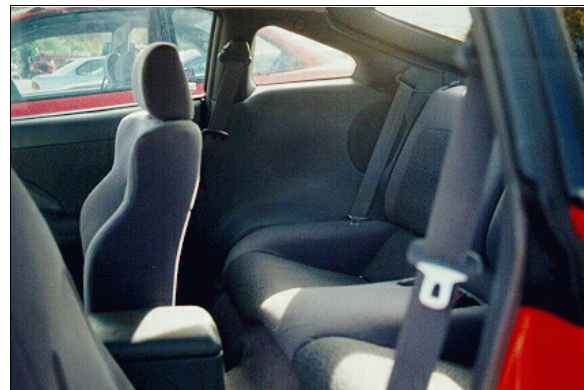
Figure 15: Case vehicle's back right seating area viewed from driver's door; Note: proximity of console storage area to front right seat, front bucket seats, and three-point safety belts in outboard seating positions (case photo #53)

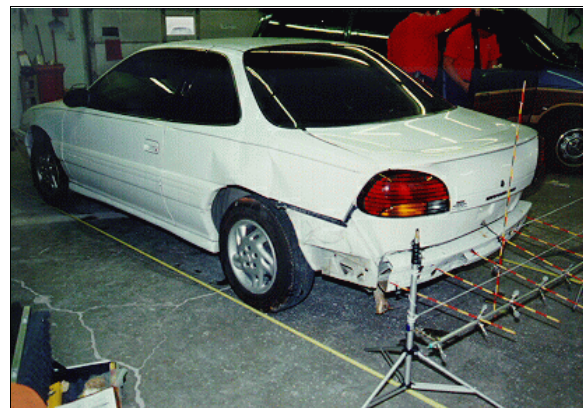
Figure 16: Pontiac's damaged back viewed from left of back; Note: induced damage to left quarter panel (case photo #64)

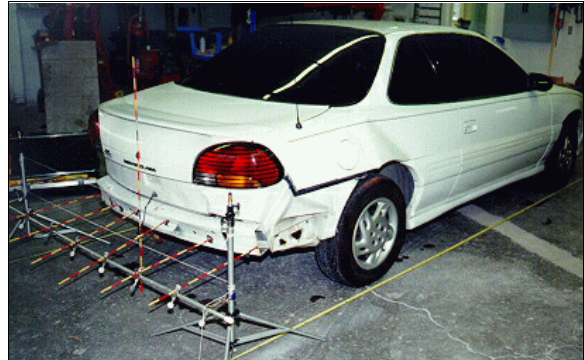
Figure 17: Pontiac's damaged back viewed from right of back; Note: induced damage to right quarter panel (case photo #68)
