**VERIDIAN ON-SITE REDESIGNED AIR BAG INVESTIGATION**  
**VERIDIAN CASE NO. CA98-43**  
**VEHICLE: 1998 CHEVROLET MALIBU LS**  
**LOCATION: PENNSYLVANIA**  
**CRASH DATE: JULY 1998**

## CALSPAN ON-SITE REDESIGNED AIR BAG DEPLOYMENT INVESTIGATION

CALSPAN CASE NO. CA98-43

VEHICLE: 1998 CHEVROLET MALIBU LS

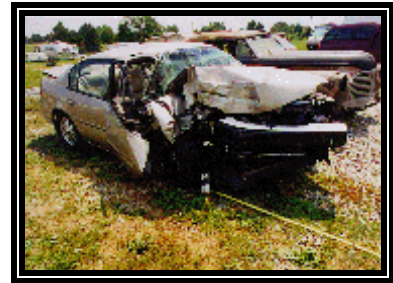
This on-site investigation focused on a severe off-set frontal impact sequence with a tree that involved a 1998 Chevrolet Malibu (**Figure 1**). The Malibu was equipped with redesigned frontal air bags that deployed as a result of the crash. The vehicle was occupied by a 47 year old male driver and his 10 year old son who was seated in the front right passenger position. The driver was not restrained by the manual belt system, however, the child passenger was properly restrained. Both occupants initiated forward trajectories and loaded the deployed air bags which offered exceptional crash protection to the high severity impact. The driver sustained incapacitating blunt force injuries of the chest and abdominal areas while the child passenger sustained soft tissue injuries of the upper extremities. Both occupants were transported by ambulance to a local hospital for treatment. The driver was admitted for treatment while the child passenger was treated and released. Due to allegations that this crash was an intentional act, the family refused to cooperate with the SCI program.

**Figure 1. Severe front right damage to the Chevrolet.**

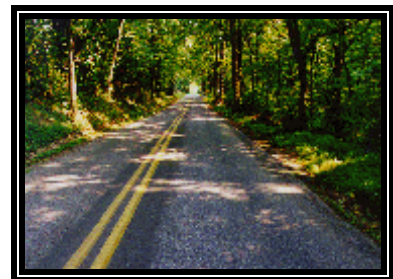
**Figure 2. Overall view of the crash site in the southbound direction.**

The crash occurred on a residential road during daylight hours in a mid block area. The roadway consisted of two travel lanes that were straight with a 1.5 percent negative grade to the south (**Figure 2**). The travel lanes were bordered by 0.8 m (2.5') wide natural dirt shoulders with large diameter trees bordering both road edges. The involved tree consisted of a cluster of two closely spaced trunks with diameters of 22.8 and 35.6 cm (9.0 and 14.0"). The mid point of the cluster was located 1.6 m (5'3") outboard of the right road edge. The dry asphalt road surface was 5.9 cm (19'7") in width and was posted with a 40 km/h (25 mph) speed limit.

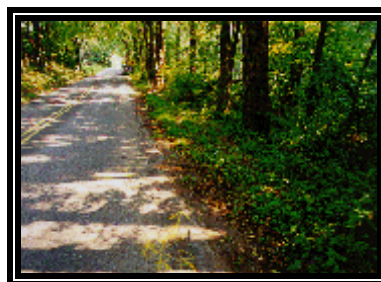
The driver and his son were attending a conference at a local college and borrowed the 1998 Chevrolet Malibu to drive to purchase soft drinks. The driver traveled on several local streets in the area and turned onto the tree-lined street, traveling in a southerly direction. The 10 year old male front right passenger relayed to the investigating officer that the driver accelerated the vehicle to a speed which exceeded the 40 km/h (25 mph) speed limit. The child passenger reminded the driver of the speed limit, however, he continued to accelerate while negotiating a series of elevation changes in the road. On the descent of a hillcrest, the driver allowed the vehicle to drift onto the earth shoulder (**Figure 3**). A rotating tire print from the right

**Figure 3. Point of departure for the Chevrolet Malibu.**

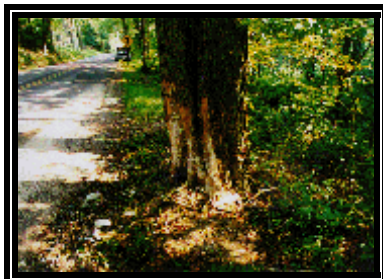
The front right area of the Malibu impacted the tree cluster (**Figure 4**) at a WinSMASH computed speed of 98.0 km/h (60.9 mph). The vehicle crushed to a maximum depth of 124.5 cm (**Figure 5**) which resulted in a WinSMASH computed velocity change of 83.1 km/h (51.6 mph) with a longitudinal component of -83.1 mph (-51.6 mph). As a result of the high velocity change, the frontal air bag system deployed. The impact force was within the 12 o'clock sector, however, due to the offset (right) impact, the vehicle rotated in a CW direction as it separated from the struck tree. The Malibu rotated approximately 84 degrees in a CW direction into the travel lanes. It should be noted that the original length of the bumper reinforcement beam was used as the damage length in the reconstruction program. This best represented the damage profile and yielded reasonable results for this severe crash.

**Figure 4. Struck tree.**

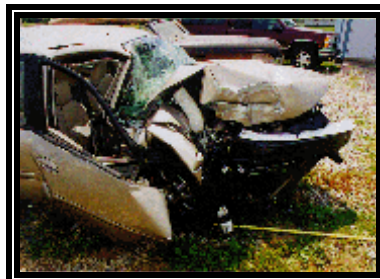
**Figure 5. Impact damage to the front right of the Chevrolet Malibu.**

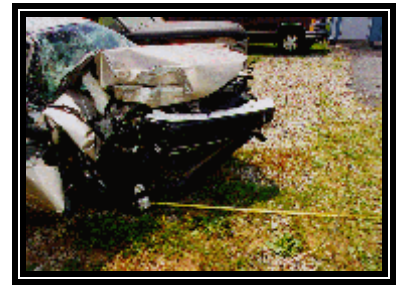
The Chevrolet Malibu sustained severe frontal damage as a result of its impact sequence with the tree cluster. Maximum crush was 124.5 cm (49.0") located on the bumper reinforcement bar, 52.1 cm (20.5") right of center. The direct contact damage began 21.6 cm (8.5") right of center of the bumper fascia and extended 50.8 cm (20.0") to the front right corner. The impact deformed the entire frontal width of the vehicle which resulted in a combined direct and induced damage length (Field L) of 59.7 cm (23.5"). The front right structure was crushed straight back which displaced the left side structure laterally to the right. The lateral shift of the leading edge of the right front fender was approximately 55.9 cm (22.0") while the bumper reinforcement bar was displaced 88.9 cm (35.0") to the right. The impact separated the bumper fascia and the styrofoam backer material, therefore the crush profile was documented at the level of the reinforcement bar (**Figure 6**). This frontal crush profile was as follows: C1 = 9.8 cm (3.9"), C2 = 29.8 cm (11.75"), C3 = 51.1 cm (20.1"), C4 = 79.4 cm (31.25"), C5 = 124.5 cm (49.0"), C6 = 123.8 cm (48.75"). The Collision Deformation Classification (CDC) for this impact was 12-FZEW-5

**Figure 6. Profile view of the frontal damage pattern.**

The severe off-set front right impact reduced the length of the right wheelbase by 60.4 cm (23.75") and elongated the left side by 1.2 cm (0.5"). Damaged components included the entire frontal structure, the right A-pillar, roof and right roof side rail, and both right side doors.

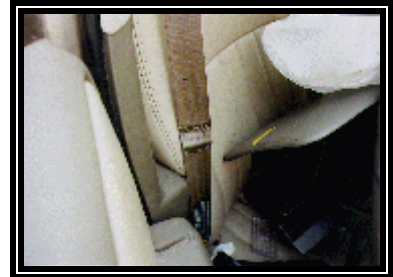
**Figure 7. Deployment of the front right energy management loop.**

The loading evidence of the front right belt system consisted of a subtle D-ring transfer on the shoulder belt webbing that was 6.4 cm (2.5") in length. There was no other damage to the front right belt system other than the occupant loading evidence.

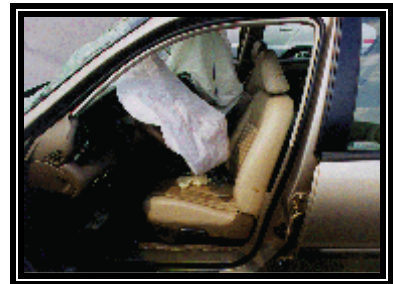
The 1998 Chevrolet Malibu was equipped with a Supplemental Inflatable Restraint (SIR) system that consisted of redesigned air bags for the driver and right passenger positions (**Figure 8**). A single point sensing and diagnostic module (SDM) which detected, deployed, and recorded deployment data was positioned under the front right seat of the vehicle. The data from the module was downloaded by an independent ESIS representative and is provided on Page 6 of this section..

**Figure 8. Overall view of the deployed redesigned frontal air bags.**

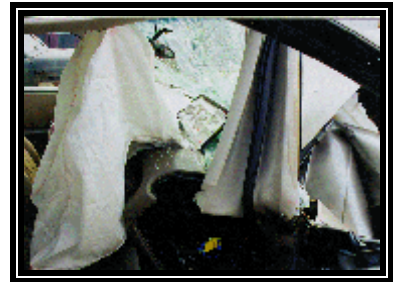
The front right air bag deployed from a top mount module in the right upper instrument panel (**Figure 9**). The module was concealed within a single cover flap that was hinged at the forward aspect of the flap. The vinyl skin of the flap was bonded to an alloy inner liner that acted as a reinforcement and hinge mechanism. The overall dimensions of the flap were 32.4 cm (12.75") laterally and 14.6 cm (5.75") in depth. The rigid hinge mechanism resulted in a fixed position of the flap post-deployment. The cover flap rotated approximately 125 degrees to the upper instrument panel during deployment. A bar coded label on the inside surface of the cover flap identified the assembly as \*AL 8522 1 5 077 U 0384\*.

**Figure 9. Deployment of the front right air bag.**

The front right air bag membrane was rectangular in shaped with overall dimensions of 50.8 cm (20.0") horizontally and 68.6 cm (27.0") vertically. The bag was tethered internally by two 7.6 cm (3.0") wide straps sewn to the face of the bag. The horizontal line of stitching was located near the mid point of the bag face, 38.7 cm (15.25") below the top aspect of the bag. The tether stitching extended the full width of the bag. There was no contact evidence or damage to the front right passenger air bag.

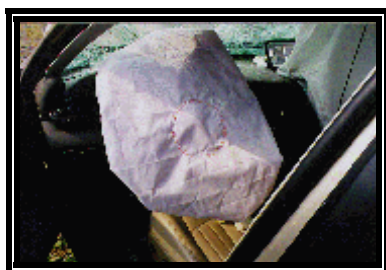
There was no damage (e.g. tears) to the deployed front left air bag. A series of vertically oriented black vinyl transfers were noted to the face of the bag at the 6 o'clock sector. The transfers were located 18.4-20.9 cm (7.25-8.25") below the horizontal centerline of the bag and centered on the vertical centerline. These transfers were related to bag expansion within the module assembly.

At impact, the unrestrained driver initiated a forward trajectory in response to the frontal impact force and initially loaded the deployed front right air bag (**Figure 10**). Due to the high severity of the crash and the lack of manual restraint usage, the driver's loading force was transmitted through the air bag into the steering assembly. This was evidenced by 2.8 cm (1.1") of steering column shear bracket separation and 3.2 cm (1.25") of upper steering wheel rim deformation (**Figure 11**). As a result of this loading sequence, the driver sustained blunt chest and abdominal injuries. His right knee contacted the intruding mid instrument panel which scuffed and fractured the plastic components. There was no injury reported to the lower extremity.

**Figure 10. Overall view of the deployed front left redesigned air bag.**

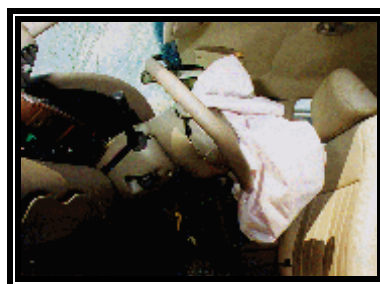
The driver loaded the deployed redesigned front left air bag and compressed the bag against the steering assembly, deforming the steering wheel rim and compressing the energy absorbing steering column. The upper rim of the 4-spoke steering wheel rim was deformed approximately 3.2 cm (1.25") forward while the lower rim was displaced 1.3 cm (0.5") forward. The shear brackets of the energy absorbing column were completely separated and displaced 2.8 cm (1.1") forward.

**Figure 11. Steering wheel deflection from driver loading through the bag.**

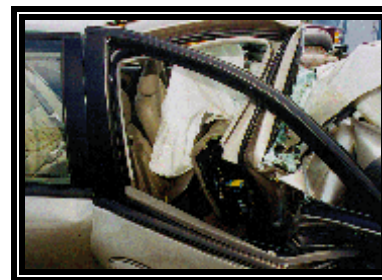
The front passenger compartment was significantly reduced in size by intrusion of numerous components. Maximum intrusion involved 50.2 cm (19.75") of rearward displacement of the right mid A-pillar with displacement of the right instrument panel and toe pan. The following table (**Table 1**) identifies the additional intruding components, the magnitude of the intrusion, and the direction of displacement.

**Figure 13. Intrusion of the right instrument panel into the front right passenger compartment.**

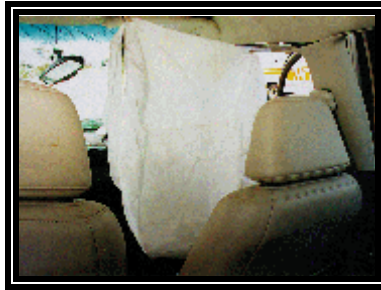
**Figure 12. Trajectory of the child passenger into the deployed front right air bag.**

loop that was incorporated into the lap belt aspect of the belt system. The belt system provided a ride-down to the passenger and held him in an upright attitude to load the deployed front right air bag with his entire upper body and head (**Figure 12**). It should be noted that the post-crash horizontal distance between the intruding right mid instrument panel and the front right seat back support (**Figure 13**) was 25.4 cm (10.0"). The combination of belt usage and automatic protection offered by the deployment of the redesigned front right air bag, afforded the child passenger with exceptional crash protection to the severe forces associated with this crash. The child passenger's knees contacted the intruding glove box door, however, no injury resulted from these contacts.

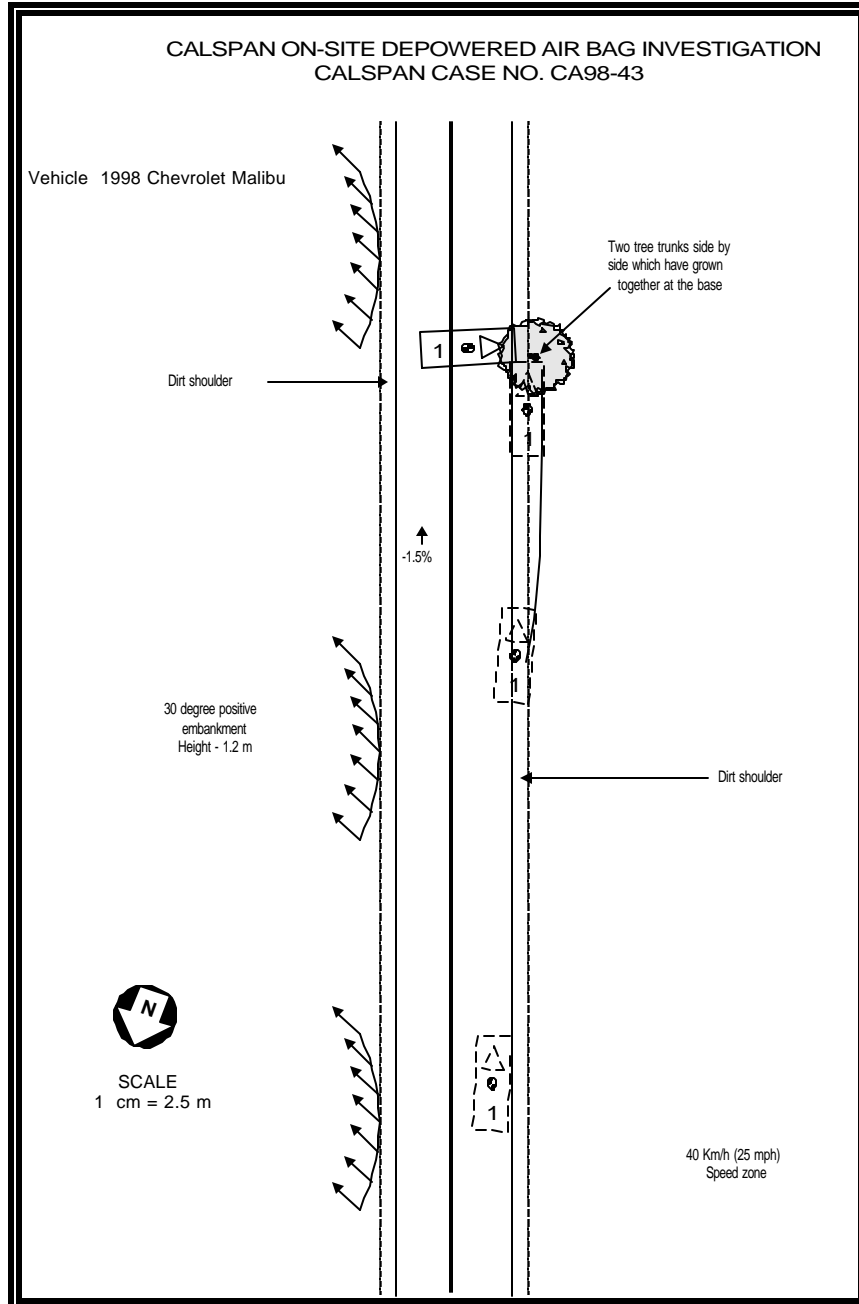
**Figure 14. Crash Schematic**

side tires marked on the earth surface for a distance of 14.1 m (46'3") as the vehicle continued in a tracking orientation toward a tree cluster that was located 1.6 m (5'3") outboard of the right road edge. The child passenger alleged his father intentionally accelerated and directed the vehicle into the tree. There was no evidence of braking on the asphalt road surface or the earth shoulder. The crash schematic is attached as **Figure 14**, Page 11.
