CALSPAN ON-SITE DRIVER AIR BAG DEPLOYMENT FATALITY INVESTIGATION

CALSPAN CASE NO. CA98-048

VEHICLE - 1996 OLDSMOBILE NINETY EIGHT

CRASH DATE - AUGUST, 1998

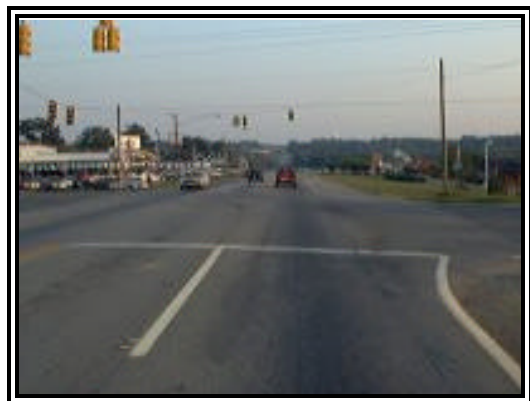
This two-vehicle crash occurred in a suburban 4-leg intersection during the morning hours of August, 1998. At the time of the crash, it was daylight and the weather was not a factor. **Figure 1** is a southward view into the intersection. The roadways comprising the intersection were configured north/south and east/west in direction and intersected at an acute angle. The north/south road was asphalt paved and consisted of three lanes, two travel lanes through the intersection and a center left turn lane. The total width of the road was 11 m (36 ft). The east/west roadway was asphalt paved and consisted of 2 lanes. The intersection was controlled by standard (overhead) red/amber/green traffic signals. A left turn arrow controlled the northbound center turn lane. The speed limit in the area of the crash was 89 km/h (55 mph).

Figure 1: Southward view into the intersection.

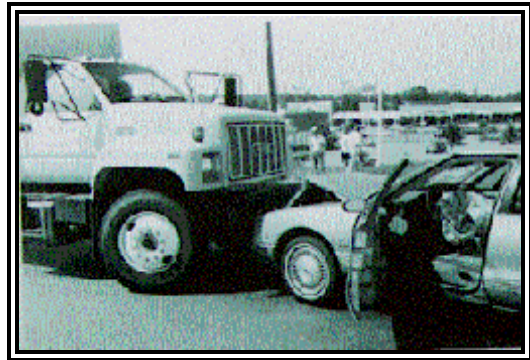
The crash occurred with the front of the Oldsmobile impacting the front of the GMC. The low frontal profile and compliant suspension of the Oldsmobile, as compared to the truck, caused the vehicle to under-ride the GMC's front bumper. **Figure 2** is an on-scene police photograph of the vehicles engaged at final rest. The vehicle's came to rest near the point of impact and in contact with one another, in the southbound lane of the intersection. There was no evidence identified at the crash scene that located the specific point of impact. The 12 o'clock direction of the impact force deployed the Supplemental Inflatable Restraint of the Oldsmobile.

Figure 2: Southwestward view of the vehicle's at final rest.

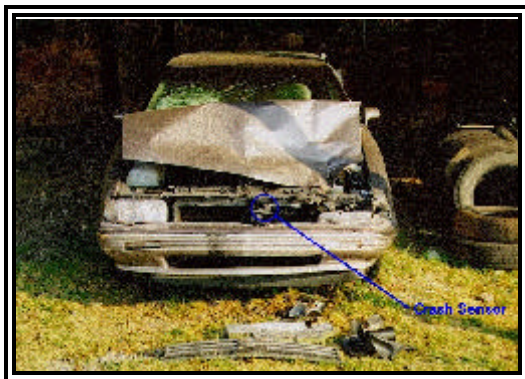
Figures 3 and 4 are the front and left lateral views of the Oldsmobile respectively. The front bumper structure of the Oldsmobile sustained 100.3 cm (39.5 in) of direct contact damage that began 21.6 cm (8.5 in) right of centerline and extended to the left corner of the bumper. Due to the under-ride nature of the crash, the bumper damage to the Oldsmobile consisted primarily of scuffs and scratches. There was approximately 2.5 cm (1.0 in) of residual crush across the width of the bumper. A tire scuff was located on the vertical surface of the bumper cover as a result of contact with the left front tire of the truck. The tire scuff began 21.6 cm (8.5 in) right of center and extended 13 cm (5 in) to the left. The front bumper was mounted to the vehicle's forward uni-body structure by two Energy Absorbing Devices (EAD's). The left and right EAD's compressed 3.2 cm (1.3 in) and 6.4 cm (2.5 in), respectively, during the impact with the truck tire. Both EAD's had returned to their original 8.9 cm (3.5 in) length through full restitution. The

Figure 3: Front view of the Oldsmobile.

under-ride damage extended rearward over the area surrounding the left headlamp structures and onto the left aspect of the hood and the left front fender. The hood buckled and shifted rearward fracturing the left lower aspect of the windshield. The scratches along the top edge of the left fender extended rearward 86 cm (34 in) from the front of the vehicle. The vehicle was mechanically operational (driveable) after the crash. There was no measurable change in the wheelbase dimensions. All the doors were operational and the side glass and backlight were intact. The windshield was fractured from the aforementioned hood contact and from the deployment of the right front passenger air bag. The Collision Deformation Classification (CDC) of the Oldsmobile was 12-FYEW-1. An analysis of the damage sustained by the Oldsmobile for the purposes of crash reconstruction was beyond the scope of the WINSMASH model. Forensic analysis of the damage based on SCI experience indicated the delta V experienced by the Oldsmobile was approximately 23 to 29 km/h (14 to 18 mph). Additionally, the crash pulse was of a long duration due to the nature of the under-ride impact.

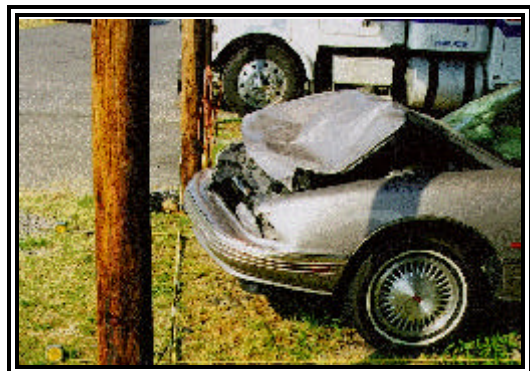
Figure 4: Left lateral view of the Oldsmobile.

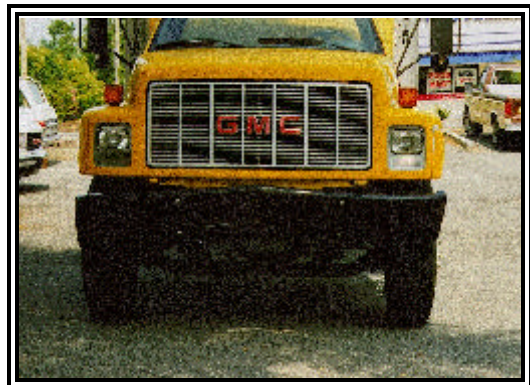
The GMC truck was unavailable for inspection. The vehicle was operational and driven from scene upon completion of the police investigation. **Figure 5** is a front view of the GMC truck obtained from the investigating officer. The vehicle's damage was confined to the front bumper structure. The truck's front bumper was frame-

Figure 5: Front view of the GMC truck.

mounted and constructed from a steel rectangular section. A series of scratches and paint transfers were located on the bumper's lower center aspect. The center section of the bumper was deformed approximately 10 cm (4 in) rearward and slightly upward. The bumper damage was indicative of the Oldsmobile's under-ride and engagement with the vehicle's hood face and radiator support.

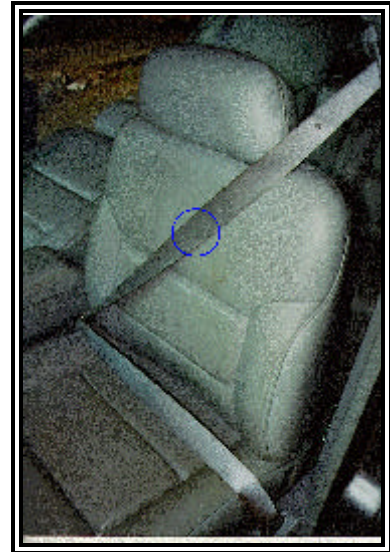
All evidence identified in the course of the investigation indicated the Oldsmobile's driver was restrained. The first responders to the crash scene indicated they removed the seat belt from the driver during the extrication process. **Figure 6** is a view of the left front restraint. Inspection of the restraint identified a region on the shoulder belt webbing that exhibited evidence of occupant contact. The contact evidence was approximately 10 cm (4 in) in length and was located 33.6-43.8 cm (13.25-17.25 in) from the latch plate. Webbing fibers located within this area were stretched and pulled. This region of the shoulder belt would have been located approximately over the driver's mid-chest and probably contributed to the driver's skeletal injuries. The left front D-ring was in the full up position. This D-ring adjustment would have introduced slack in the belt system, given the driver's short stature. The D-ring probably should have been adjusted to the full down position to provide a better fit of the shoulder belt to the driver's stature.

Figure 6: View of the left front restraint.

The driver initiated a forward trajectory in response to the 12 o'clock direction of the impact force and loaded the 3-point restraint. Inspection of the left front restraint identified a 10 cm (4 in) section of the webbing with fibers that were stretched/pulled, **Figure 6**. This deformed section of the belt would have been positioned approximately over the driver's mid-chest. In the crash, the Oldsmobile under-rode the GMC truck's front bumper and contacted the truck's left front tire. The "soft" (under-ride) nature of the impact delayed the deployment of the Oldsmobile's SIR until a point late in the collision sequence. The SDM commanded deployment of the air bag system 147 milliseconds (0.147 seconds) after detection of the crash. The late air bag deployment resulted in increased manual restraint loading and greater occupant

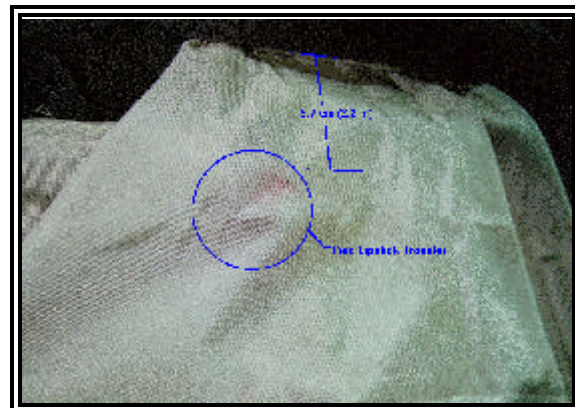
The driver air bag module was designed in the typical configuration within the center hub of the steering wheel. The I-configuration cover flaps measured 8.3 cm by 12.7 cm (3.3 in by 5.0 in) width by height. There was no contact evidence on the exterior surfaces of the cover flaps. A 2.5 cm by 1.2 cm (1.0 in by 0.5 in) red lip stick transfer from occupant contact was identified on the back side of the air bag. The transfer was located in the 10 o'clock sector approximately 5.7 cm (2.2 in) from the module (**Figure 7**).

Figure 7: Lip stick transfer to the back side of the driver air bag.

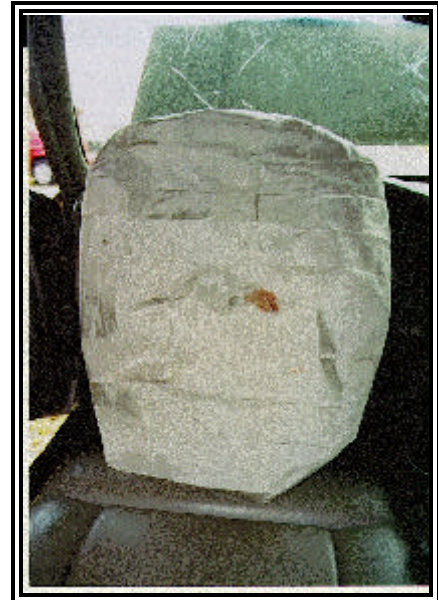
Figure 8 is a view of the face of the driver air bag. The air bag was oval shaped and measured 51 cm by 61 cm (20 in by 24 in) width by height. The bag was not tethered. There were two 2.5 cm (1.0 in) vent ports located in the 3/9 o'clock sectors on the back side of the bag. One 3 mm (1/8 in) diameter blood

spatter and two 3 mm (1/8 in) diameter blood spatters were located on the face of the air bag in the upper left and lower right quadrants, respectively. A 3.8 cm (1.5 in) diameter blood transfer was located on the face of the bag 4.5 cm (1.8 in) right of center. A red lip stick transfer, 1.2 cm (0.5 in) in length, was located 12.1 cm (4.8 in) left of the center of bag. The transfers on the face of the air bag resulted from the driver's rebound contact.

Figure 8: View of the driver air bag.

The air bag expanded across the driver's chest, neck and face. The continued expansion of the bag hyper-extended the driver's head causing an atlanto-occipital dislocation and a brainstem contusion. Expansion of the bag caused the multiple abrasions/contusions to the face and the laceration of the lower lip. The driver rebounded to the seat back and then forward again into contact with the face of the air bag evidenced by the lip stick and blood transfers on the face of the bag, **Figure 8**. Post-crash, the driver was found slumped over the steering wheel and unresponsive.
