SCI/NASS COMBINATION CASE REPORT

CASE NUMBER - NASS-1999-05-103G

VEHICLE - 2000 MERCEDES BENZ S430V

CRASH DATE - September, 1999

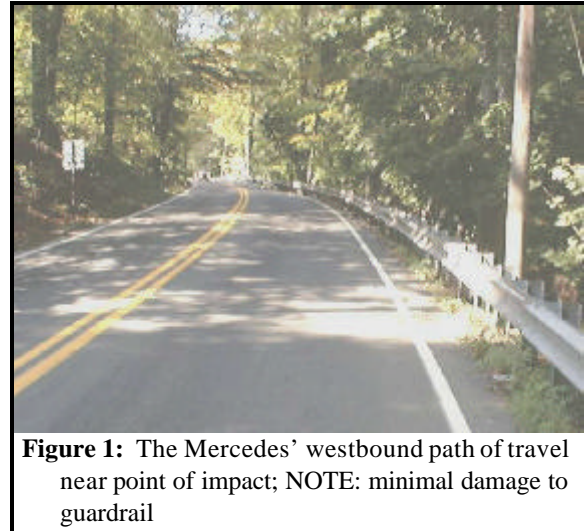
The Mercedes was traveling west in the westbound lane of a two-way, undivided county roadway, negotiating a curve left and intending to continue traveling west (**Figure 1**). The Oldsmobile was traveling east in the eastbound lane of the same roadway negotiating a curve right. The bituminous roadway was curved and level at the point of the crash, with no defects. It was daylight at the time of the crash with no adverse weather and the roadway was dry. The posted speed limit was 40 km.p.h. [25 m.p.h.]. The roadway was controlled by a curve warning sign. The roadway was divided by a double yellow line and bordered by solid white fog lines, with a W-beam guardrail along the north edge. According to the Police Crash Report, the driver of the Oldsmobile steered into the westbound lane to avoid an animal. The Mercedes' driver braked and steered to the right in an attempt to avoid the crash with the Oldsmobile. The crash occurred in the westbound lane of the roadway.

Figure 1: The Mercedes' westbound path of travel near point of impact; NOTE: minimal damage to guardrail

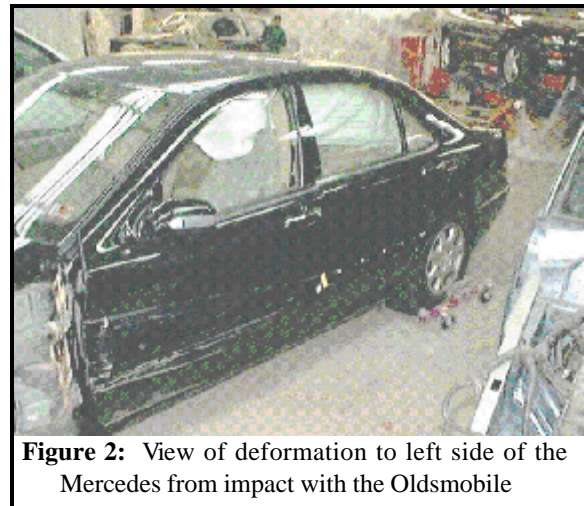
The Mercedes' initial contact with the Oldsmobile involved the left front fender just behind the left front axle and extended rearward (**Figures 2 and 3**). The Mercedes' front left tire was restricted. The maximum crush to the Mercedes' left side was a measured 12 centimeters [4.7 inches]. The wheelbase on the left side was shortened 2 centimeters [0.8 inches], with the right side being lengthened 3 centimeters [1.2 inches]. The left front tire was deflated during the vehicle's initial impact with the Oldsmobile. Direct damage to the Mercedes from the right side impact with the guardrail was swiping-type damage with maximum crush limited to surface scratches only.

Figure 2: View of deformation to left side of the Mercedes from impact with the Oldsmobile

The CDCs were determined to be: **11-LYEW-1 (340)** and **01-RFES-1 (20)** for the Mercedes. No reconstruction program was used on the Mercedes' left side impact due to the collision conditions being beyond the scope of the WinSMASH reconstruction program (swiping-type damage). This contractor's visually estimated Delta V for the left side impact is between 8 km.p.h. [5 m.p.h.] and 16 km.p.h. [10 m.p.h.].

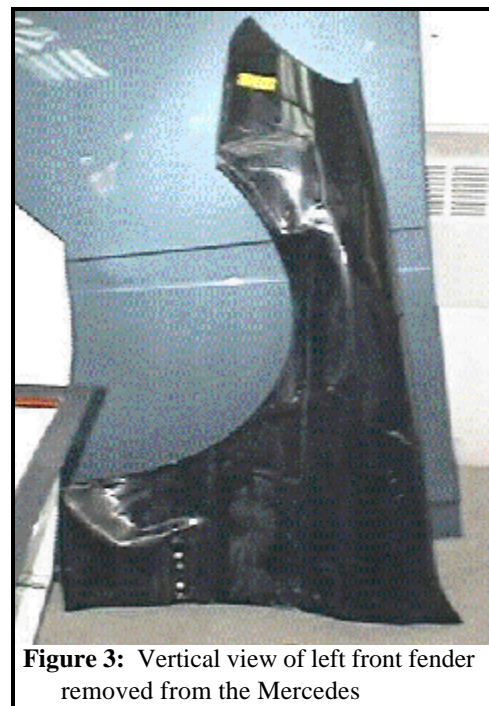
Figure 3: Vertical view of left front fender removed from the Mercedes

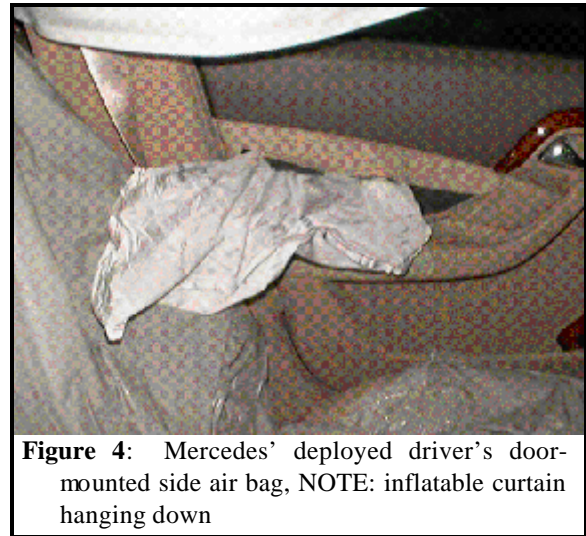
Both left side door air bags deployed from their respective door panels above the armrests where each was mounted. Both door-mounted air bag module covers had overall dimensions of 5 centimeters [2 inches] vertically and 35 centimeters [13.8 inches] horizontally. The covers appear to be made of thick vinyl/leather type material. Both left side door-mounted air bags were 50 centimeters [19.7 inches] longitudinally and 15 centimeters [5.9 inches] vertically and were not tethered or vented. An inspection of both of the Mercedes' left side door-mounted air bags and cover flaps revealed no visible evidence of direct contact (**Figures 4 and 5**). It should be noted that there was no occupant in the left rear seat position.

Figure 4: Mercedes' deployed driver's door-mounted side air bag, NOTE: inflatable curtain hanging down

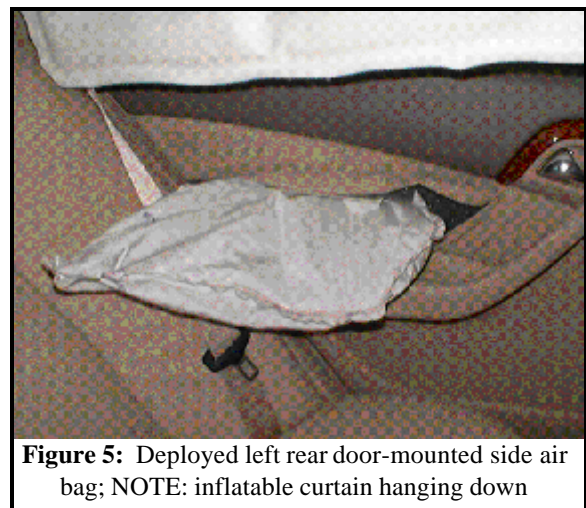
Figure 5: Deployed left rear door-mounted side air bag; NOTE: inflatable curtain hanging down

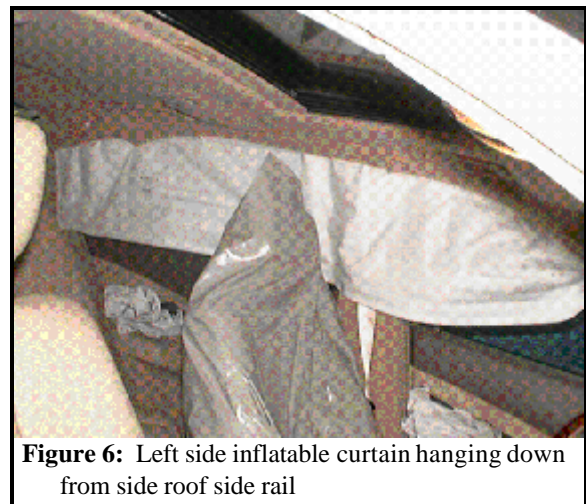
The Mercedes' left side inflatable curtain deployed from the left roof rail where it was mounted. The single cover flap had overall dimensions of 160 centimeters [63 inches] longitudinally and 8 centimeters [3.2 inches] vertically. The inflatable curtain's dimensions were 160 centimeters [63 inches] longitudinally and 28 centimeters [11 inches] vertically and was not tethered or vented (**Figure 6**). An inspection of the Mercedes' left side inflatable curtain and cover flap revealed no visible evidence of direct contact except for a hair on the curtain near the driver's seat position.

Figure 6: Left side inflatable curtain hanging down from side roof side rail

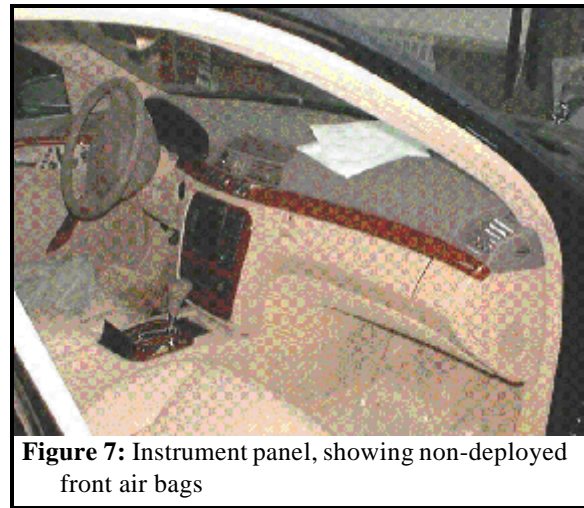
The Mercedes' two frontal air bags did not deploy in the left side impact. The driver's front air bag was mounted to the steering wheel hub and the front right passenger's front air bag was mounted to the knee bolster (**Figure 7**).

Figure 7: Instrument panel, showing non-deployed front air bags
