Remote, Redesigned Air Bag Special Study

Dynamic Science, Inc., Case Number ( 1999-79-031C)

1998 Toyota Tacoma pickup

March/1999

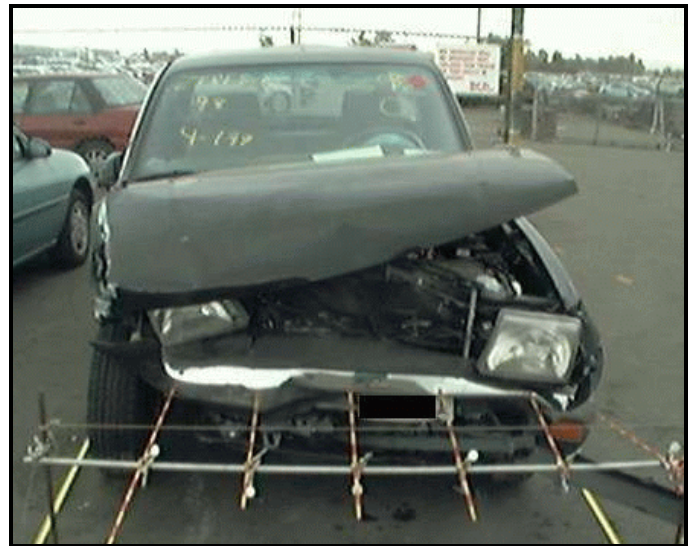
**Figure 1.** Front view, Vehicle 1 (case vehicle), Toyota Tacoma

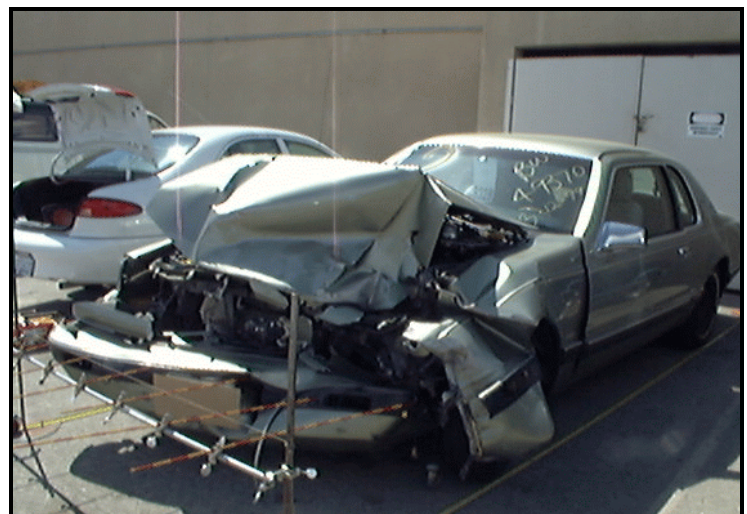
**Figure 2.** Front left view, Vehicle 2, Ford Thunderbird

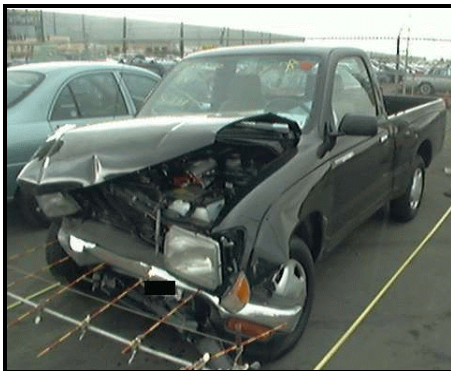
**Figure 3.** Front left view, Vehicle 1

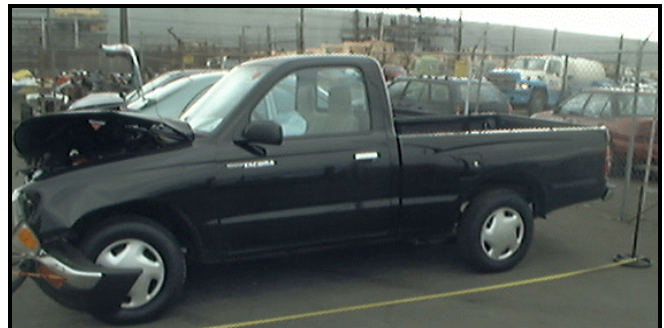
**Figure 4.** Left side, Vehicle 1

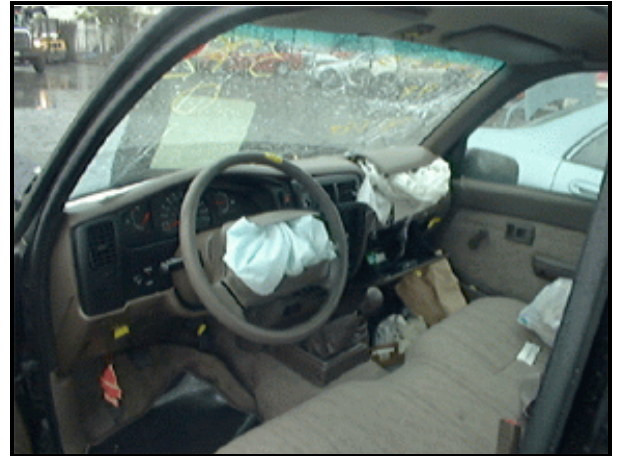
The case vehicle was equipped with a tilt-forward cloth bench seat that had been adjusted to between the forward most and middle track position. The bench seat was equipped with integral headrests at the outboard positions.

**Figure 5.** Driver's seated position

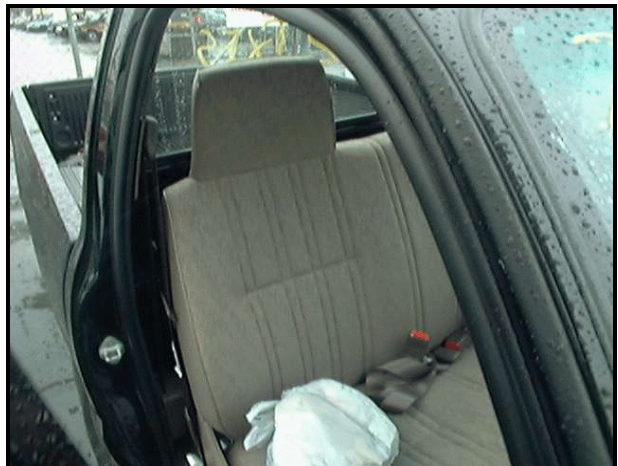
**Figure 6.** Passenger's seated position

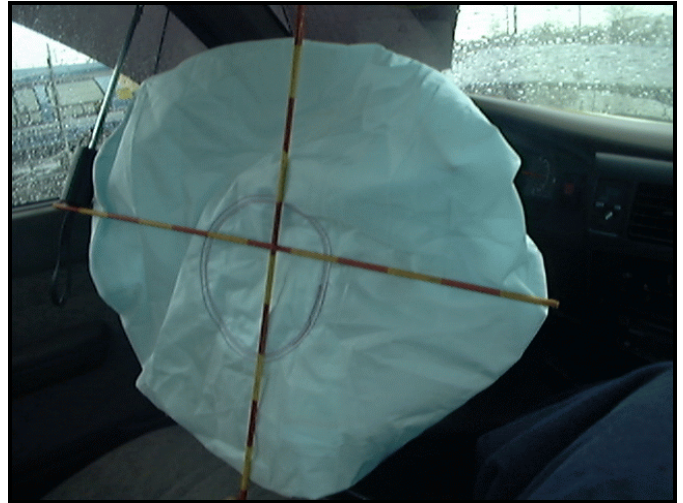
The Toyota Tacoma was equipped with a redesigned air bag system which consisted of front left and front right air bag modules which housed air bags and depowered inflator units. The front left air bag was housed in the steering wheel hub and was concealed by H-configuration cover flaps that were not damaged. The circular air bag was equipped with four tethers and two vent holes. No contact evidence was found on the air bag and the air bag was not damaged.

**Figure 7.** Driver's frontal air bag

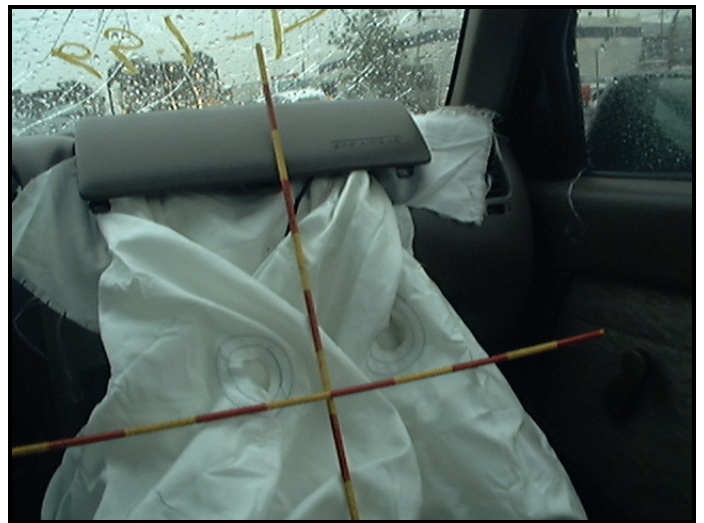
The front right air bag was housed in the mid instrument panel. The air bag was equipped with two vent ports, but did not come equipped with tethers. Neither the air bag nor the module covers were damaged. The passenger air bag had a shut off switch; the switch was in the "ON" position.

**Figure 8.** Passenger's frontal air bag

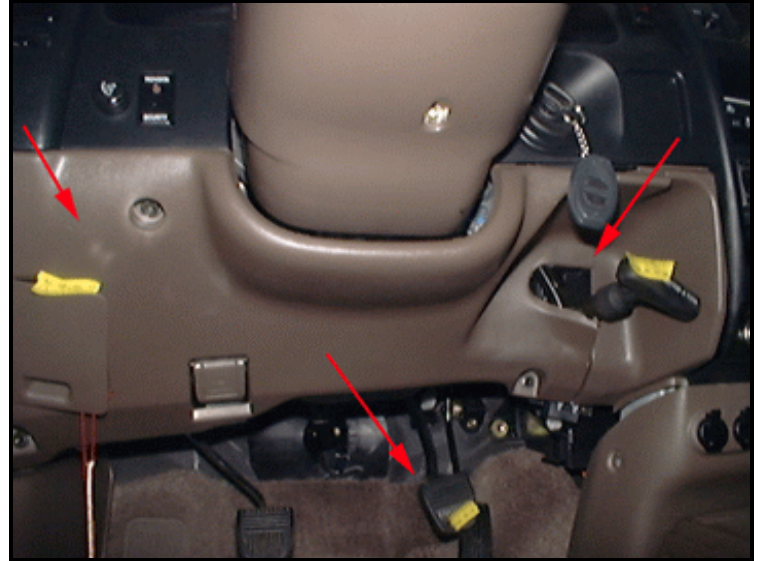
The interior of the Toyota Tacoma sustained moderate damage from occupant contacts. The mirror had been displaced and the upper steering wheel rim was deformed 3 cm forward. There were knee contact deformations to both sides of the left instrument panel. The brake pedal had been deformed by the driver's right foot. On the passenger side there were bilateral contacts to the right instrument panel as a result of interaction with the front right passenger's knees.

**Figure 9.** Contacts to left lower instrument panel and deformation of brake pedal

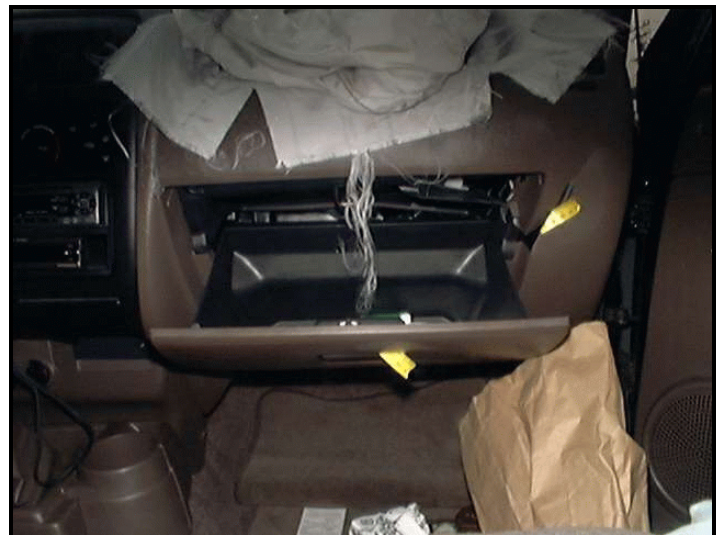
**Figure 10.** Contacts to right instrument panel
