U.S. Department
of Transportation

National Highway
Traffic Safety
Administration

Analysis of Electronic Control Unit and Accelerator Pedal Mechanism Components Damaged During EMC Testing

February 2011

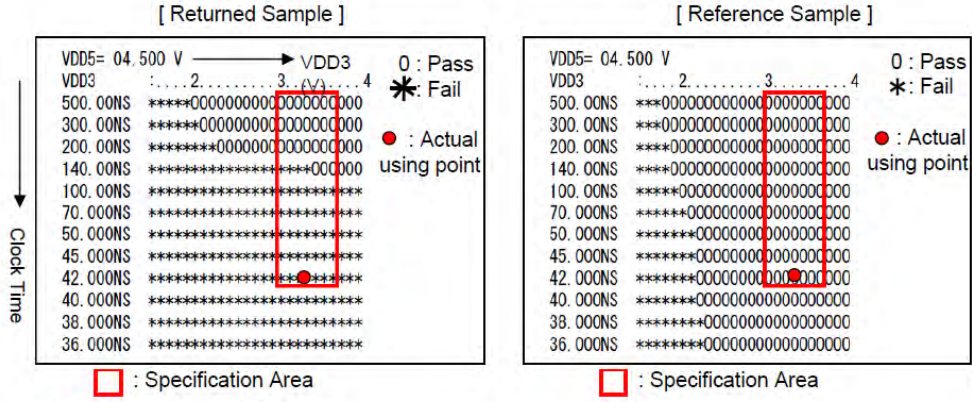
(5) FLASH Memory Reading check : Abnormality was observed

Can not read out the data from FLASH Memory at high speed frequency .
 (Speed marginal failure of reading FLASH memory)

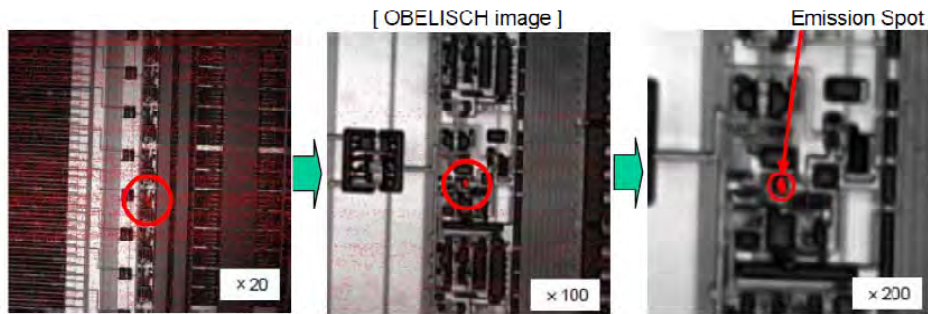
(2) OBELISCH check : Abnormality was observed

The supplier performed OBELISCH analysis at the low marginal memory cell in FLASH macro area , and confirmed the abnormal emission spot in the sense AMP circuit .

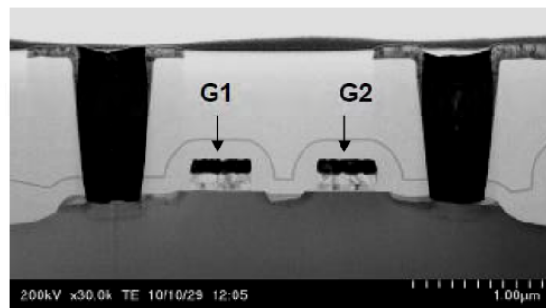
(3) TEM check : Abnormality was observed

The supplier performed TEM analysis at the above emission point (N-ch Transistor) , and confirmed the abnormality (delamination & Void) .

***A : Delamination between Silicide and Interlayer insulator**
***B : Void (Ti-ion was moved by heat)**

Above physical analysis revealed that the resistive impedance between G1 drain and G2 source goes up and it introduced malfunction of FLASH memory reading at high frequency .

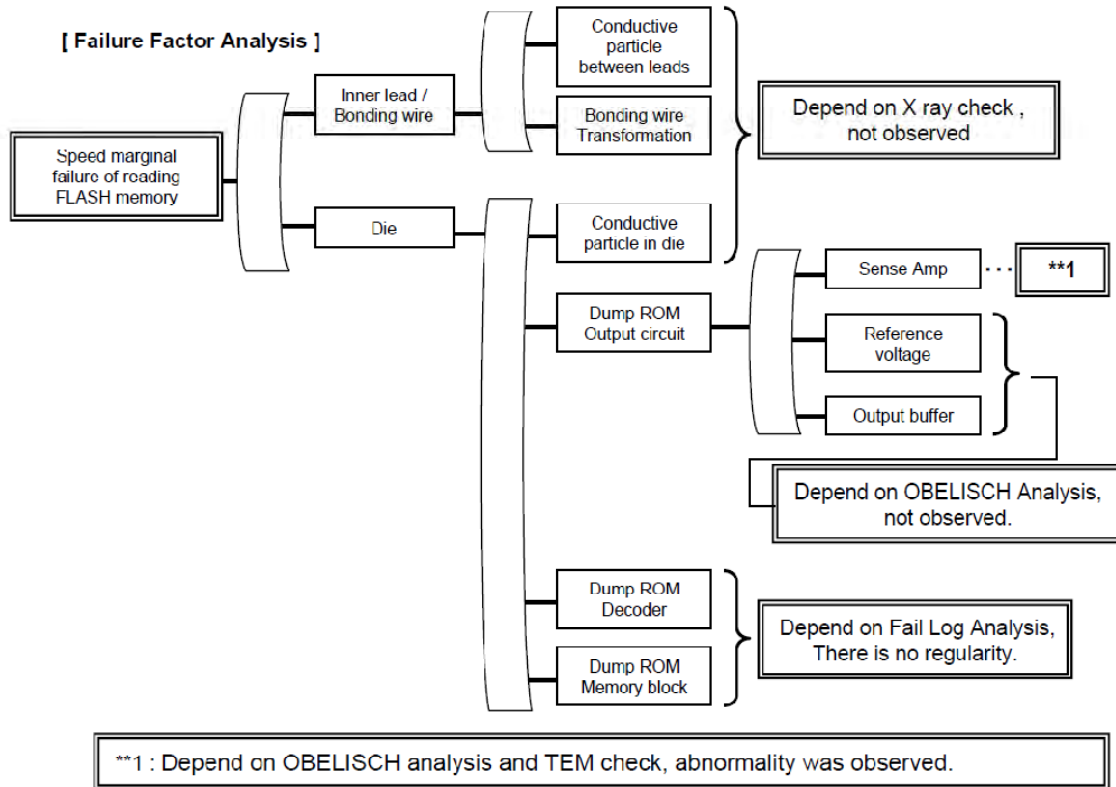
(4) FTA (Failure Tree Analysis)

The supplier found defective points of die, and these were sense Amp circuit N-ch MOSs (G1 & G2).

These points had delamination and voids, and became high resistive characteristic. This high resistive characteristic of these transistors can explain the malfunction of FLASH memory reading at high speed frequency.

- A high current flowed into the sense AMP circuit under the abnormal electric field, and overheated.
- The delamination and voids occurred.

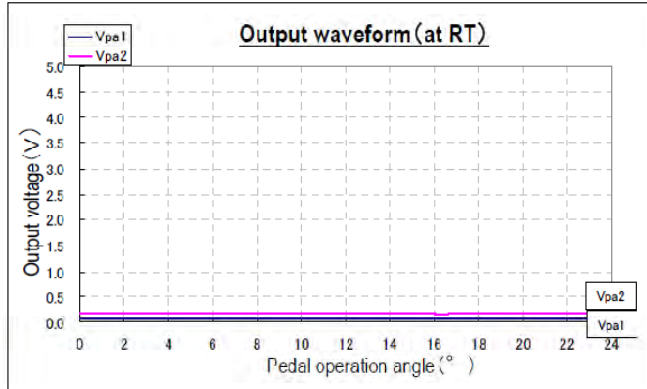
Waveform of the investigated part

• Abnormalities are observed in Vpa1 and Vpa2.

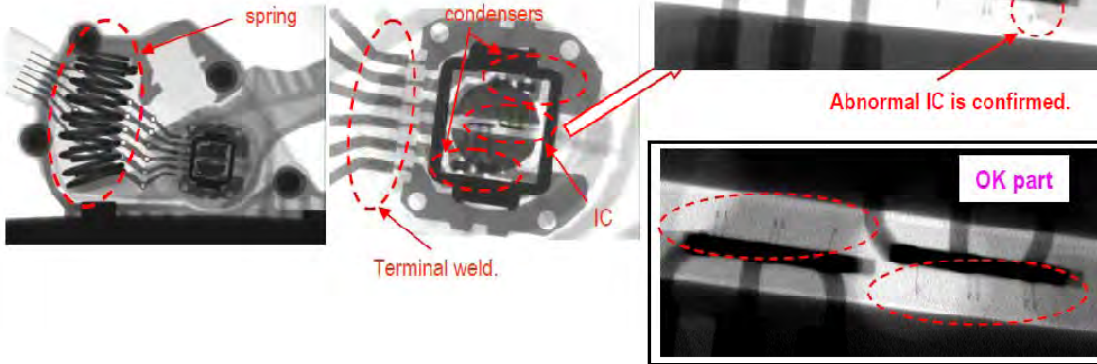
6) X-ray

- No abnormality was found in the internal assembling conditions.
- No abnormality was found in the capacitor assembling conditions.
- Abnormal IC is confirmed.

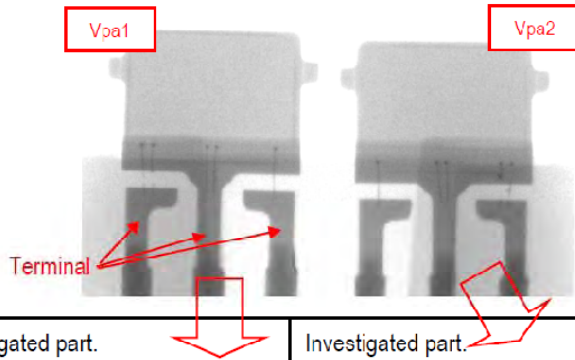
- ② X ray check for the 1st molding condition.
The wire bonding was broken.

Investigated part. IC Vpa1 side.	Investigated part. IC Vpa2 side.	OK part. Representative(IC Vpa1 side)
<p>Vc GND Vpa</p> <p>Broken wire</p>	<p>Vpa GND Vc</p> <p>Broken wire</p>	<p>Wire bond(Five)</p>
Terminal Vc: The wire bonding is broken.	Terminal Vc: The wire bonding is broken.	No abnormality is found.

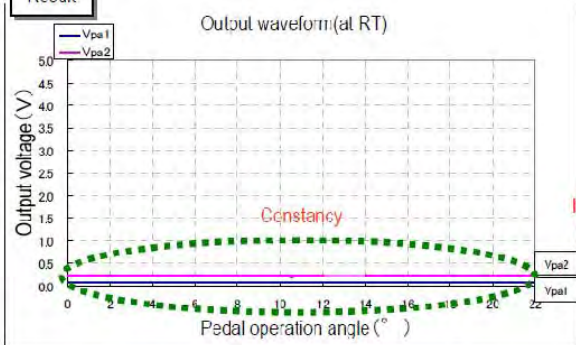
Result

Abnormalities are observed in Vpa1 and Vpa2.

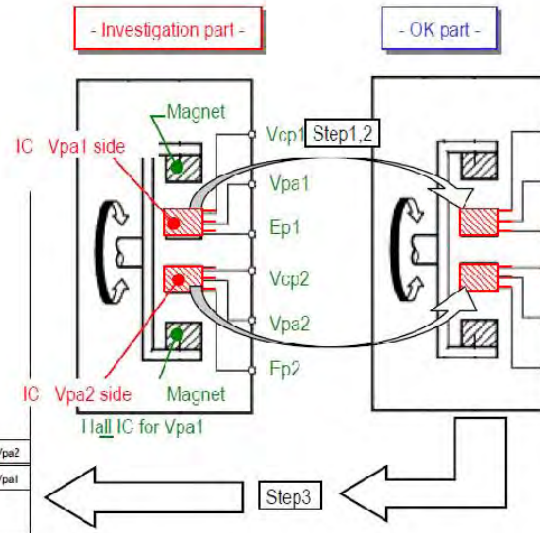
IC(Vpa1/Vpa2): Abnormalities were found in Vpa1 and Vpa2 .

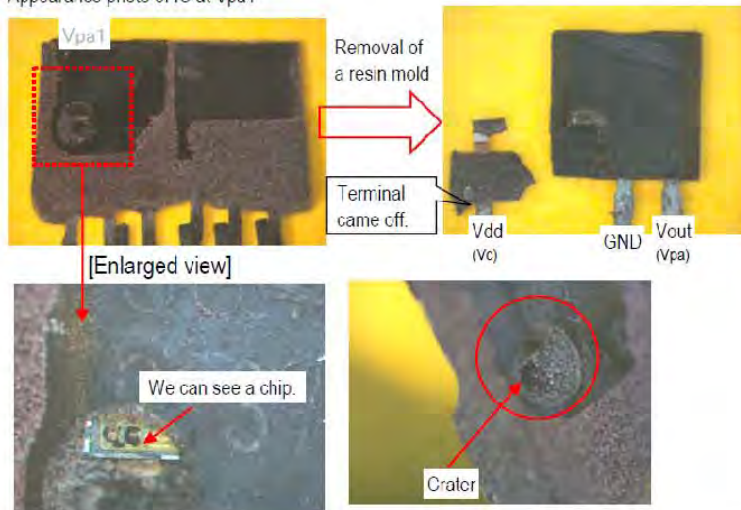
• Appearance photo of IC at Vpa1

- When removing a resin mold, Vdd terminal came off.
- To the extent that we can see the chip inside, a crater (molten material) in the package near Vdd was found.

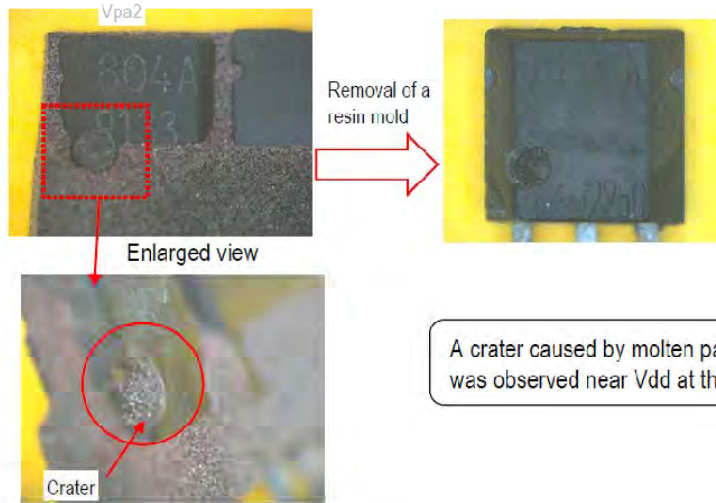
• Appearance photo of IC at Vpa2

A crater caused by molten package materials was observed near Vdd at the IC package.

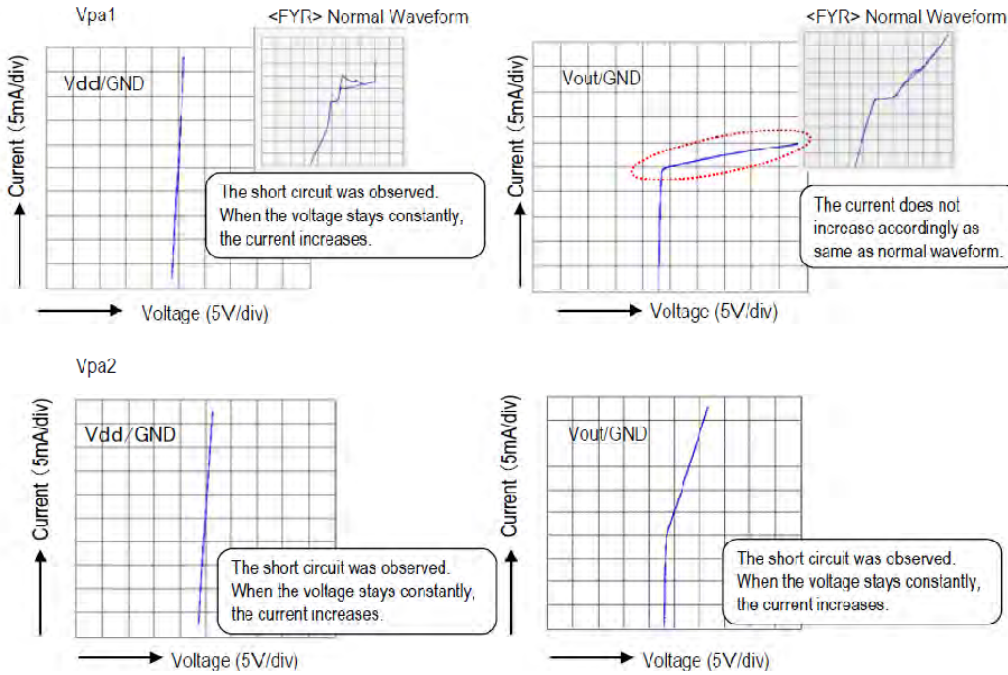
4-2 Curve Tracing

The characteristics of curve tracing are no good for Vpa1 and Vpa2.

* Abnormalities were found in the electrical characteristics. (Vpa1 and Vpa2)

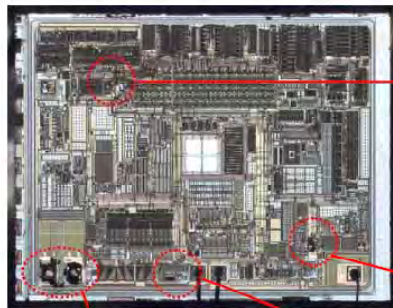
Vpa1

We identified the discoloration and molten near Vdd pads, GND pads, Output Amp and EPROM block.

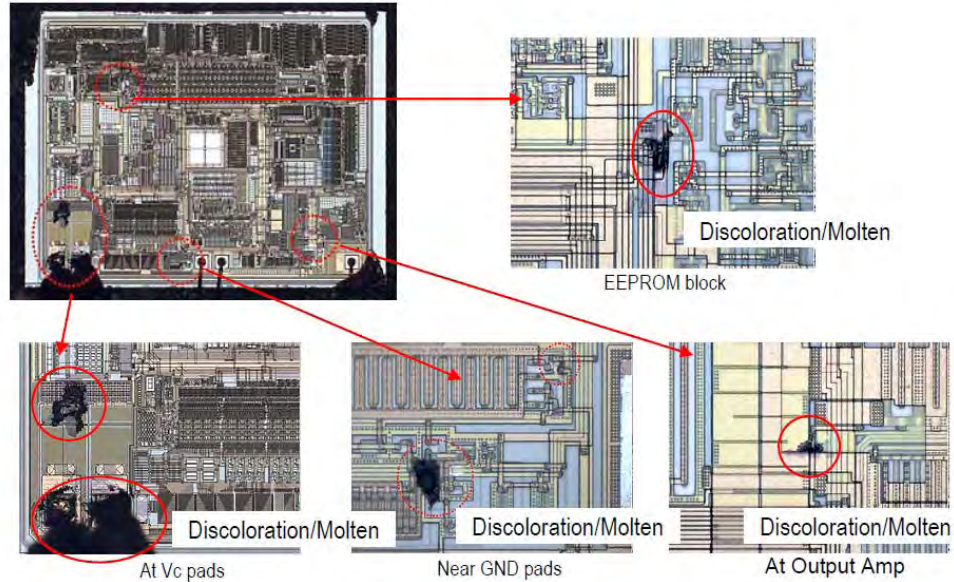
Vpa2

We identified the discoloration and molten near Vdd pads, GND pads, Output Amp and EPROM block.

Through the investigation, at both VPA 1 and VPA2, we identified the wire bonding molten which are used to make interconnections between IC and terminals.
 We identified molten metal wires (Al) and the discoloration at several areas including bond pads.
 Therefore we came to a conclusion that excessive electrical overstress was applied to the IC through the external sources. The electrical overstress (EOS) may have caused the IC to break.

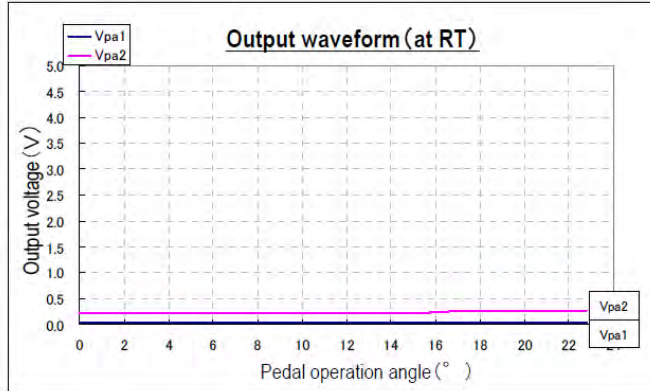
Waveform of the investigated part

- Abnormalities are observed in Vpa1 and Vpa2.

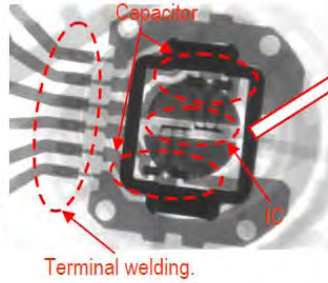
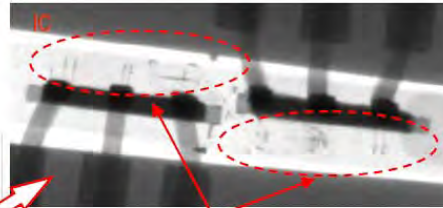
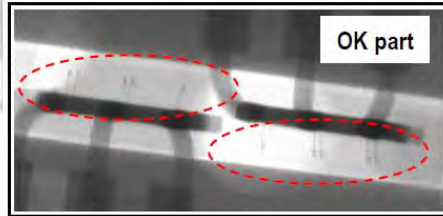
6) X-ray

- No abnormality was found in the internal assembling conditions.
- No abnormality was found in the capacitor assembling conditions.
- Abnormal IC is confirmed.

Abnormal IC is confirmed.

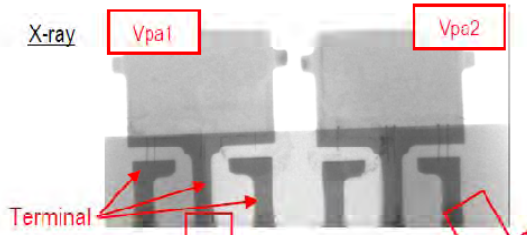
② X ray check for the 1st molding condition.

The wire bonding was broken.

Investigated part. IC Vpa1 side.	Investigated part. IC Vpa2 side.	OK part. Representative(IC Vpa1 side)
<p>Vc GND Vpa</p> <p>Broken wire</p>	<p>Vpa GND Vc</p> <p>Broken wire</p>	<p>Wire bond(Five)</p>
Terminal Vpa: The wire bonding is broken.	Terminal Vpa and GND: The wire bonding is broken.	No abnormality is found.

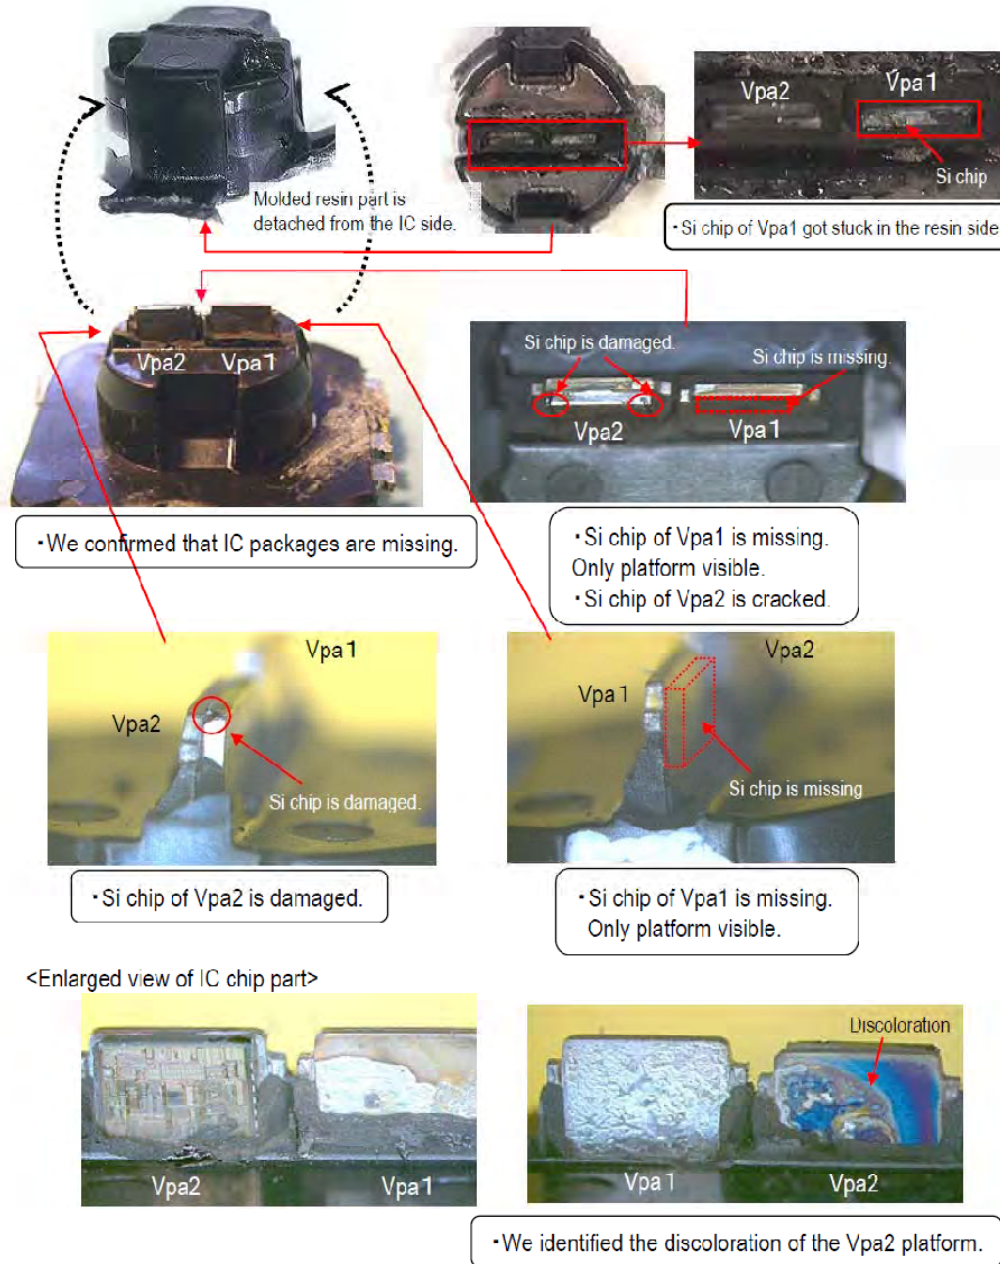
4-1 External Visual Inspection

Si chip of Vpa1 came off when disassembling, Si chip got stuck in the molded resin part. We cannot continue to carry out further investigation. However, we confirmed the discoloration of the Vpa2 platform. Therefore we came to a conclusion that excessive electrical overstress was applied to the IC through the external sources. The electrical overstress (EOS) may have caused the IC to break.
