Case 469 : Narrative

Case Vehicle (A): 1999 Ford	Vehicle (B): 1997 Chrysler
Type: Taurus SE, 4-door sedan	Type: Sebring LXI, 2-door coupe
Driver: 45-year-old female	Driver: 39-year-old female
CDC: 12-FYEW-1	CDC: 01-FZEW-1

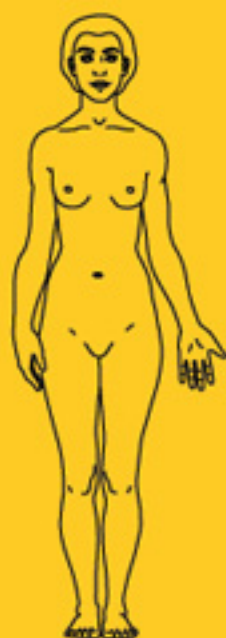
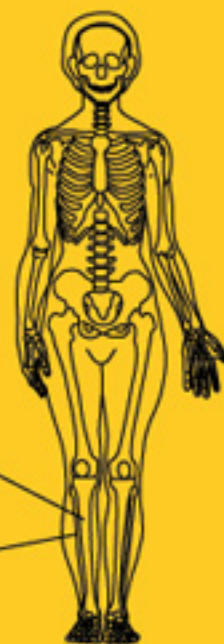
During the frontal impact, the driver moved forward relative to the vehicle interior, into the 3-point belt, steering-wheel airbag, and knee bolster. She sustained displaced transverse fractures to the mid shafts of the right tibia and fibula, probably from contact of the right knee and leg with the knee bolster, [31](#) as evidenced by forward displacement and indentation of the knee bolster.

Displaced transverse fracture,
mid shaft of right tibia (3)

Displaced transverse fracture,
mid shaft of right fibula (2)

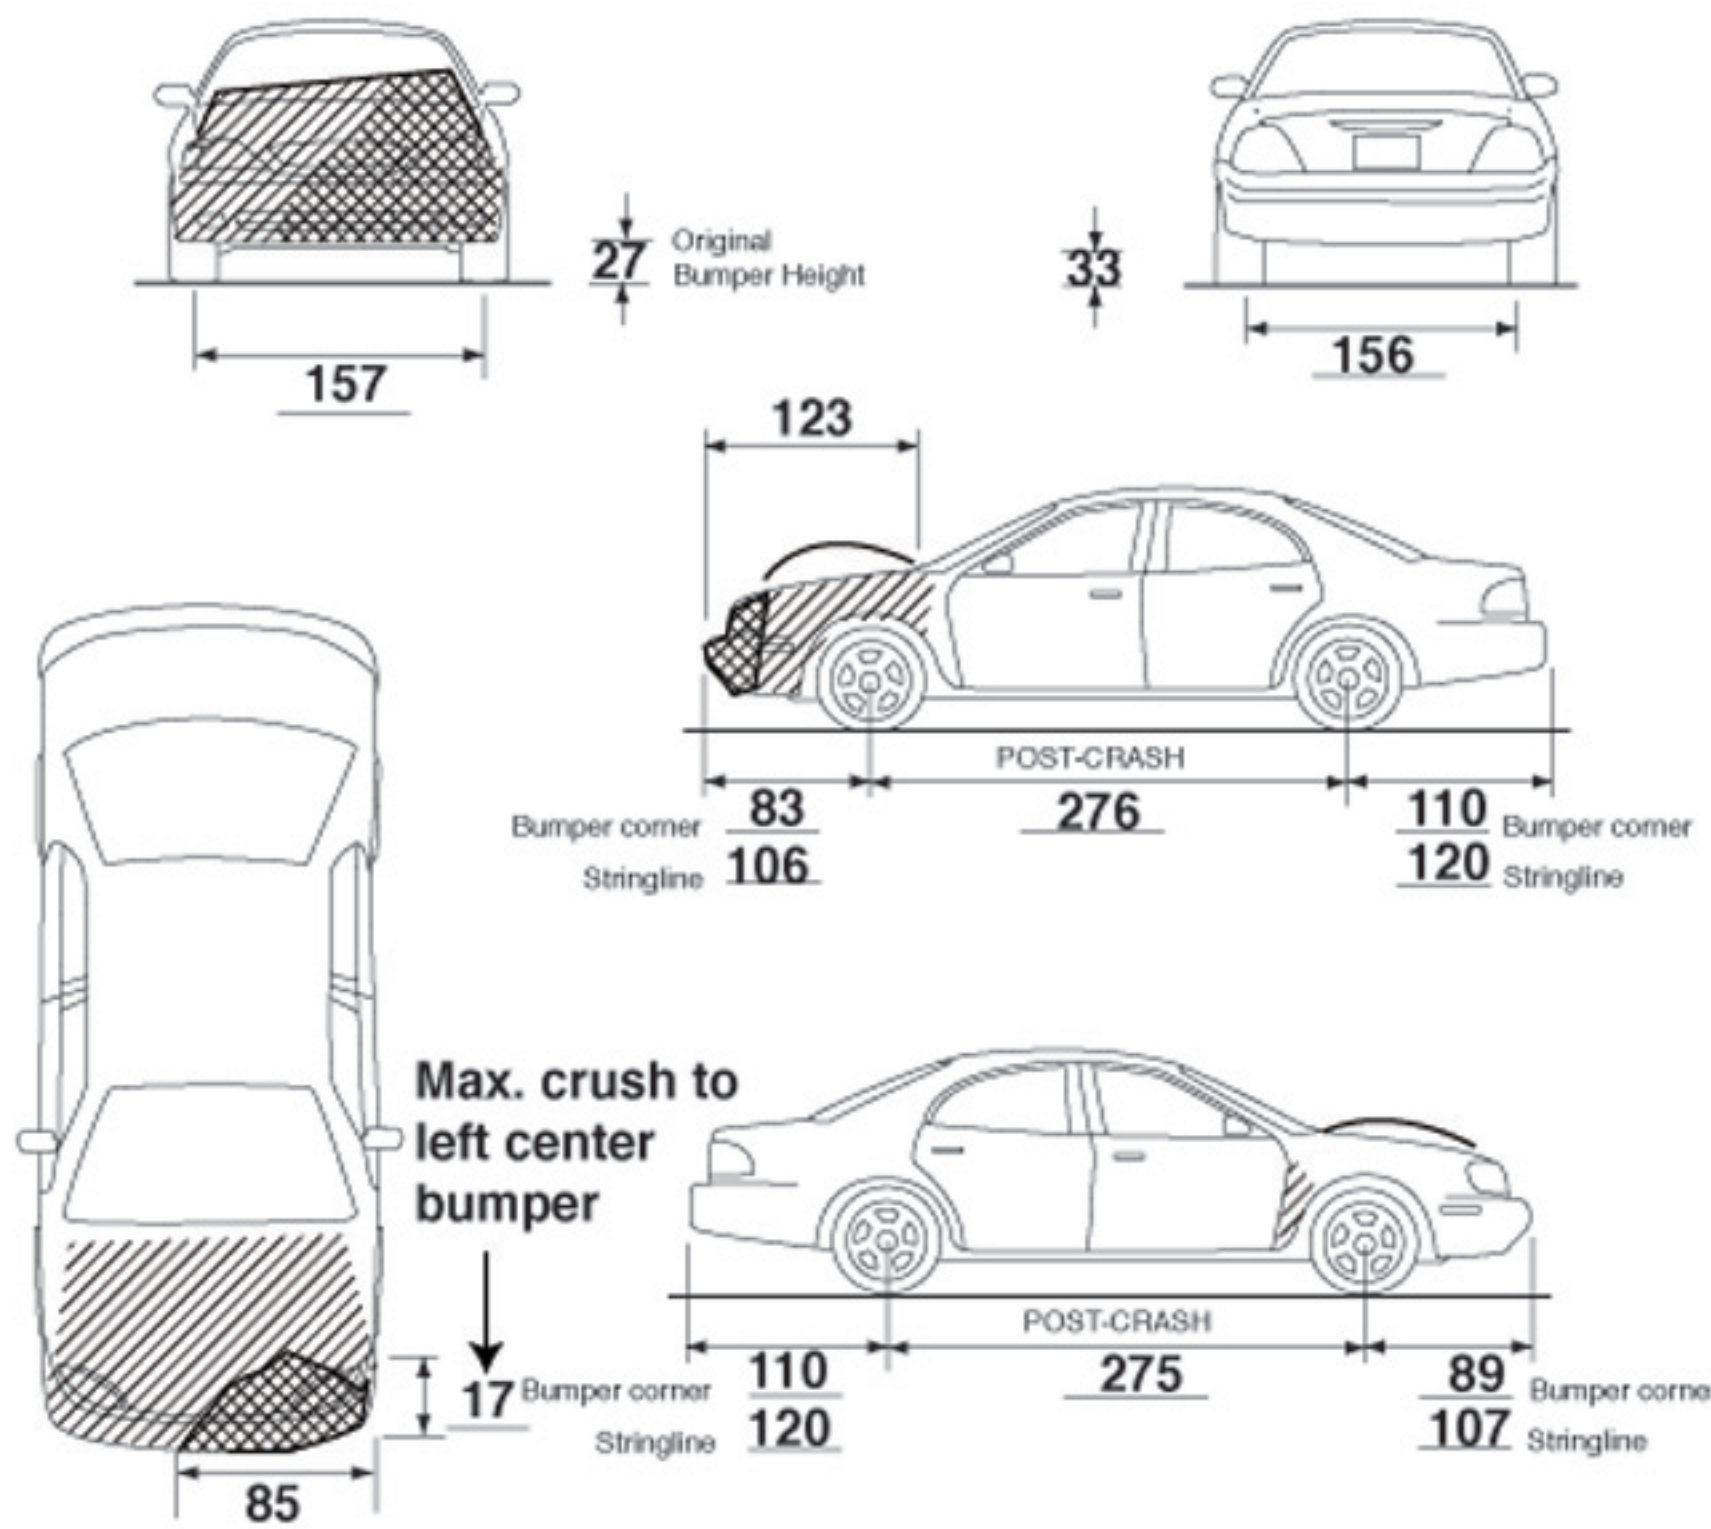
Width of direct damage to front

[4](#) Damage to case vehicle (A) was moderate. [5](#) Direct damage began at the left-front bumper corner and extended 85-cm across the front into the right turn-signal assembly, resulting in 56% vehicle overlap (% VOL). The maximum rearward crush was 17 cm and it occurred near the center of the front bumper.

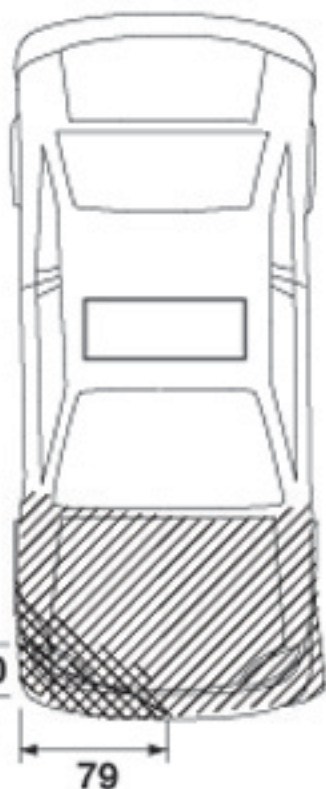
Max. crush to front right bumper corner

[6](#) [7](#) Damage to the right front of vehicle (B) was moderate. Direct damage began at the right-front bumper corner and extended 79-cm to the left, resulting in a 52% VOL. The maximum rearward crush was 20 cm and it occurred at the right-front bumper corner. There was no measurable change to the either wheelbase.
