Case 478 : Narrative

Case Vehicle (A): 2003 Ford	Vehicle (B): 2004 Saab	Vehicle (C): 2004 Ford
Type: Taurus SE, 4-door sedan	Type: 9-5 Aero, 4-door sedan	Type: Freestar SE, 4-door minivan
Driver: 38-year-old female	Driver: 42-year-old female	Driver: 67-year-old male
CDC: 01-FDEW-2, 09-LBEE-2	CDC: 12-FYEW-4	CDC: 99-0000-0

This was a fatal crash in which the belt-plus-airbag restrained driver of vehicle (B) died as a result of head, neck, and chest trauma in a severe frontal crash with case vehicle (A).

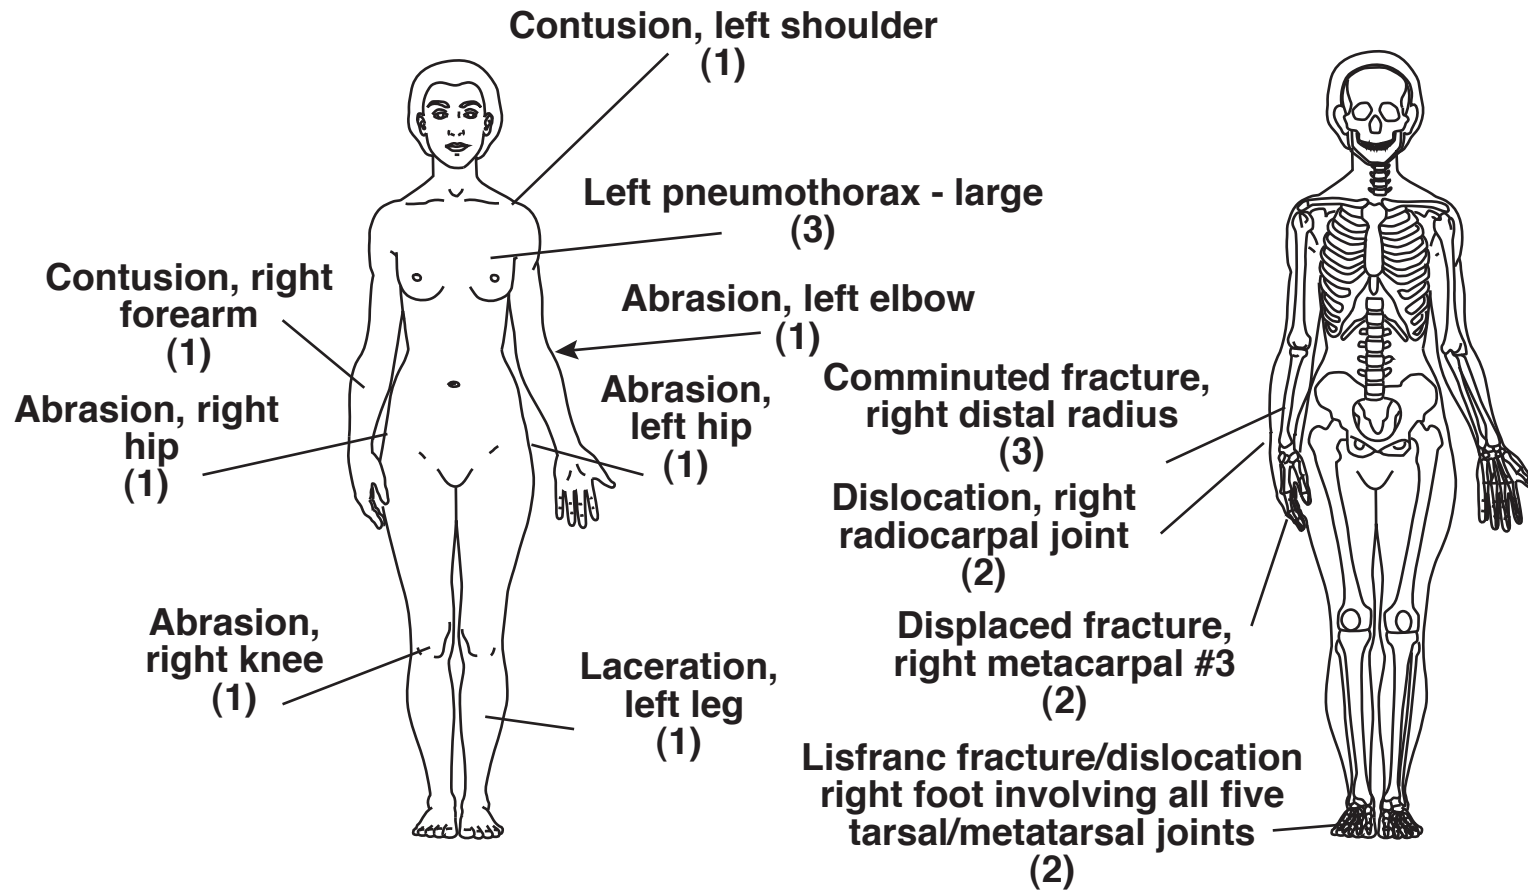
Occupant: Driver		Age: 38 years		Gender: Female	
Restraints: 3-point belt with pretensioner; steering-wheel airbag		Stature: 165 cm (5 ft, 5 in)		Mass: 54 kg (120 lb)	
Injury Description	A.I.S.	Injury Source			
		Definite	Probable	Possible	
—	—	—	—	—	
Left pneumothorax, large	3	Shoulder belt	—	—	
Contusion, left shoulder	1	Shoulder belt	—	—	
Abrasion, left elbow	1	—	Armrest on driver door	—	
Comminuted fracture, right distal radius	3	—	—	Steering wheel (bracing)	
Dislocation, right radiocarpal joint	2	—	—	Steering wheel (bracing)	
Contusion, right forearm	1	—	—	Steering wheel	
Displaced fracture, right metacarpal #3	2	—	—	Steering wheel (bracing)	
Abrasion, left and right hips	1	Lap belt	—	—	
Abrasion, right knee	1	Knee bolster	—	—	
Laceration, left leg	1	Knee bolster	—	—	
Lisfranc fracture/dislocation right foot involving all five tarsal/metatarsal joints	2	—	Accelerator	pedal/toe pan (high-heel shoes)

Maximum A.I.S. Level	3	—	—	—	
Injury Severity Score	19	—	—	—

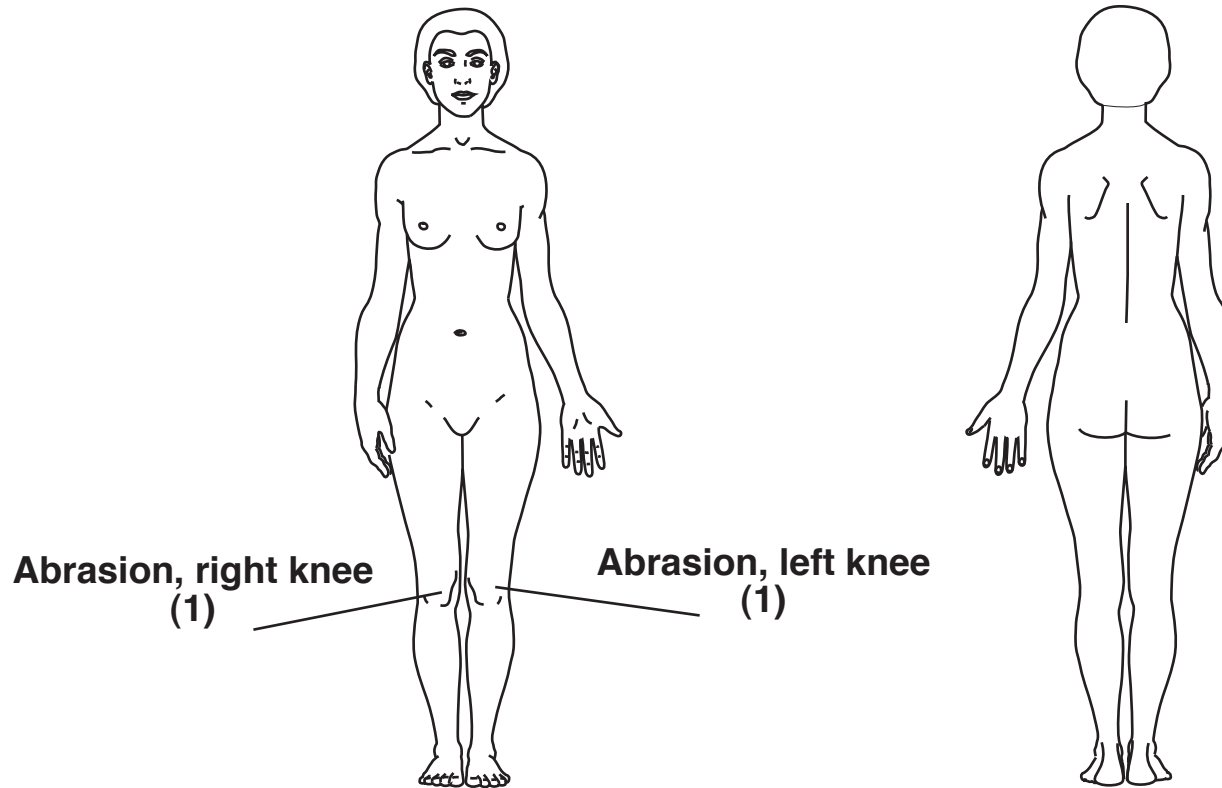
Occupant: Right front		Age: 18 years		Gender: Female	
Restraints: 3-point belt with pretensioner;		Stature: Unknown		Mass: Unknown	
Injury Description	A.I.S.	Injury Source			
		Definite	Probable	Possible	
—	—	—	—	—	
Abrasion, left knee	1	Knee bolster/glove box	—	—	
Abrasion, right knee	1	Knee bolster/glove box	—	—	
Maximum A.I.S. Level	1	—	—	—

Injury Severity Score	1	—	—	—
-----------------------	---	---	---	---

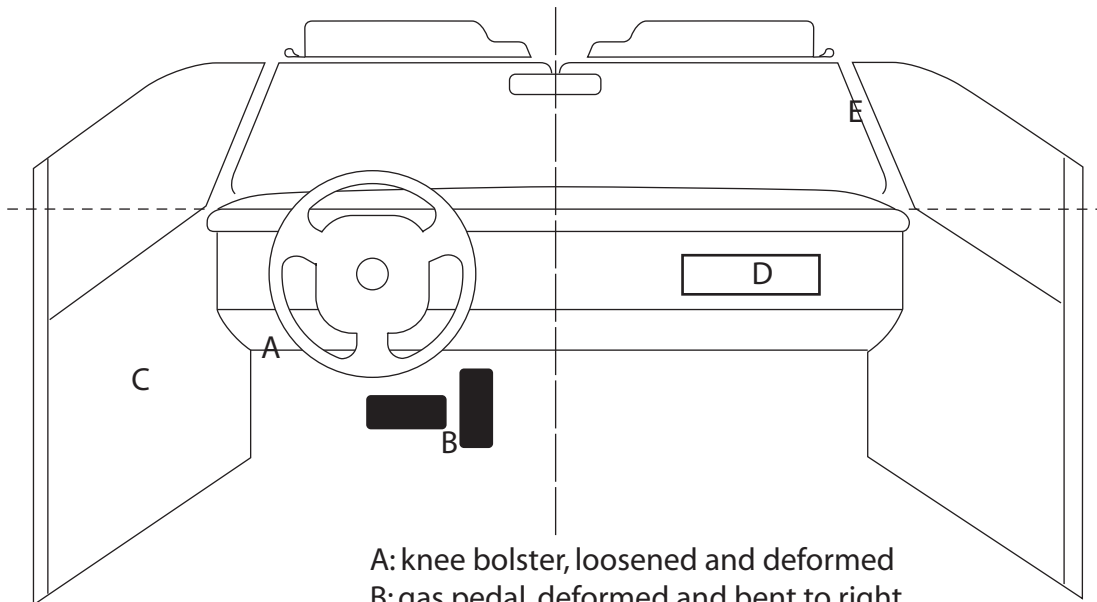
- A: knee bolster, loosened and deformed
- B: gas pedal, deformed and bent to right
- C: driver-door armrest, scuff
- D: glovebox, loosened and scuff
- E: A-pillar, scuff and blood
