**CALSPAN ON-SITE SCHOOL BUS/PEDESTRIAN ACCIDENT INVESTIGATION  
CALSPAN CASE NO. 95-5  
SCHOOL BUS: 1989 INTERNATIONAL CHASSIS/WAYNE BODY  
LOCATION:  
DATE: 1995**

Contract No. DTNH22-94-D-07058

Preliminary Photographs  
Calspan Case No. 95-5  
, OH

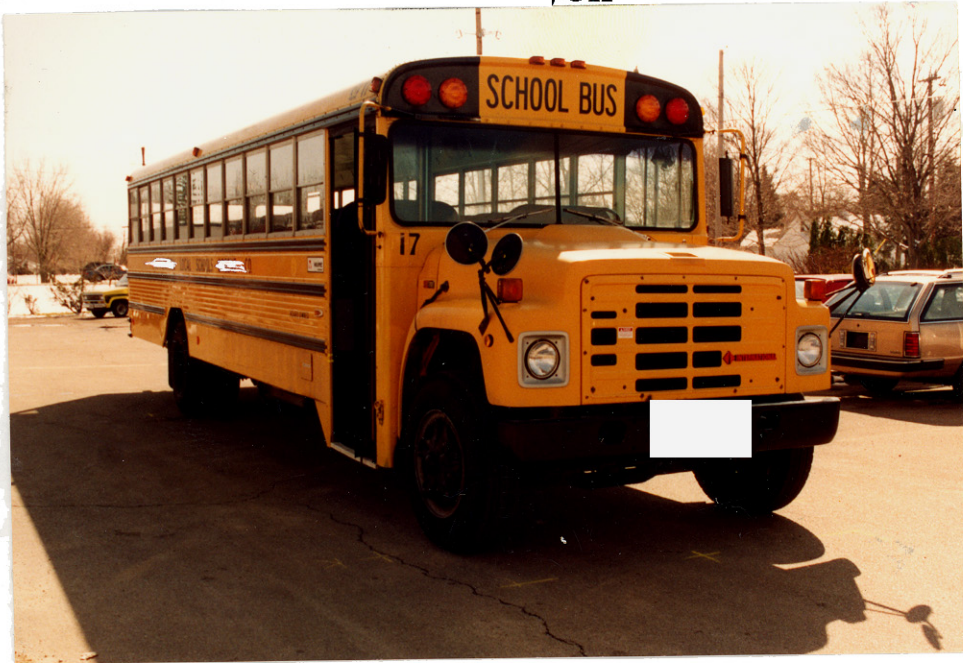
1. Right front three-quarter view of the 1989 Type C International/Wayne Body school bus.

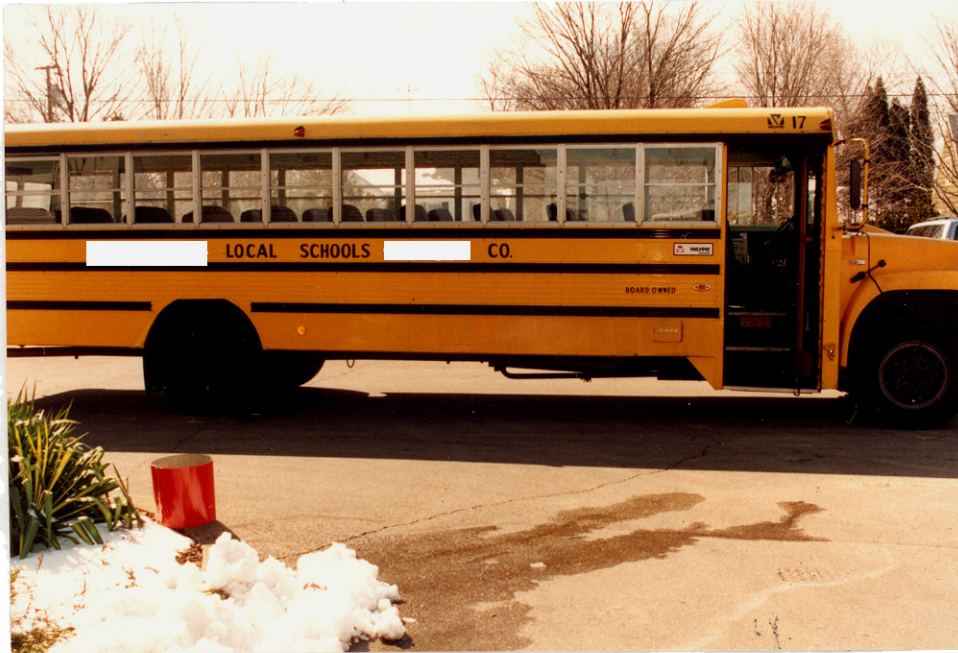
2. Right side view of the involved school bus.

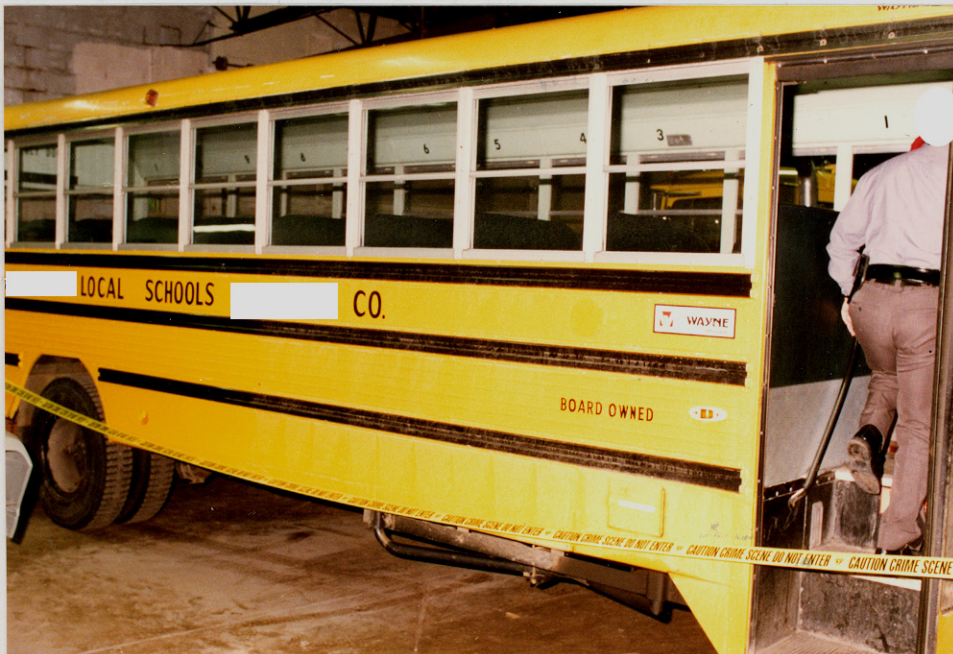
3. Loading door area of the school bus.

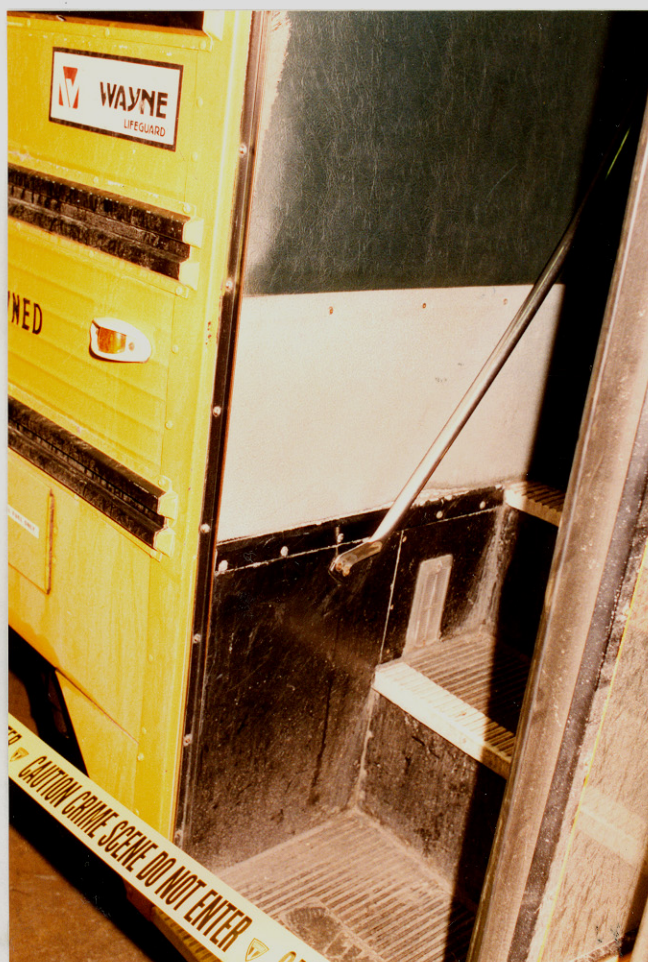
There are two primary causal factors for this accident. The handrail design allowed for an object such as the drawstring to become snagged between the downstream end of the rail and the stairwell wall. Secondary, driver error resulted in the pedestrian being dragged and subsequently run over by the rear tires of the bus. The driver failed to allow the pedestrian sufficient time to safely clear the bus prior to closing the door and accelerating from the bus stop. In addition, the driver did not visually track the pedestrian to ensure that she was a safe distance from the vehicle or check the mirror system for potential hazards prior to accelerating the bus.

4. Stairwell and the downstream end of the handrail.

The Wayne Corporation school bus division that manufactured this bus was out of business prior to this accident. Wayne Wheeled Vehicles, which purchased certain assets of the Wayne Corporation, issued a [redacted] dated [redacted] 1994, offering a retrofit rubber bushing for the handrail and a complete handrail package to all owners of these buses. The Transportation Supervisor of the [redacted] School District stated that he never received this [redacted] and therefore was unaware of the potential hazards. A copy of this [redacted] is included as an attachment to this summary.

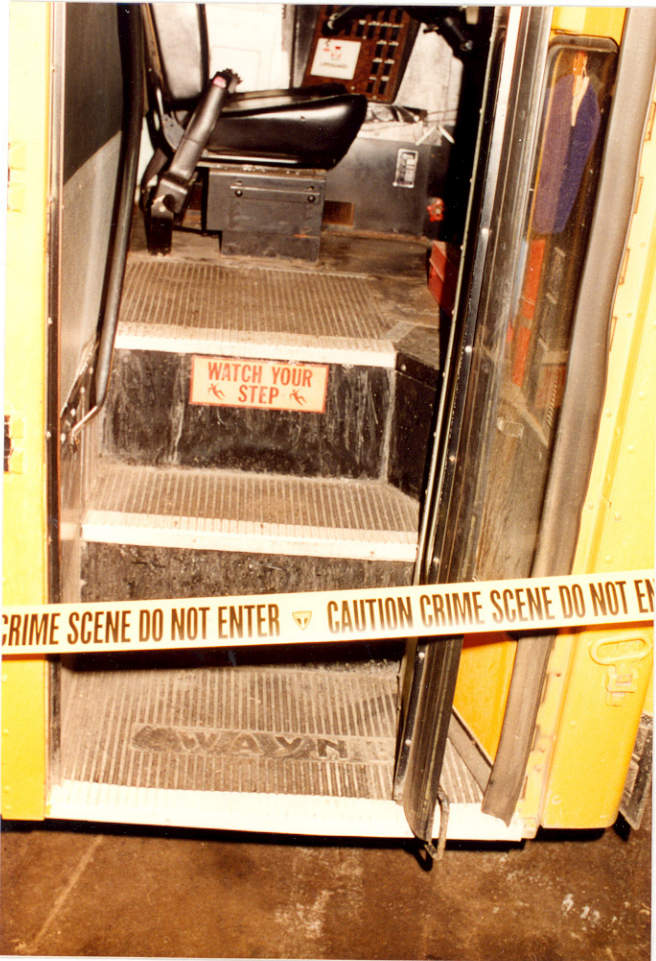
The bus was equipped with a manually operated bi-fold door that opened to the forward side of the stairwell, which provided a 22.4" opening. Three steps provided access to the bus with a vertical transition of 37.75" from ground to floor level. Attached to the trailing side of the stairwell was a 1" diameter stainless steel handrail. The handrail was attached to the padded wall adjacent to the stairwell and was approximately 42" in length. The lower end of the handrail was formed to a flat surface and was bent at an angle of approximately 35 degrees for its attachment point at the base of the stairwell. There was no modification to the lower attachment point of the hand rail. The District's Transportation Supervisor stated that he was unaware of the potential hazard of the hand rail design and that he had never received notification from the manufacturer, or state and federal officials.

5. View of the stairwell, door opening, and handrail.

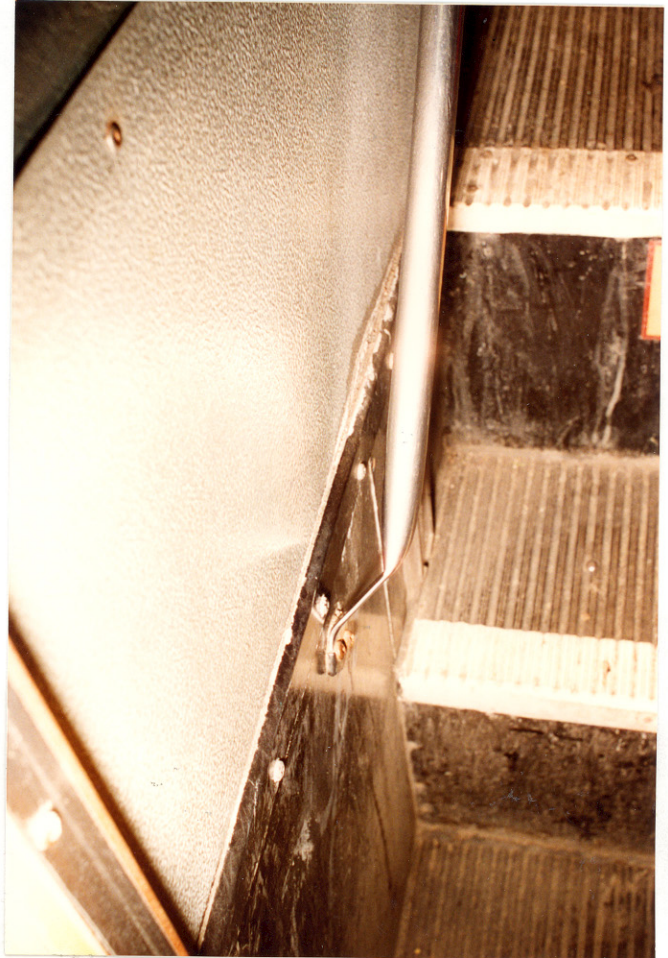
6. Lower handrail attachment point.

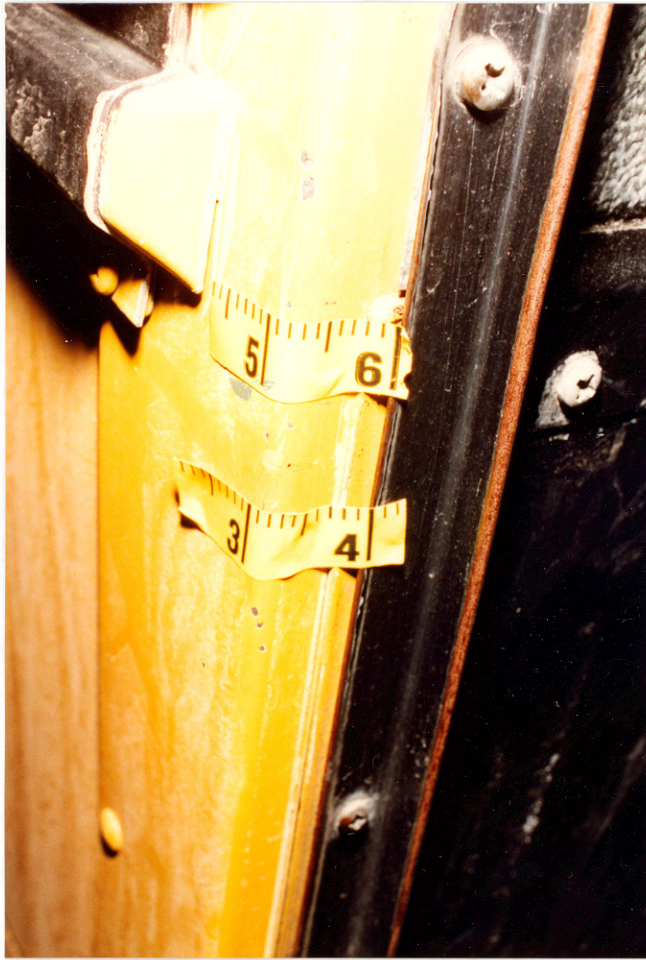
The pedestrian was subsequently pulled by the bus which probably rotated her in a clockwise direction into the right side surface of the vehicle. She was then dragged by the school bus as she began to fall. The drawstring loaded against the painted surface of the bus directly outboard of the handrail and scuffed the paint 37" above ground level, or 22.5" above the bottom step of the bus.

7. Paint abrasion from draw string contact on the rearward edge of the door opening.

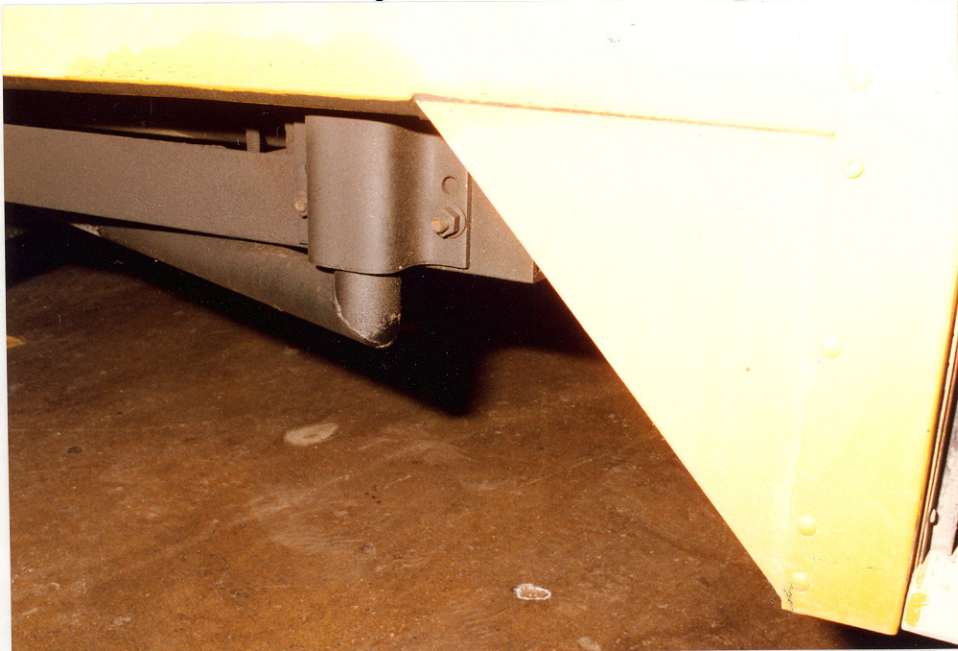
A yellow paint transfer was noted to the draw string located 12.5" above the end cap. There was a wipe mark (area where road film had been removed) on the leading edge of the fuel tank safety cage that probably resulted from contact with the pedestrian's leg as she fell between the wheelbase of the moving bus. The drawstring broke and the pedestrian fell in a face down attitude on the asphalt road surface with her head lying near the center of the road and her feet toward the right roadedge. The right rear tire(s) overrode the left posterior shoulder and upper scalp of the pedestrian resulting in fatal injuries. The pedestrian came to rest approximately 75' beyond the point at which she exited the school bus.

8. Probable pedestrian leg wipe mark on fuel tank safety cage.

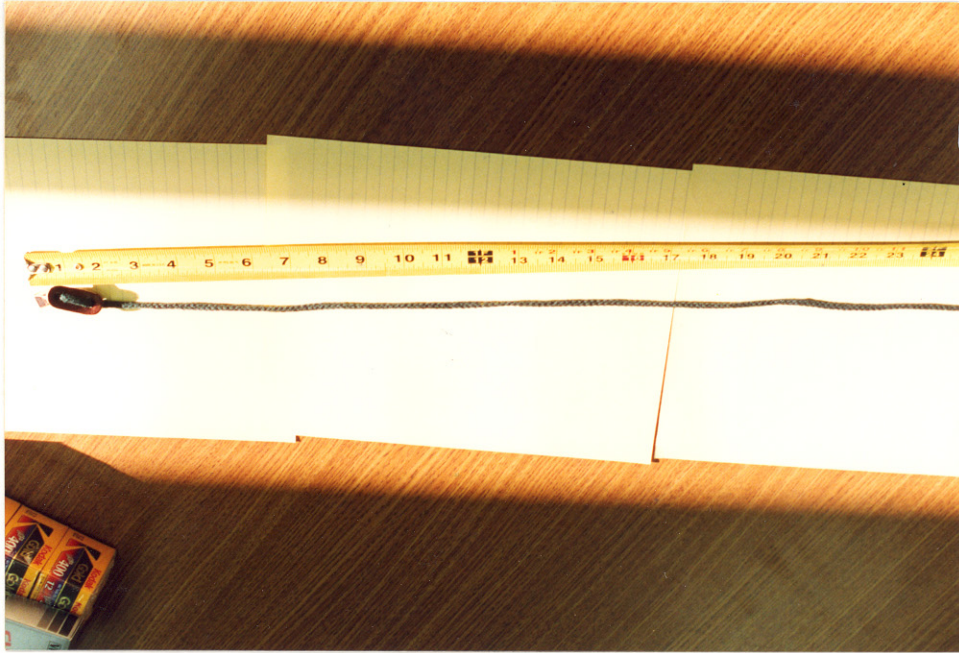
9. Torn right side draw string.

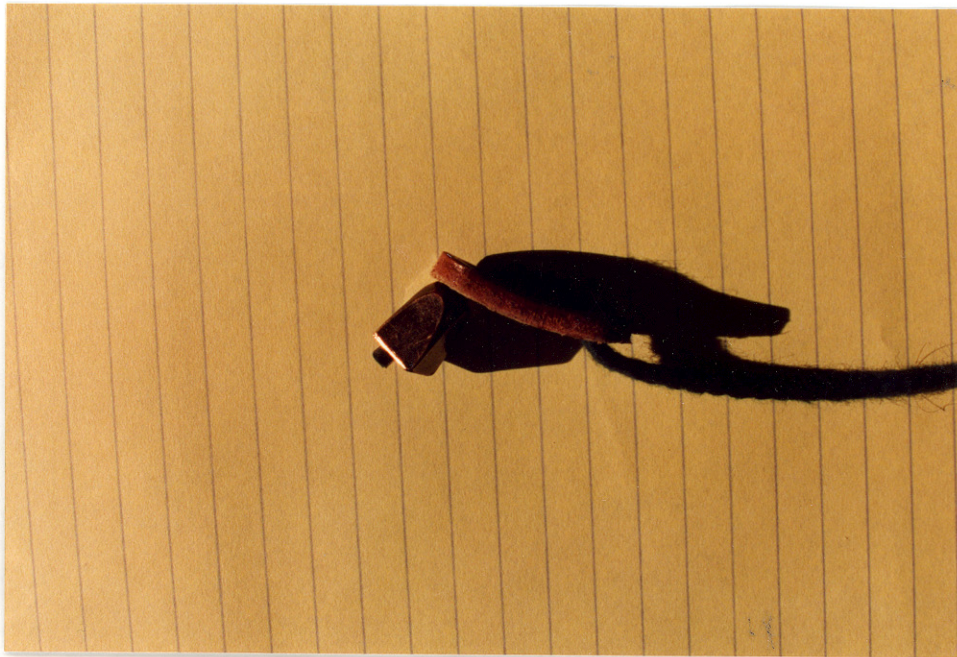
The pedestrian was a 13 year old female middle school student. She was initially seated toward the rear of the bus in the eighth row on the left side adjacent to the window. The pedestrian was wearing denim jeans, white athletic shoes, and a dark blue jacket that was zippered closed. At the bottom of her jacket was a draw string that apparently extended below the hip length jacket. The drawstring was a braided fabric that was approximately 3/16" in diameter with a plastic tapered cap at the end which measured 5/16 x 3/8" in width and 9/16" in length. Located directly above the plastic cap was a leather adjustment slide that was 5/8" in width, 1 7/16" in length, and 3/16" in thickness.

10. Plastic tab and leather slack adjuster which snagged in handrail/stairwell juncture.

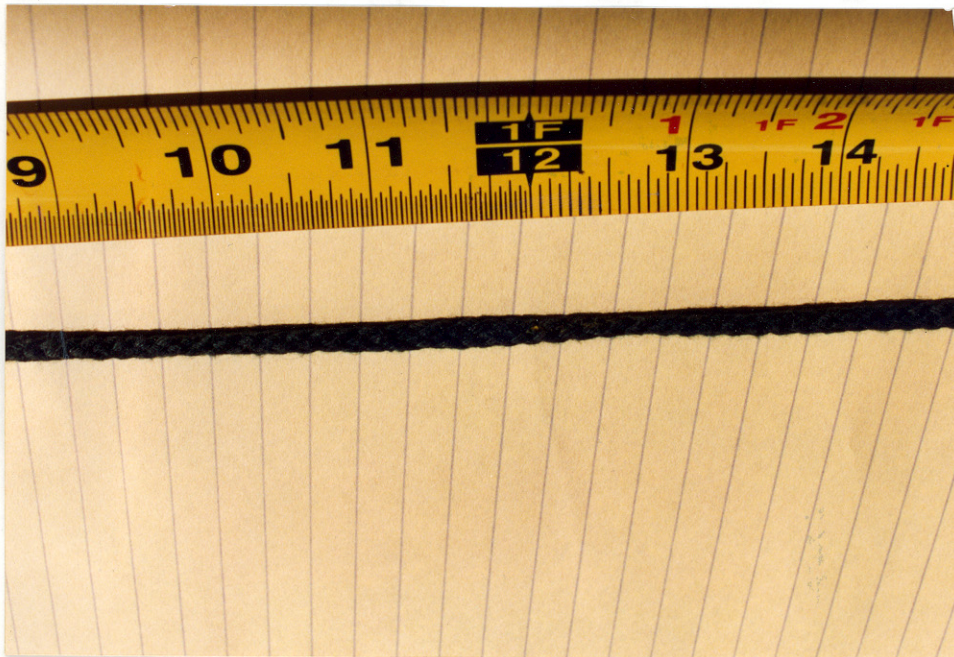
11. Yellow paint transfer at the 12" mark on the draw string.

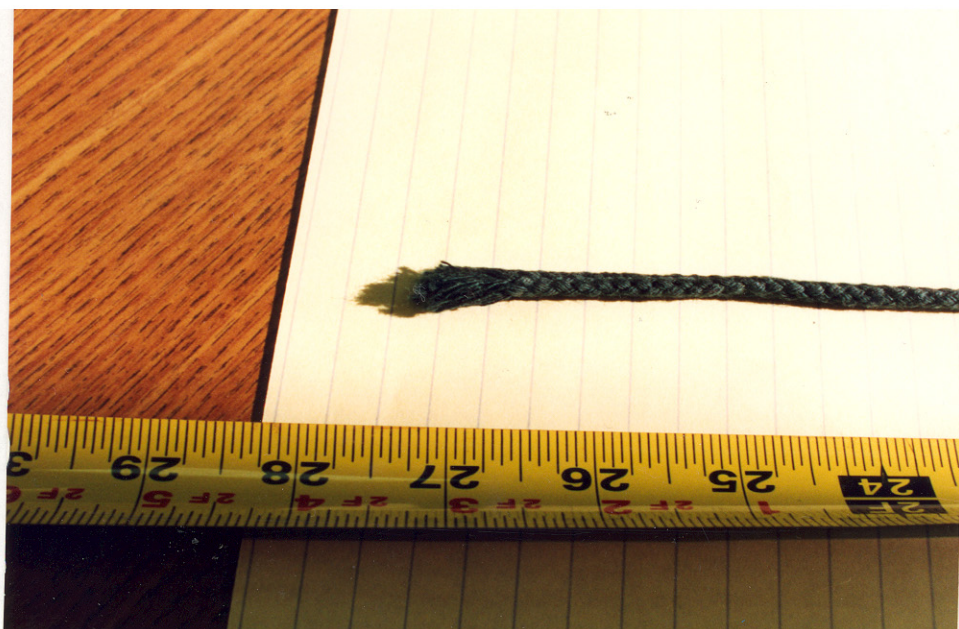
The separated end of the snagged drawstring was examined at the Police Headquarters on [redacted] 1995. This section of the drawstring was 28.25" in length. The bottom end treatments (tabs) were previously identified. The broken end of the string was frayed, however, the string did not yield evidence of stretching. The jacket was identified by the coroner as having three separate drawstrings; one for the attached hood, a mid section (waist) drawstring, and the lower hip length drawstring which snagged in the handrail.

12. Frayed and torn end of the draw string.

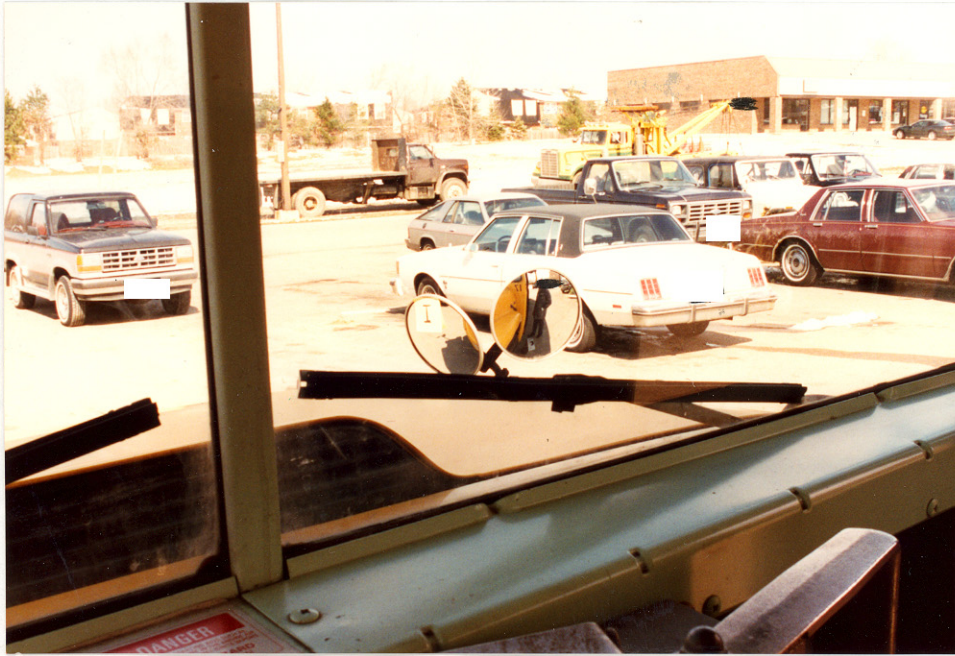
position. Two 8" diameter convex mirrors were mounted at each corner of the engine cowl. The forward mounted convex mirrors provided the driver with a view across the frontal area of the bus while the rearward mounted mirror provided the driver with a view along the sides of the bus. The right side convex mirror provided the driver with an excellent view of the door area of the bus as depicted in Photograph No. 13. In addition to the mirrors, the school bus was equipped with a interior *Buscam* video monitoring system. The District has approximately 63 buses in its fleet and all units were equipped with the bulkhead mounted video box. Four video cameras are rotated within the fleet and it is currently unknown if the accident involved bus was equipped with a video camera on the day of the accident.

13. Conspicuity of a pedestrian adjacent to the right door area in the right side convex mirror.
