**CALSPAN ON-SITE SCHOOL BUS/PEDESTRIAN ACCIDENT INVESTIGATION
CALSPAN CASE NO. 95-7
SCHOOL BUS: 1989 FORD CHASSIS/THOMAS BUILT BODY
LOCATION:
DATE: 1994**

CALSPAN ON-SITE SCHOOL BUS/PEDESTRIAN ACCIDENT INVESTIGATION

CALSPAN CASE NO. 95-7

SCHOOL BUS: 1989 FORD CHASSIS/THOMAS BUILT BUS BODY

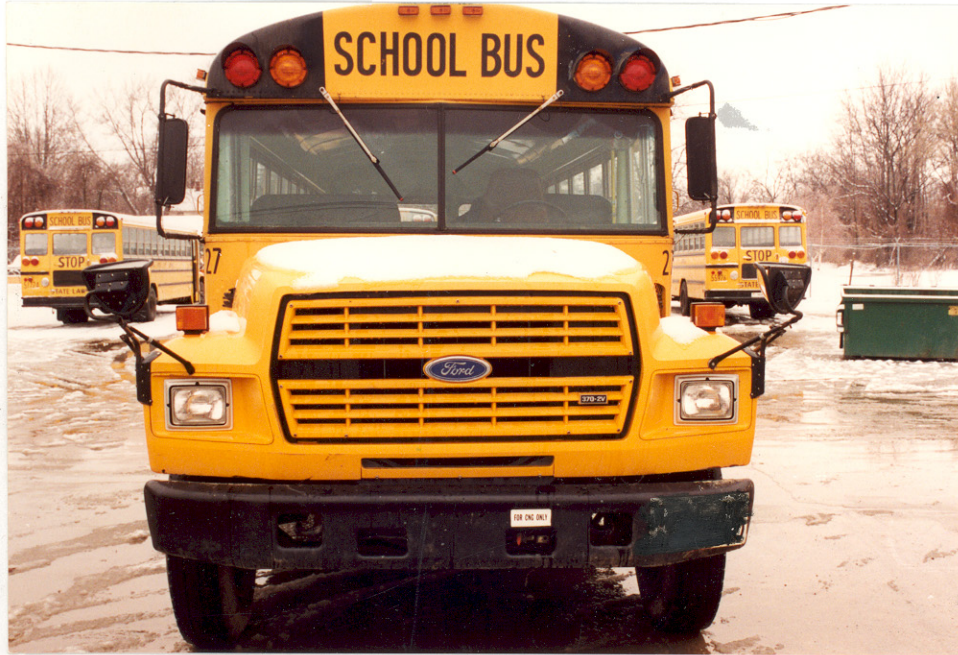
1. Frontal view of the involved Type C Ford/Thomas Built Body school bus.

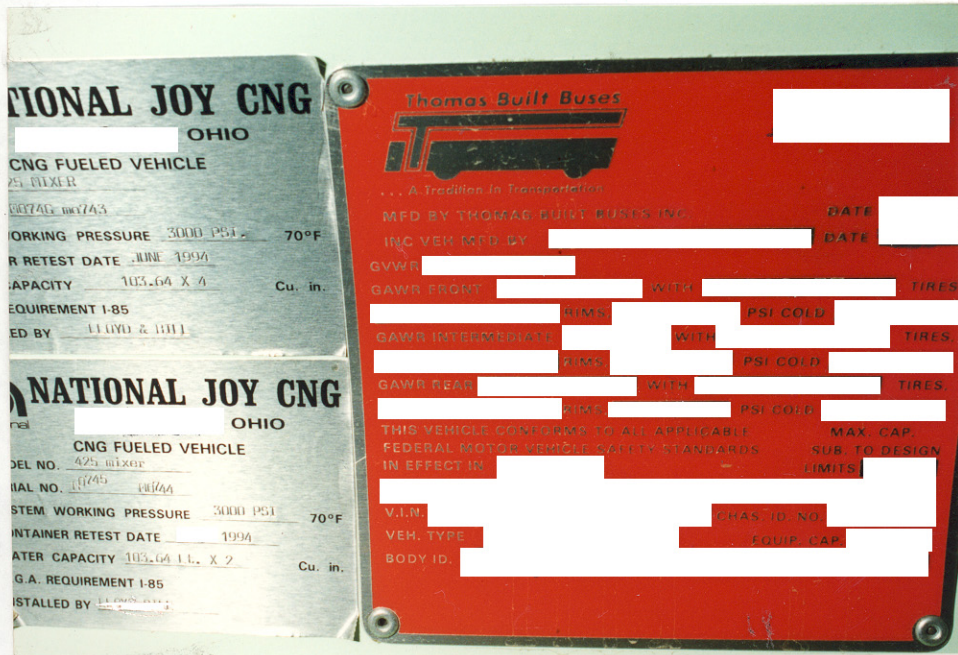
2. Identification label affixed to left front ceiling of bus.

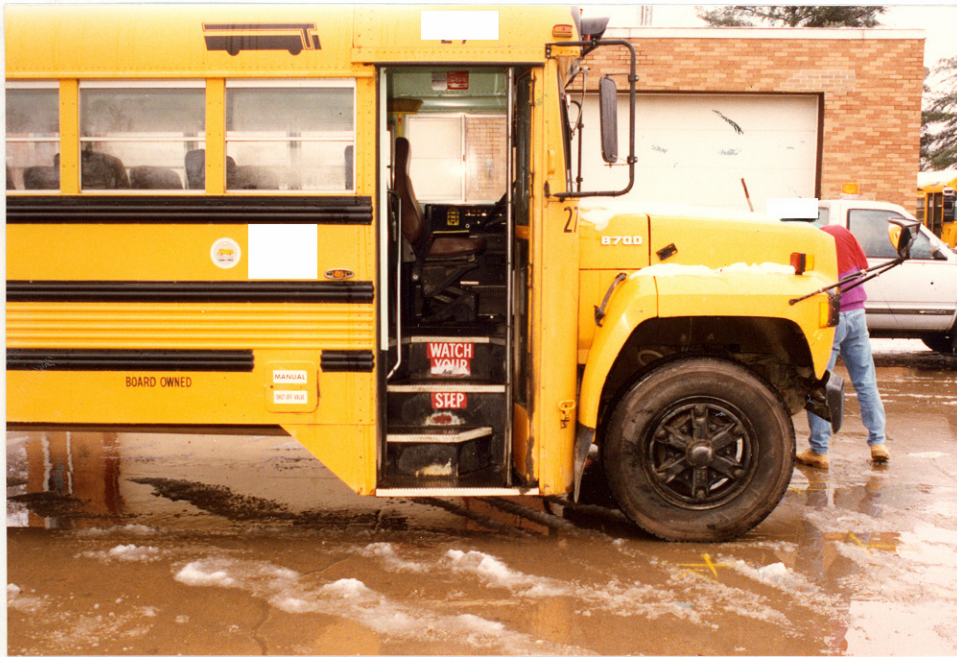
The bus was equipped with a manually operated bi-fold door that opened inward toward the forward side of the stairwell. The control lever handle for the door was conventionally located at the center instrument area. There were four steps within the stairwell. Located at the trailing side of the stairwell was a 1" diameter stainless steel handrail. The handrail was formed with a radius at the upper end and protruded 4.75" outward of the padded attachment point. The handrail extended 42" downward to a formed angle of approximately 32 degrees, then continued 4.25" to the attachment point with the stairwell wall. The lower end of the handrail was mounted approximately 9.0" inboard of the door opening.

3. Door, stairwell area of the involved bus.

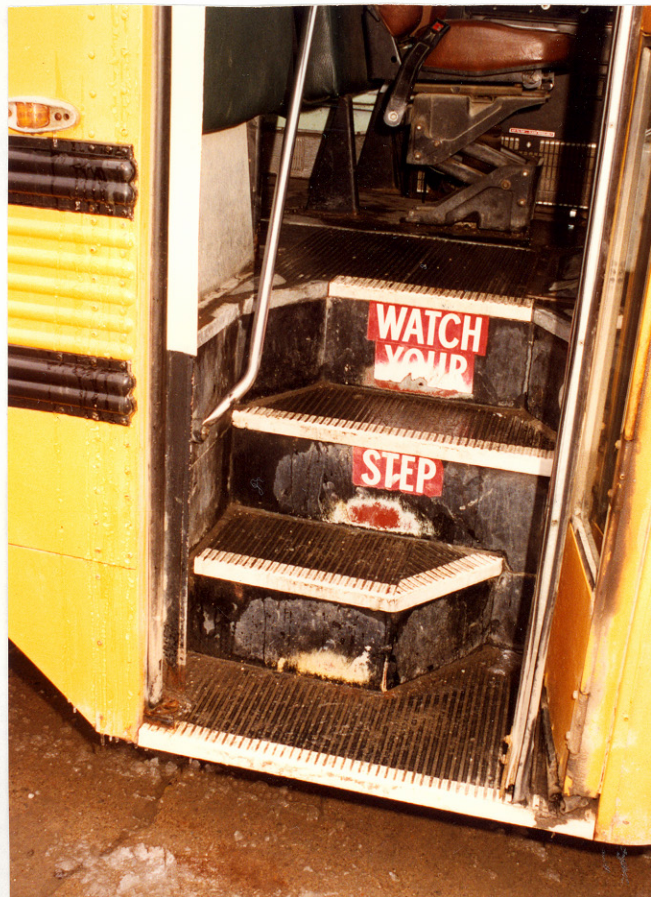
The primary causal factors for this school bus/pedestrian accident was the design of the handrail which permitted objects such as the drawstring to become caught during egress from the bus. In addition, the bus mechanic failed to ensure that all buses were modified with the retrofitted rubber bushing that was identified in the recall notice dated 1993. Driver error was also a major factor in this accident since she failed to provide the pedestrian with sufficient time to safely clear the bus prior to accelerating from the stop. The driver also failed to visually track the child and check the rear view mirrors to ensure that it was safe to depart the bus stop.

4. Interior view of the stairwell and post-accident modified handrail.

The Transportation Supervisor for the School District had received the recall notification for the handrail modifications for the Thomas Built bus bodies. He ordered the appropriate rubber bushings and directed his chief mechanic to install the units on all 34 buses in the fleet. The mechanic modified 33 of the buses and failed to check to ensure that all buses were retrofitted with the bushing. One of the buses was not modified with the handrail bushing, Bus No. the Type C bus involved in this accident.

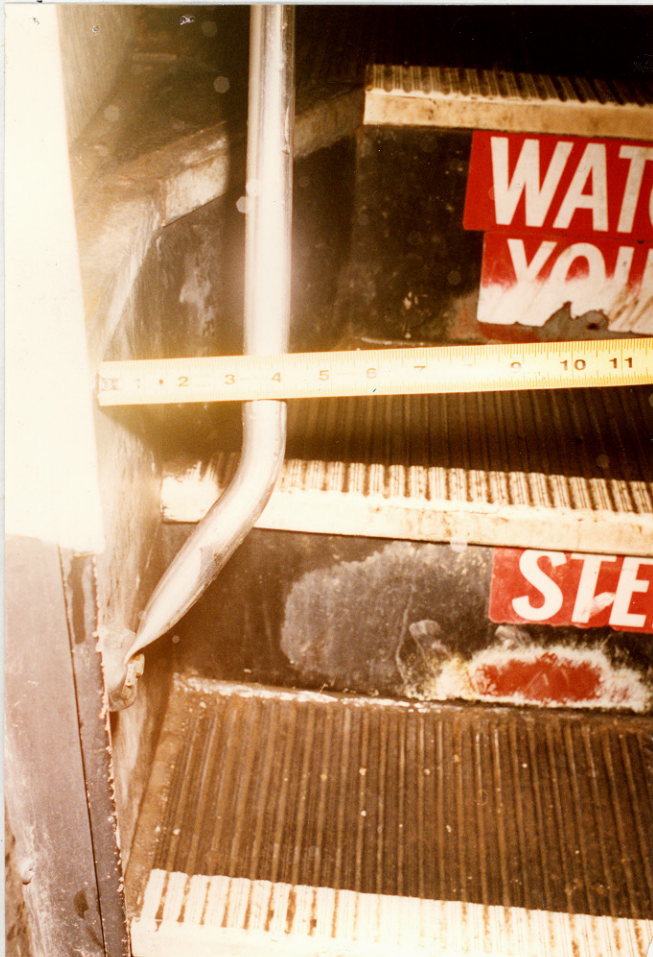
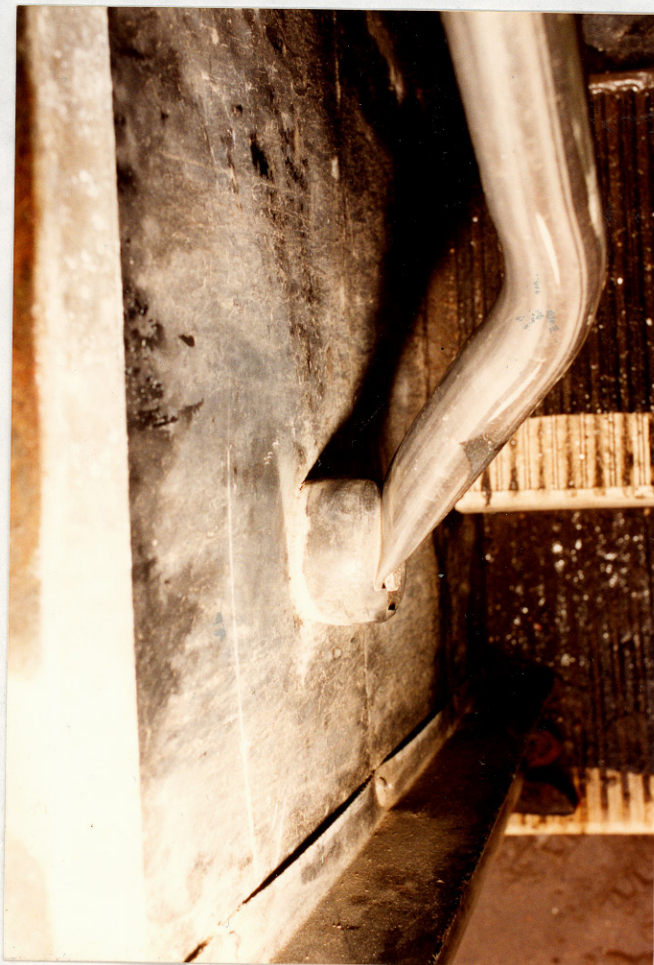
5. & 6. Post-accident retrofitted rubber bushing at the lower attachment of the handrail.

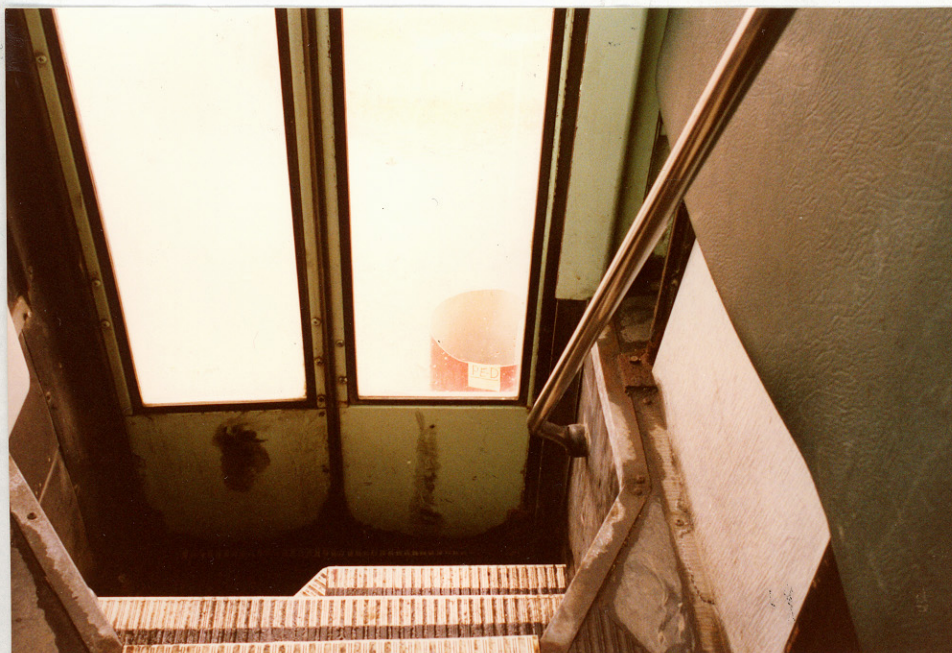
7. Interior view of the post-accident modified handrail.

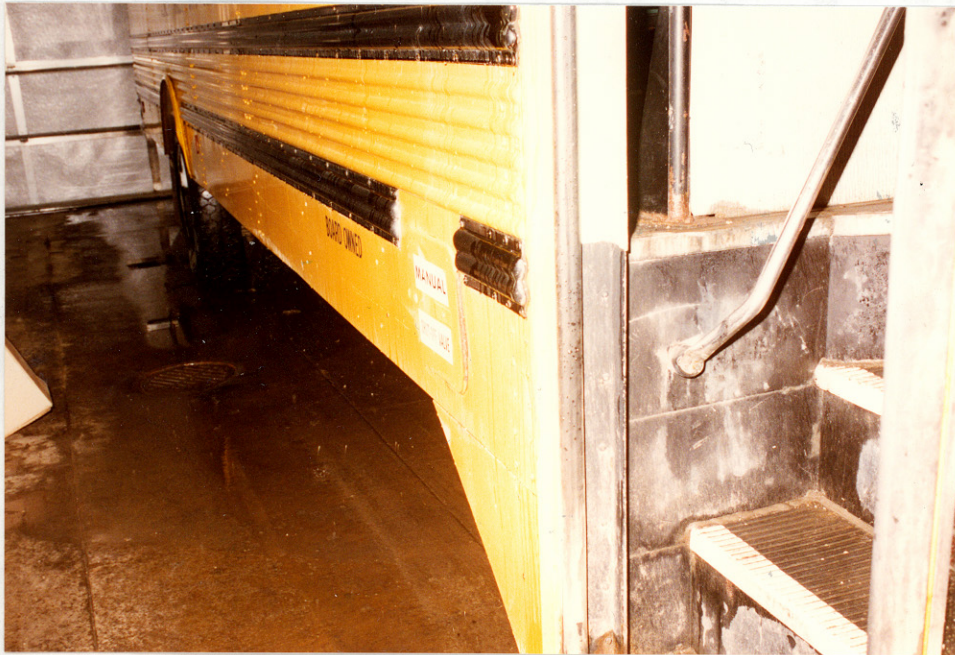
8. Handrail, door jamb, and the side surface of the involved school bus.

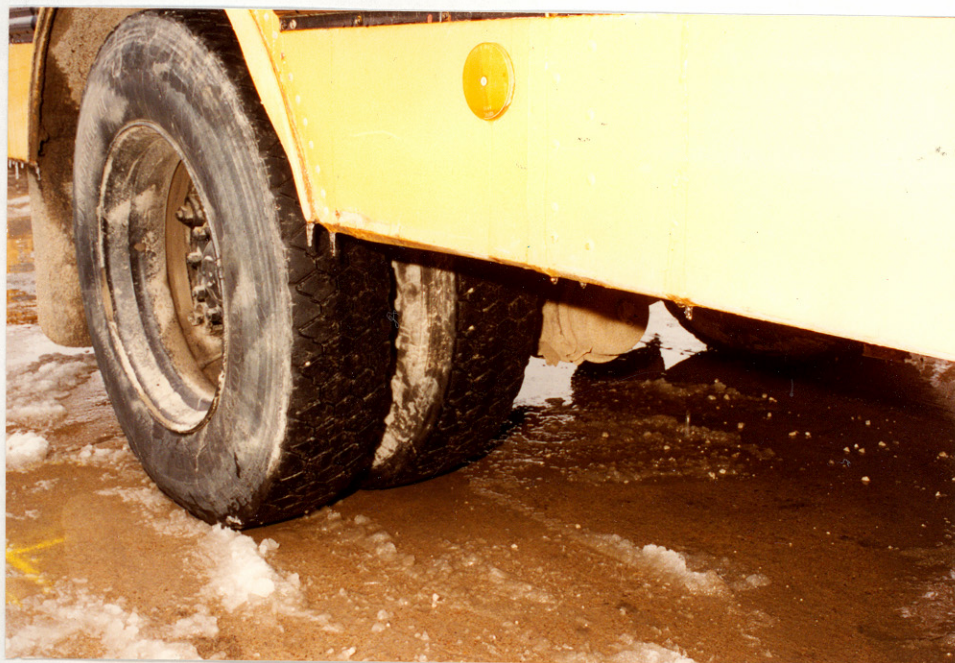
The driver returned to the school and notified the bus garage of the accident. The pedestrian was subsequently transported by ambulance to a local hospital where she was diagnosed with a fractured right humerus and a dislocation of the right clavicle (AIS-2). The lack of a crushing injury suggests that the pedestrian was not run over by the tire of the bus, but struck by the side wall or leading edge of the tread which could have deflected the arm away from the tire.

9. Sidewall and tread of the right rear tire.
