REPORT NUMBER: 221-MGA-05-003

**SAFETY COMPLIANCE TESTING FOR
FMVSS NO. 221
SCHOOL BUS BODY JOINT STRENGTH**

**Les Entreprises Michel Corbell Inc.
2004 Corbell 30 Passenger School Bus
NHTSA No.: C40902**

**PREPARED BY:
MGA RESEARCH CORPORATION
5000 WARREN ROAD
BURLINGTON, WI 53105**

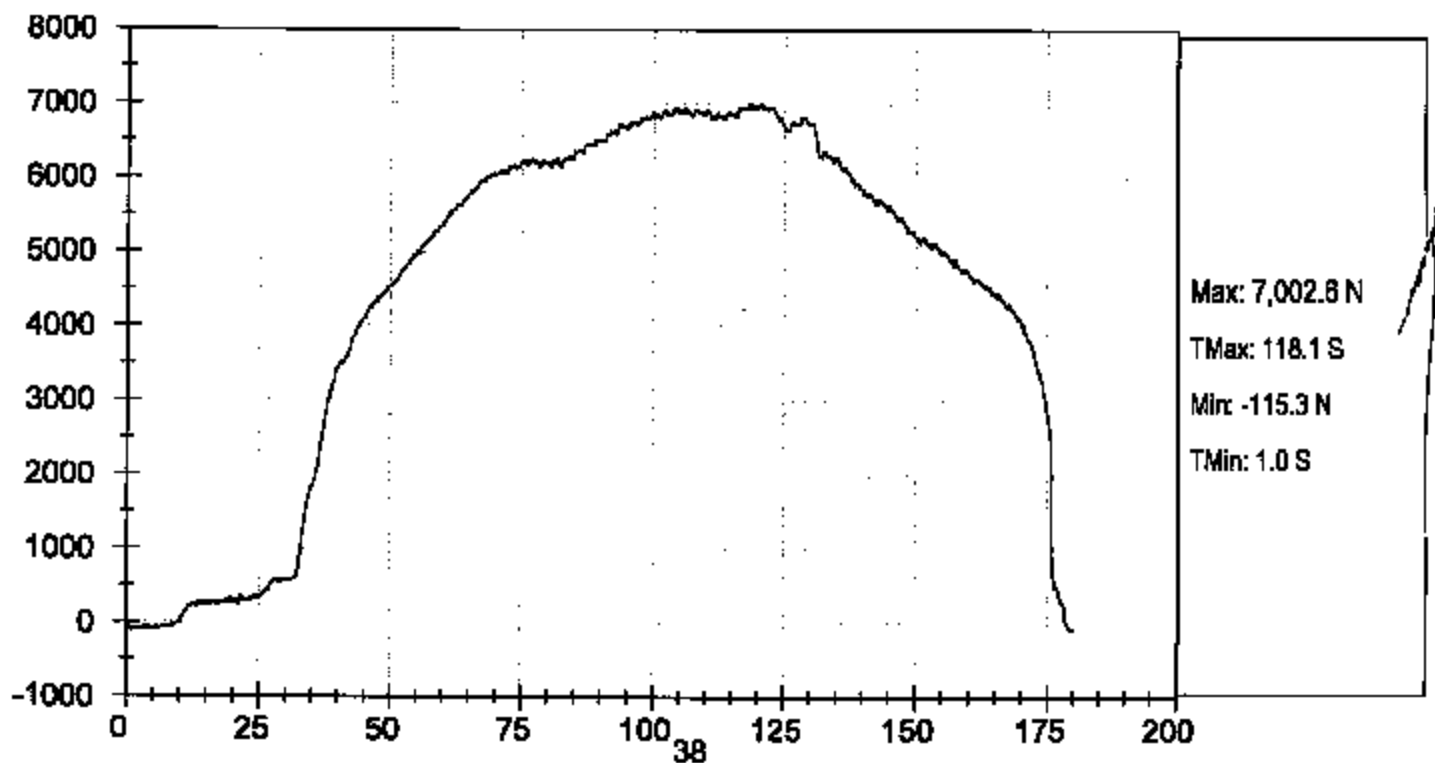
Test Desc: FMVSS 221 (Required Load 16278N)
Sample: Corbel Sample 1

Weaker Member	Stronger Member
Material	AL EP 3003 H-14 Aluminum	N/A
Tensile Strength (MPa)	137.9	N/A
Gage/Thickness (mm)	- / 1.016	N/A
Fastener Holes (No./Diameter - mm.)	2 / 4.78	N/A
Net Area (Sq. mm.)	196.8	N/A
Material Strength (N)	27130.6	N/A
60% of Material Strength (N)	16278.3	N/A
Maximum Load From Tensile Test of Joint (N)	7002.6	N/A
PASS/FAIL	FAIL	N/A
