Report Number: 214-TRC-04-009

**Safety Compliance Testing For FMVSS 214**

**Side Impact Protection**

**Mitsubishi Motors North America, Inc.  
2006 Mitsubishi Eclipse GS 2-door sport coupe**

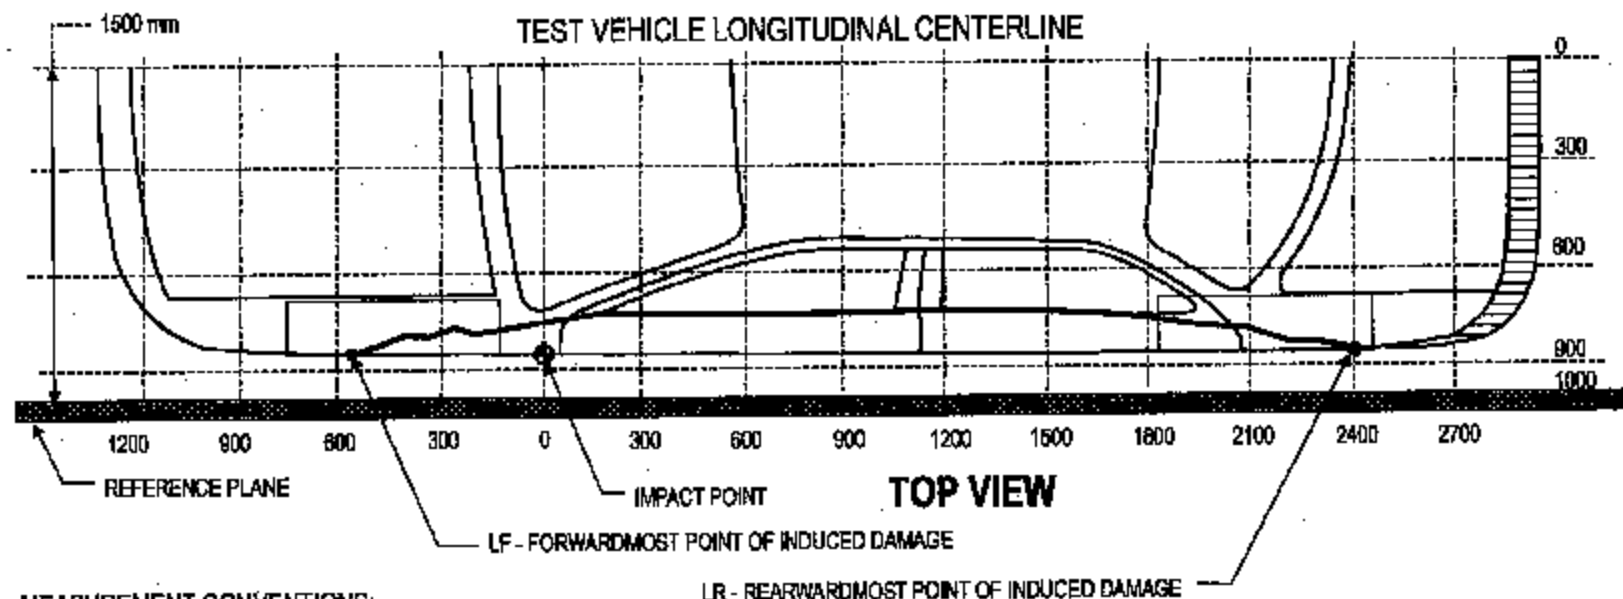
Vehicle Damage Profile Distances

Full length of induced damage was 1650 mm.

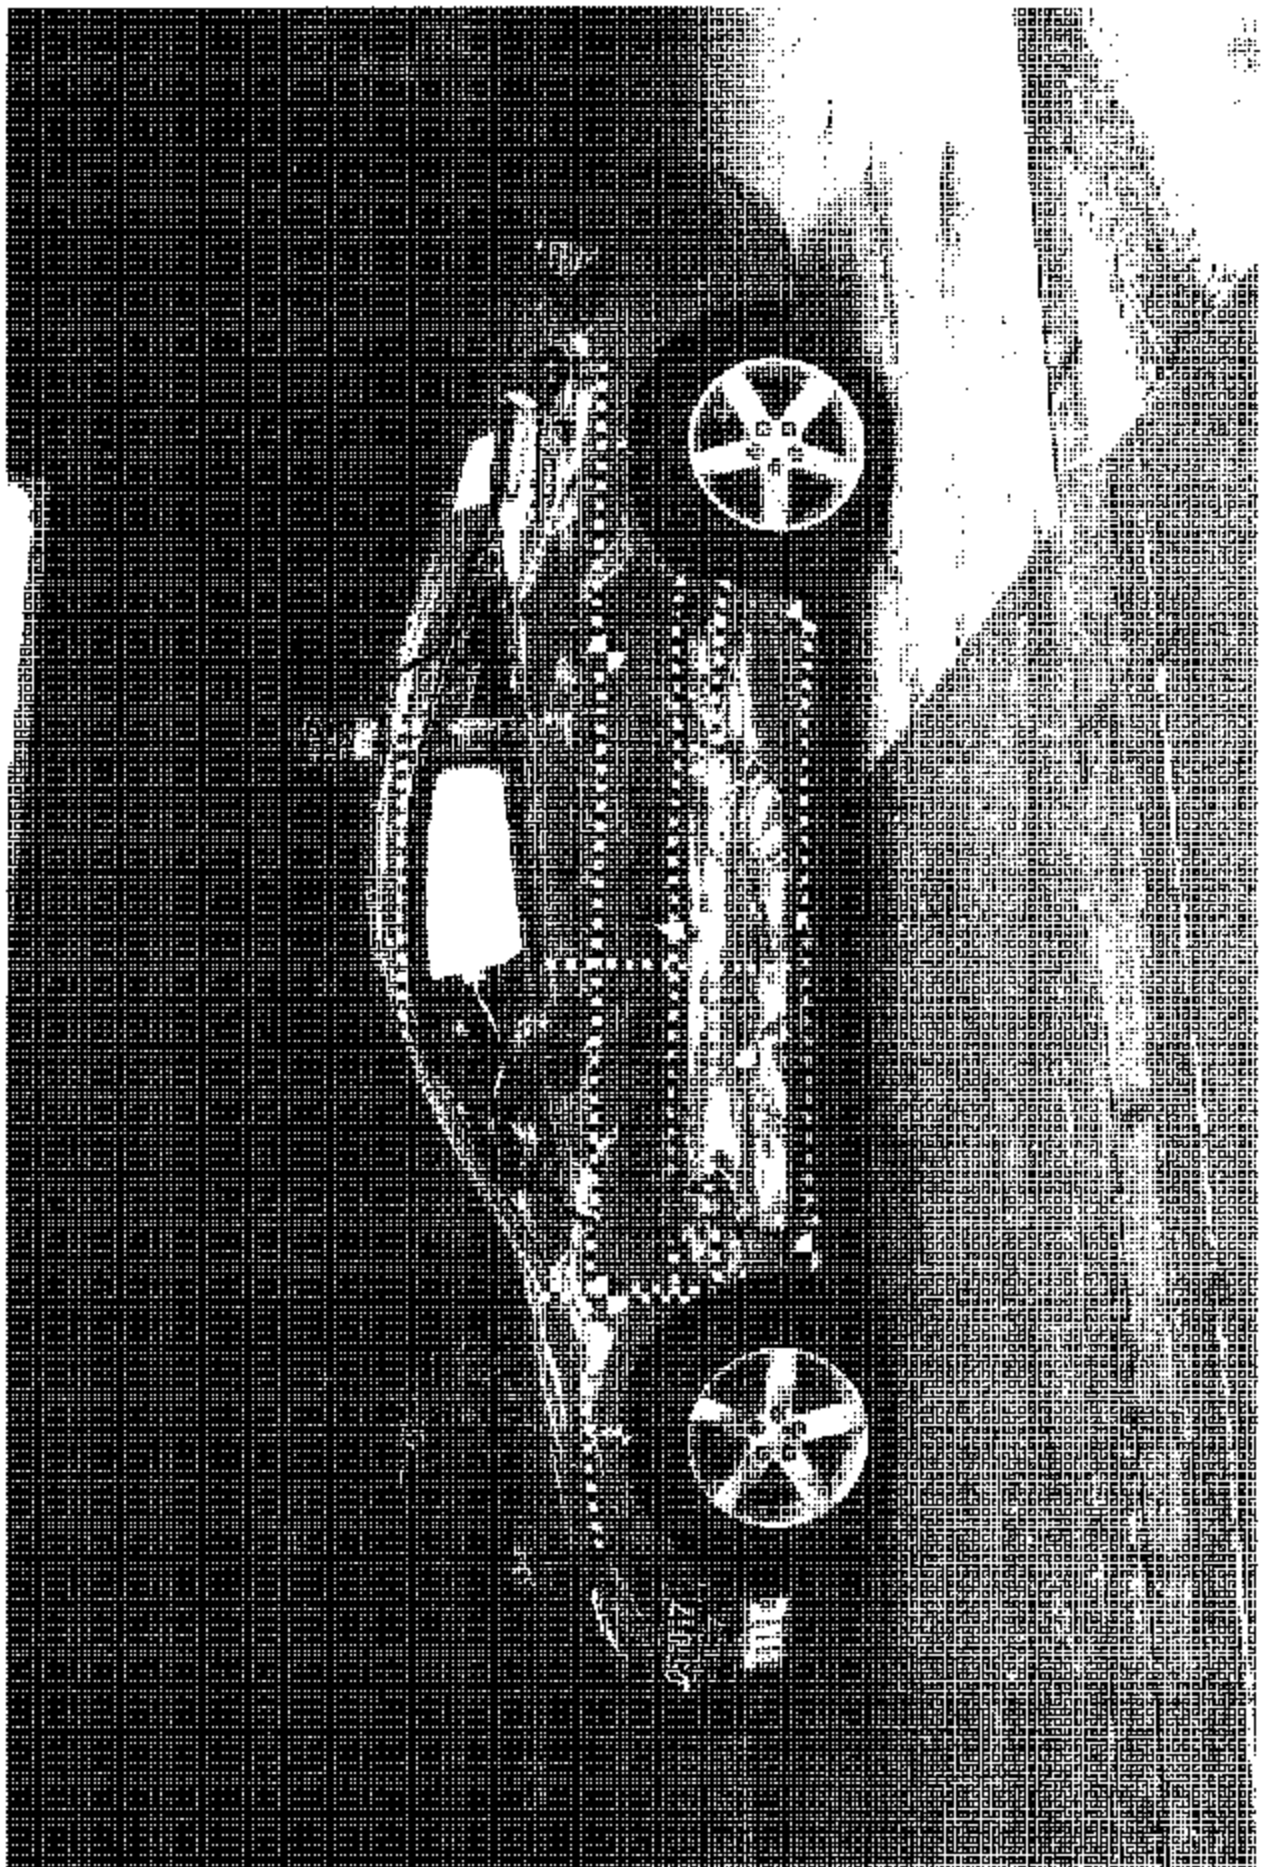
Window: Impacted side window broken.

Figure A-4 Post-Test Impacted Side View of Test Vehicle
