Mobile Acetylene Trailer Accidents:
Fire During Unloading in Dallas, Texas, July 25, 2007;
Fire During Unloading in The Woodlands, Texas
August 7, 2007; and
Overturn and Fire in East New Orleans, Louisiana,
October 20, 2007

Special Investigation Report

NTSB/SIR-09/01
PB2009-917002

**National
Transportation
Safety Board**

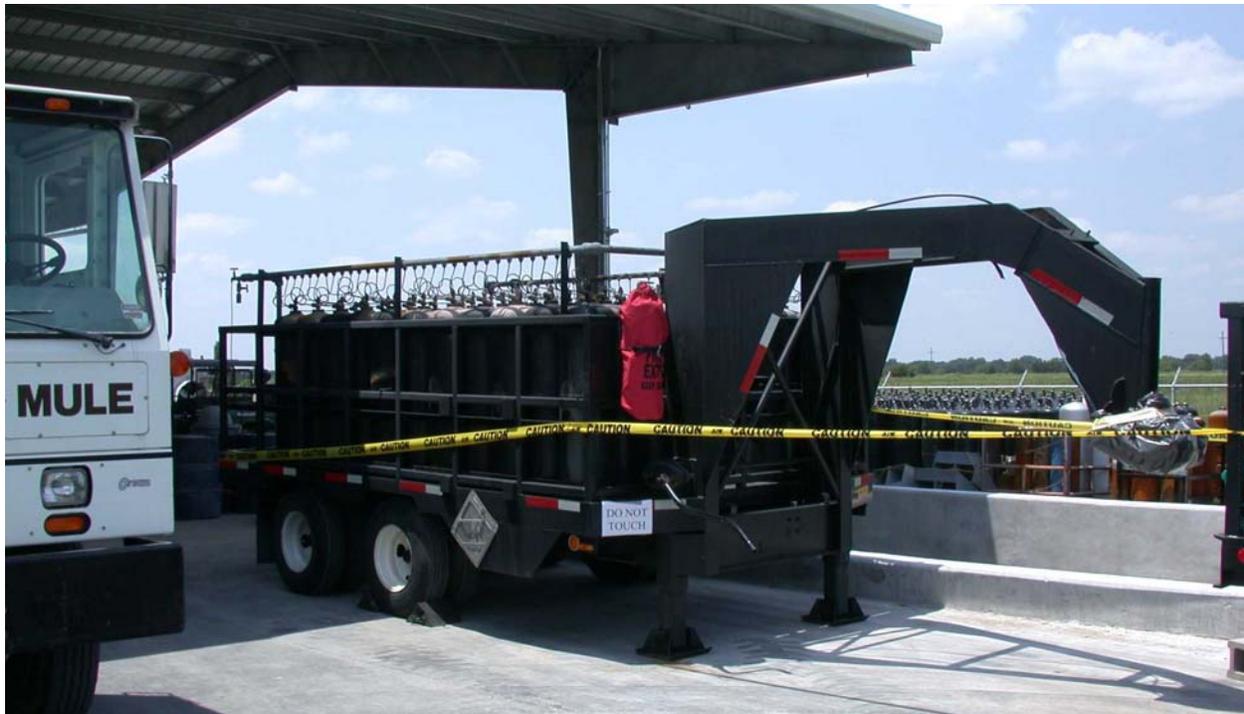
Figure 1. The Woodlands trailer (a small mobile acetylene trailer).

Although the trailer has strong outer railings and the manifold is mounted above the top of the cylinders, neither the railings nor the manifold protects the cylinder valves in case of a trailer overturn. The four accident mobile acetylene trailers had no rollover protection for the valves, nor were they required to.

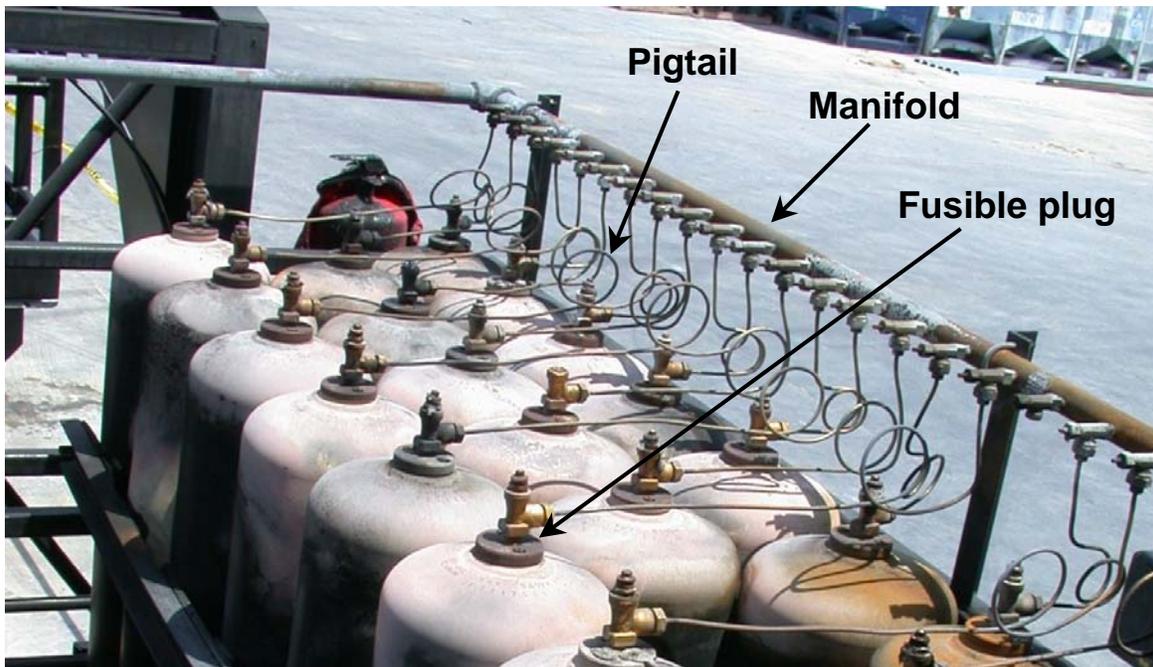
Figure 2 shows cylinders on a mobile acetylene trailer. The valve opening on each cylinder is connected by spiral tubing, called a pigtail, to the manifold that delivers or receives the acetylene gas to or from the cylinder. Attached to the manifold, on the back of the trailer, is a cargo transfer fitting, which is not visible in this photograph. This fitting is the connection between the trailer and the piping from the plant. The tubing and manifold piping are designed to contain the energy of an accidental decomposition reaction. A manual block valve (block valve) controls the flow of acetylene to and from the cargo transfer fitting. The piping includes an air-actuated valve that shuts off the flow if a trailer pulls away accidentally before it is disconnected. A needle valve on the manifold is used to reduce pressure on the manifold after cargo transfer and leak testing. Pressure gauges are mounted on the trailer: one on the manifold and one on the trailer piping between the block valve and the connection to the plant piping. According to Western, filling the cylinders through the manifold connection takes about 12 hours.

Figure 2. The Woodlands cylinders on front right of accident trailer.

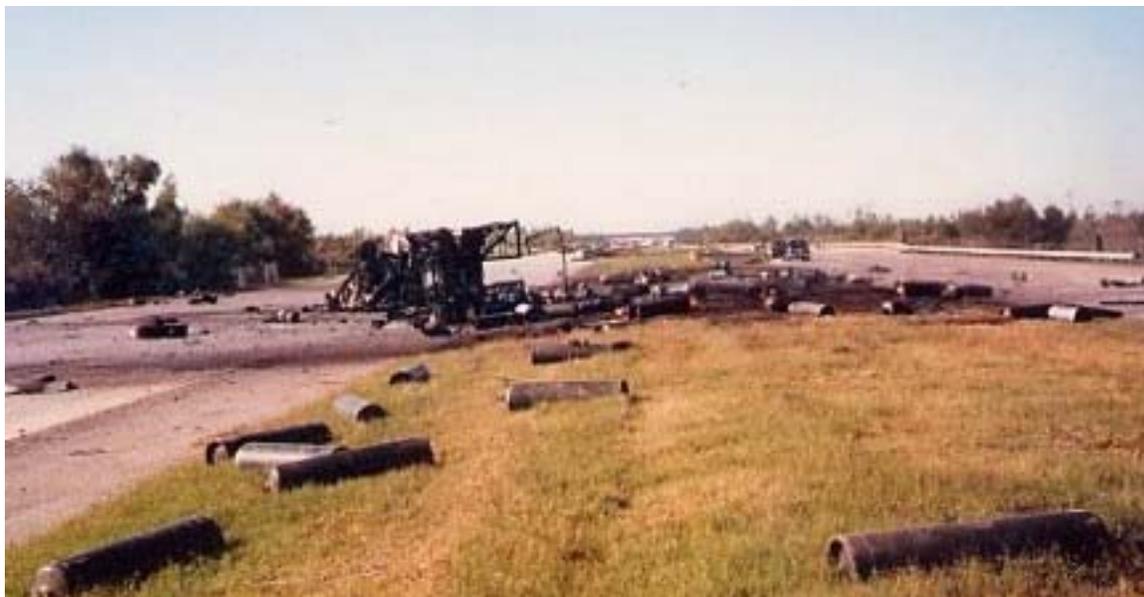
Of the 145 cylinders that released acetylene, 88 were so severely damaged that they were discarded. Of the remaining 57 cylinders that released acetylene, 32 had their valves broken off, and all 57 had evidence of heat exposure and melted fusible plugs. Significant damage to these cylinders included burst heads, a bulging and burst sidewall near the top head weld, extreme localized bulging of the heads and sidewalls, and denting. (See figure 5.)

Figure 4. East New Orleans accident vehicle and cylinders.

In the East New Orleans, Louisiana, accident in which the tractor and mobile acetylene trailer overturned, the cylinders mounted on the trailer were thrown from the vehicle. The postaccident examination of the cylinders recovered from the scene revealed that 32 of the cylinders recovered had their valves broken off during the accident, releasing acetylene that ignited. Similarly, in the Lamar, Colorado, accident, about half of the 225 cylinders were thrown from the trailer. The postaccident examination of the cylinders recovered from the scene revealed that 86 of the cylinders had their valves broken off during the accident, resulting in the release and ignition of the residual acetylene. An examination of these cylinders showed that the fire from the cylinders with broken valves caused the fusible plugs of other cylinders to melt, releasing additional acetylene that ignited. Possible ignition sources include the generation of a static charge in the rapidly escaping acetylene and solvent and a spark caused by the steel cylinders striking concrete, rocks or stones, or the road surface.

The Safety Board concludes that the fires in the East New Orleans, Louisiana, and Lamar, Colorado, accidents occurred as a result of the ejection of unsecured cylinders during the rollovers of the mobile acetylene trailers, resulting in damage to many of the cylinder valves and the release of acetylene, which then ignited.

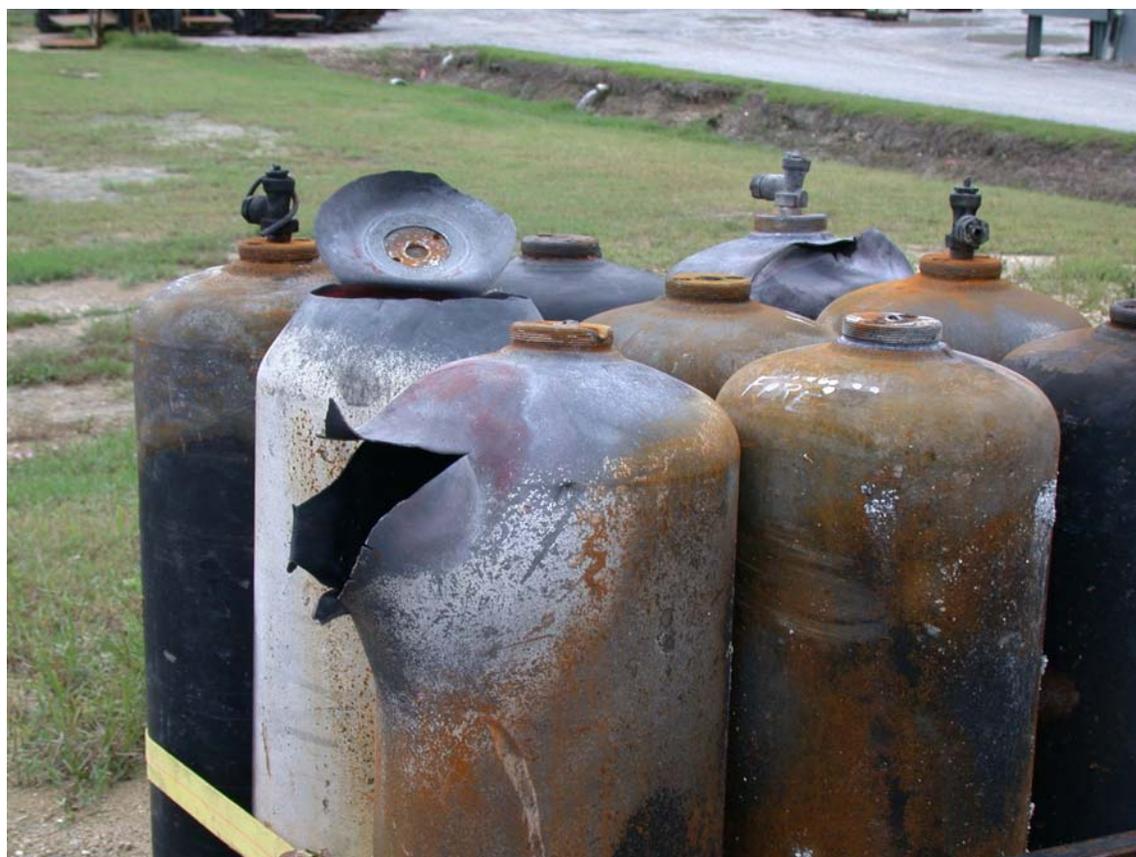
Figure 5. East New Orleans cylinder showing burst near head.

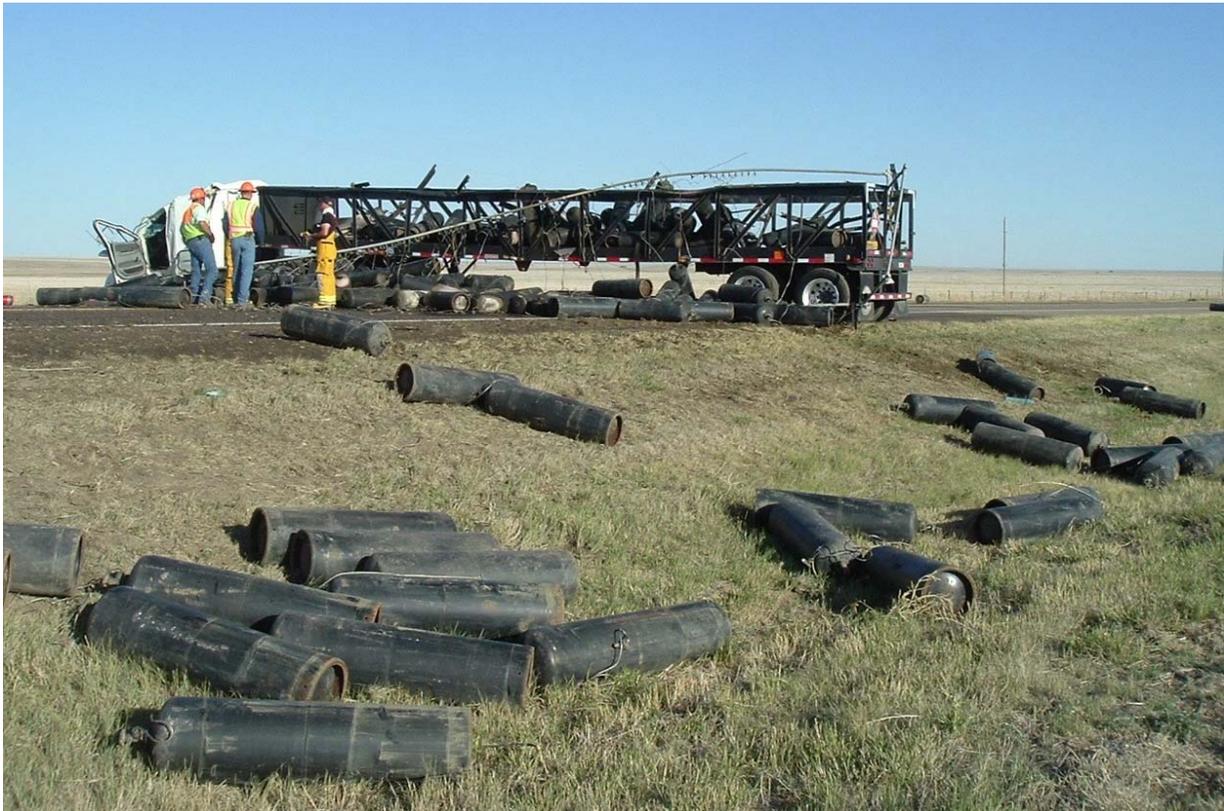
Figure 6. Lamar accident vehicle.

The trailer had been unloaded at a Western facility in Pueblo, Colorado, and was en route to Louisiana to be refilled. There was still a residue of acetylene in each cylinder. The valves of all the cylinders were closed during transportation. Before this trip, the operator had been off duty since June 6, 2008. The Colorado accident report indicated that the vehicle skidded for 106 feet, went off the right side of the roadway, and traveled an additional 250 feet before striking a delineator pole. The vehicle was then steered to the left onto the roadway, where it rolled over completely. The vehicle came to rest perpendicular to and completely across the two-lane road. At least half of the cylinders were thrown from the vehicle, and the remainder fell over. The valves were broken off of 52 cylinders, and acetylene was released and ignited. The fire caused

fusible plugs on other cylinders to melt, which released acetylene that also ignited. About 86 cylinders were damaged by the fire. The tractor and trailer had extensive collision damage; the trailer had some fire damage.

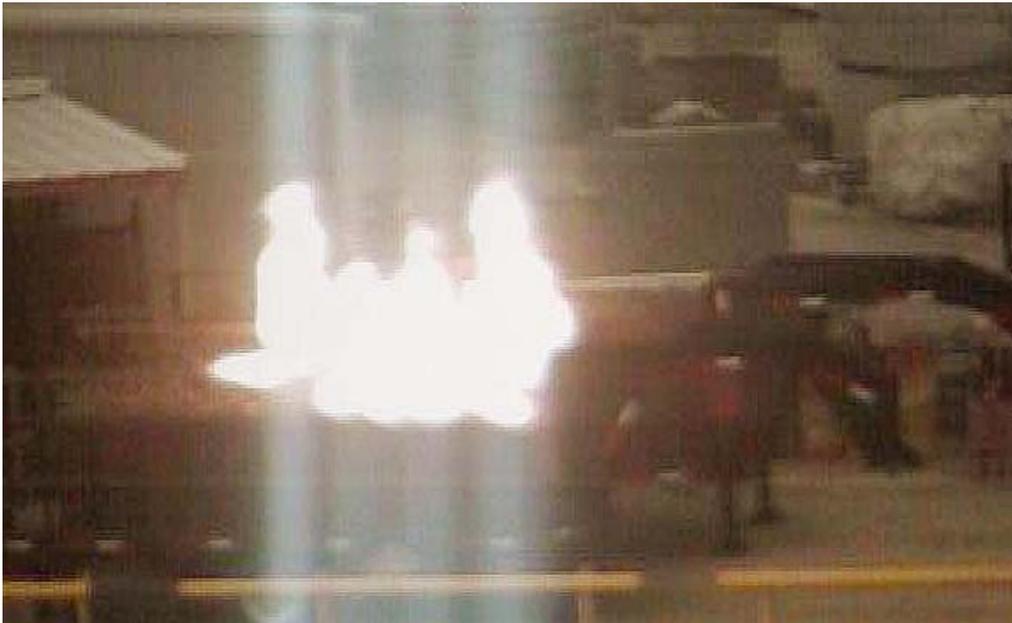
Figure 7. Security camera photograph of acetylene gas fire in The Woodlands, Texas.

3. The ignition of the acetylene in the accident in The Woodlands, Texas, likely occurred because of the operators' failure to follow Western International Gas & Cylinders, Inc.'s, standard operating procedures, which resulted in the introduction of high-pressure acetylene into closed piping that contained air, which in turn initiated an acetylene decomposition reaction.

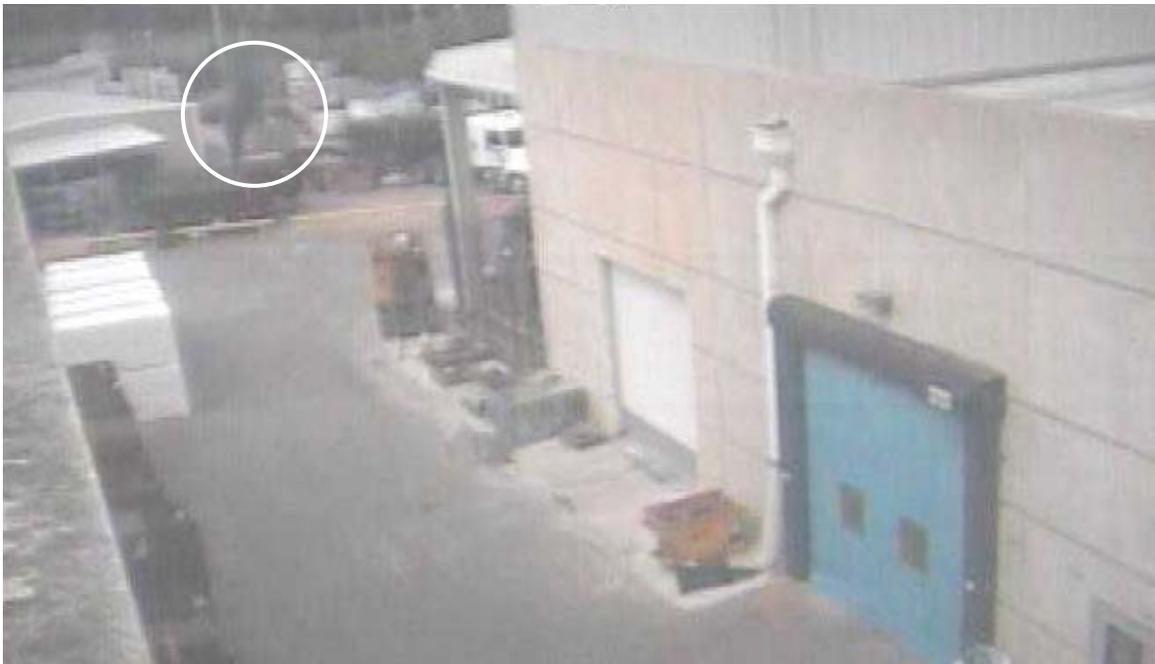
Figure 8. Security camera photograph of black plume coming from a cylinder on trailer in The Woodlands, Texas.

The postaccident examination of the trailer being prepared for unloading revealed that the trailer and manifold piping had some fire damage at and above the level of the top of the acetylene cylinders. There was little damage to the trailer below that level. The cylinders' fusible plugs were all melted, with some evidence of fusible material remaining on the top of some of the cylinders. At least three cylinders in one cluster had visible bulging on their sidewalls just below the circumferential head weld. The cylinder valves appeared to be intact; however, the hand wheels had been consumed in the fire. The pigtails also had evidence of heat exposure but appeared to be intact. The connection fitting from the trailer to the plant piping had a large deposit of black powderlike material inside. A large deposit of the same black material was also in the plant discharge arm at the Hughes Christensen plant. There was no deposit of a similar material in the discharge arm for the second trailer.

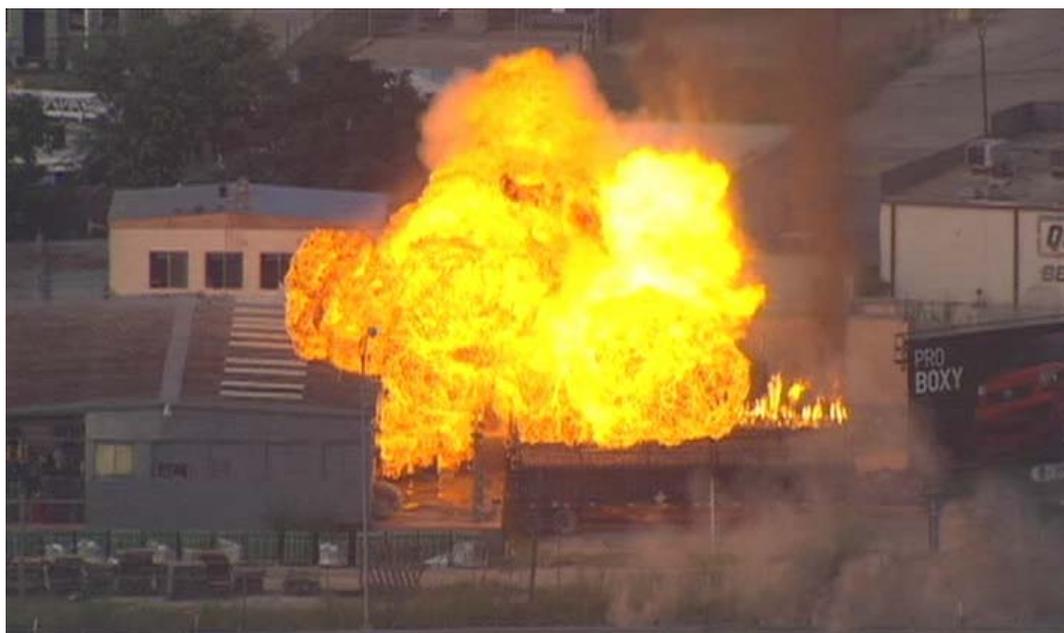
About 9:50 a.m. on July 25, 2007, acetylene gas ignited on a Western mobile acetylene trailer containing 225 manifolded DOT 8AL specification cylinders (450 standard cubic feet capacity each) on the docks at the Southwest Industrial Gases (Southwest) facility in Dallas, Texas. (See figure 9.) The fire occurred as the operator was preparing the trailer to be unloaded. A video recording made by a Dallas television network did not record the initiation of this accident; however, it showed a gradual progression of the fire and explosions from the trailer on which the operator was working to adjacent trailers, to Southwest's building, and to vehicles parked in front, one of which contained acetylene-filled cylinders for delivery. The fire and explosions destroyed the Southwest facility and many vehicles, damaged several nearby buildings, and caused the failure of hundreds of acetylene-filled cylinders from three other Western acetylene trailers,¹³ the delivery truck, and the facility's docks and storage. (See figure 10.) The operator sustained back injuries, and the plant manager and general manager were severely burned during the accident. There were no fatalities. Property damages have not been fully assessed, but Southwest estimated losses of more than \$5 million.

Figure 9. Acetylene gas fire at Southwest facility in Dallas.

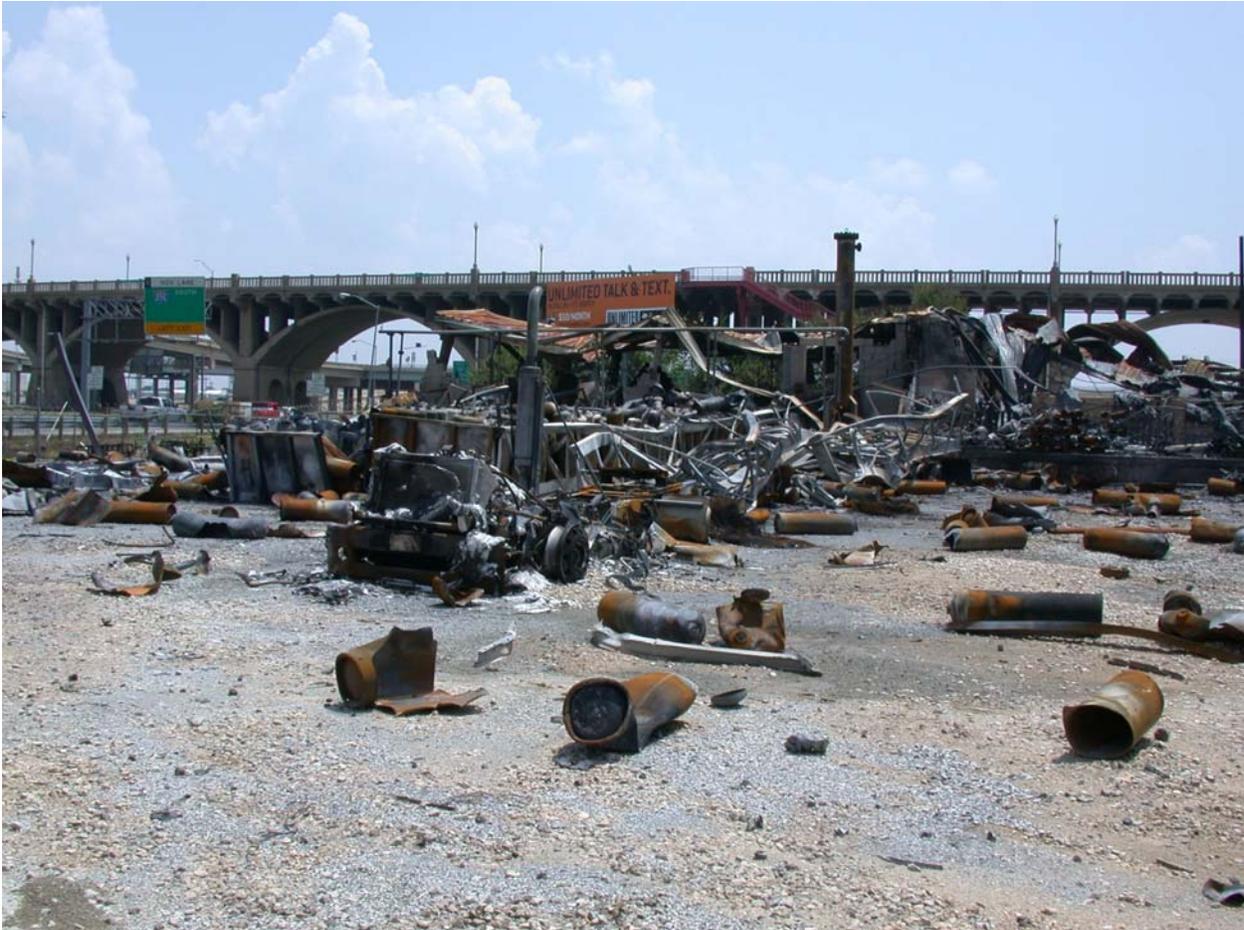
Figure 10. Dallas accident damage to Southwest facility and vehicles. (Accident trailer and cylinders in foreground.)

Postaccident examination of the accident site revealed that the discharge arm to the accident trailer had broken from the plant's piping and the trailer connection. The discharge arm valve was found in the closed position. No acetylene cylinders were found on the accident trailer. The three other Western mobile acetylene trailers that were attached to Southwest's unloading apparatus were destroyed, although some cylinders remained on two of these trailers. More than 1,000 cylinders from the trailers and from plant inventory were recovered from an area with a radius of about 1/4 mile. (See figure 12.) Although the cylinders from the Western trailers could be differentiated from Southwest's cylinders, Western's records did not identify the cylinders that were mounted on each trailer, so no detailed examinations were performed on the cylinders. A sampling of cylinders of the same size and construction as those from the trailers were visually examined. Damage ranged from a melted fusible plug to a longitudinal tear running the length of the cylinder. In some cases, the top or bottom cylinder head had torn off.

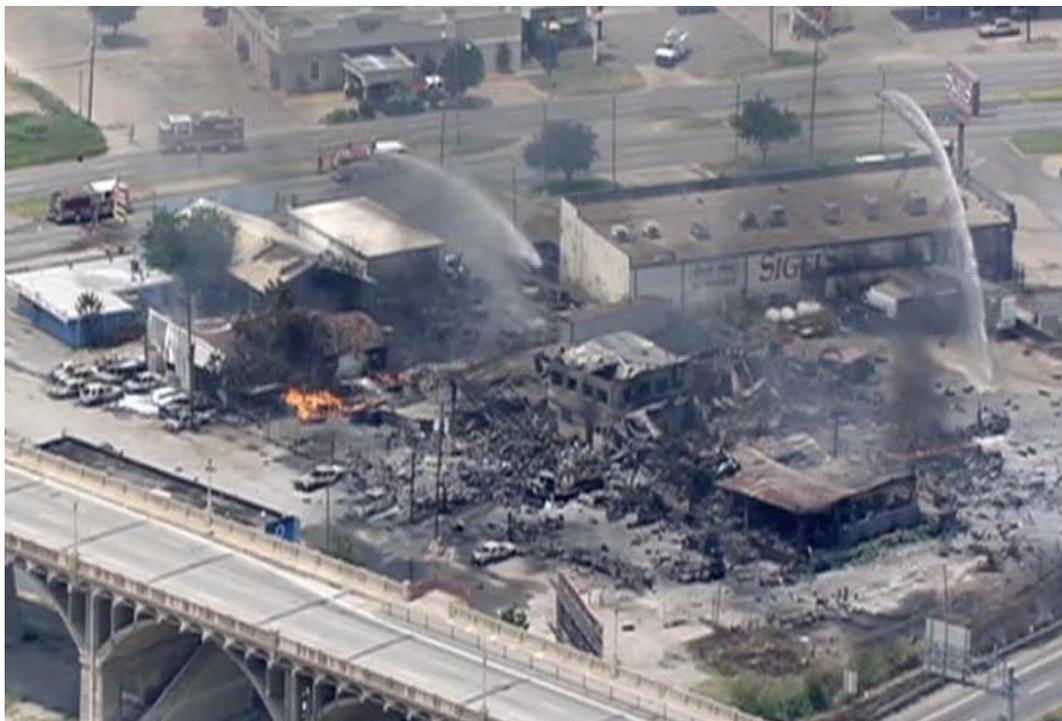
Both managers then helped operate the fire hose, and both saw cylinder explosions, were knocked down, and received second and/or third degree burns while they were operating the hose. Another employee turned on a permanently mounted water monitor and began spraying water onto the trailer. However, because supplying water to the monitor reduced the water pressure in the fire hose, the water monitor was shut off. The hose was not effective in suppressing the fire, which was extinguished about 9 hours later by the Dallas Fire Department. (See figure 11.) The only fire-fighting equipment available at the Dallas plant included fire extinguishers, one fire hose, and the manually operated water monitor on the roof. There was no automated water deluge system.

Figure 11. Final phase of fire suppression at Southwest facility in Dallas.

Revise the recommended practices in Compressed Gas Association standard G-1.6, section 7, *General Provisions*, to require automated water deluge systems at all mobile acetylene trailer loading and unloading locations to control the spread of fire to other cylinders on a trailer and to nearby mobile acetylene trailers. (H-09-03)

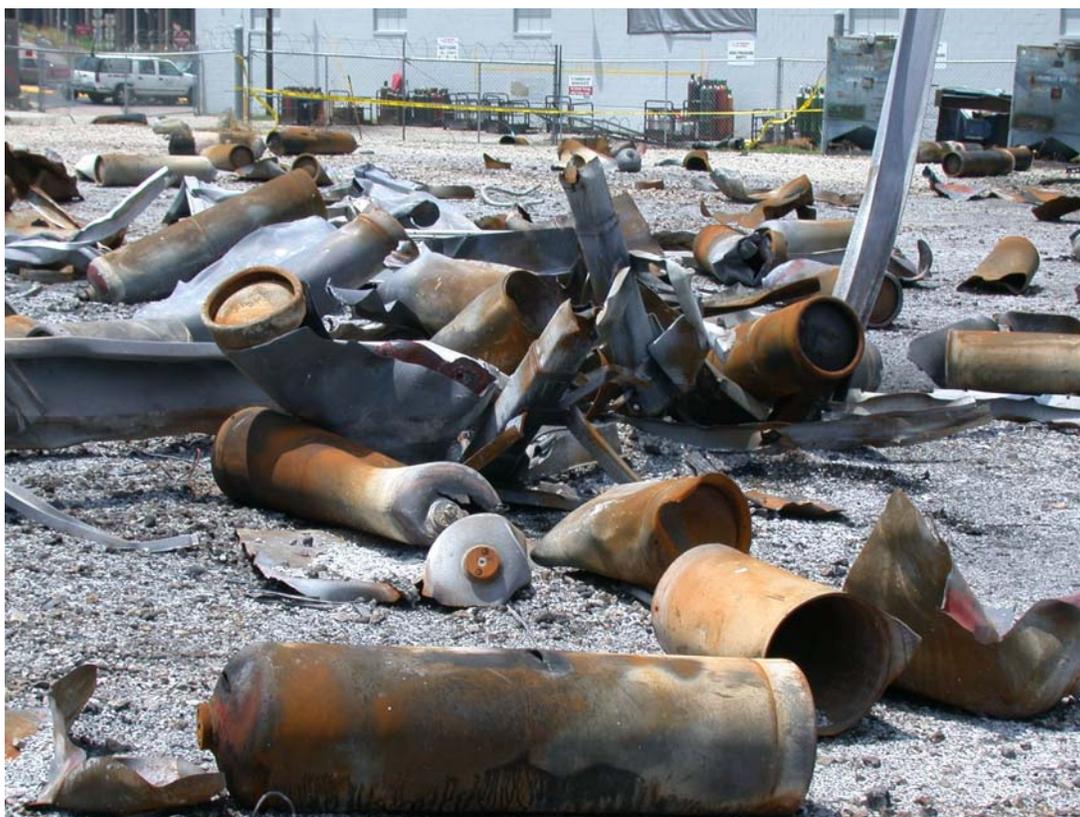
Figure 12. Dallas cylinder damage.
