Safety Defect and Noncompliance Report Guide for Vehicles
PART 573 Defect and Noncompliance Report³

On , August 31th, 2010, Fontaine Modification decided that a defect which relates to motor vehicle safety exits in the motor vehicles listed below, and is furnishing notification to the National Highway Traffic Safety Administration in accordance with 49 CFR Part 573 Defect and Noncompliance Reports.

Make(s): Model Years Involved: Model(s): Production Dates: Beginning: Ending: VIN Range:
Beginning: 4/15/09 **Ending:** 5/7/10 **Vehicle Type: Bodystyle:** *Freightliner Medium Duty M2 / with Fontaine Modified Dual Steering*

Descriptive information which characterizes/distinguishes the recalled vehicles from those model vehicles not included in the recall: *These Freightliner Medium Duty M2s have been modified by adding dual steering components by Fontaine Modification.*

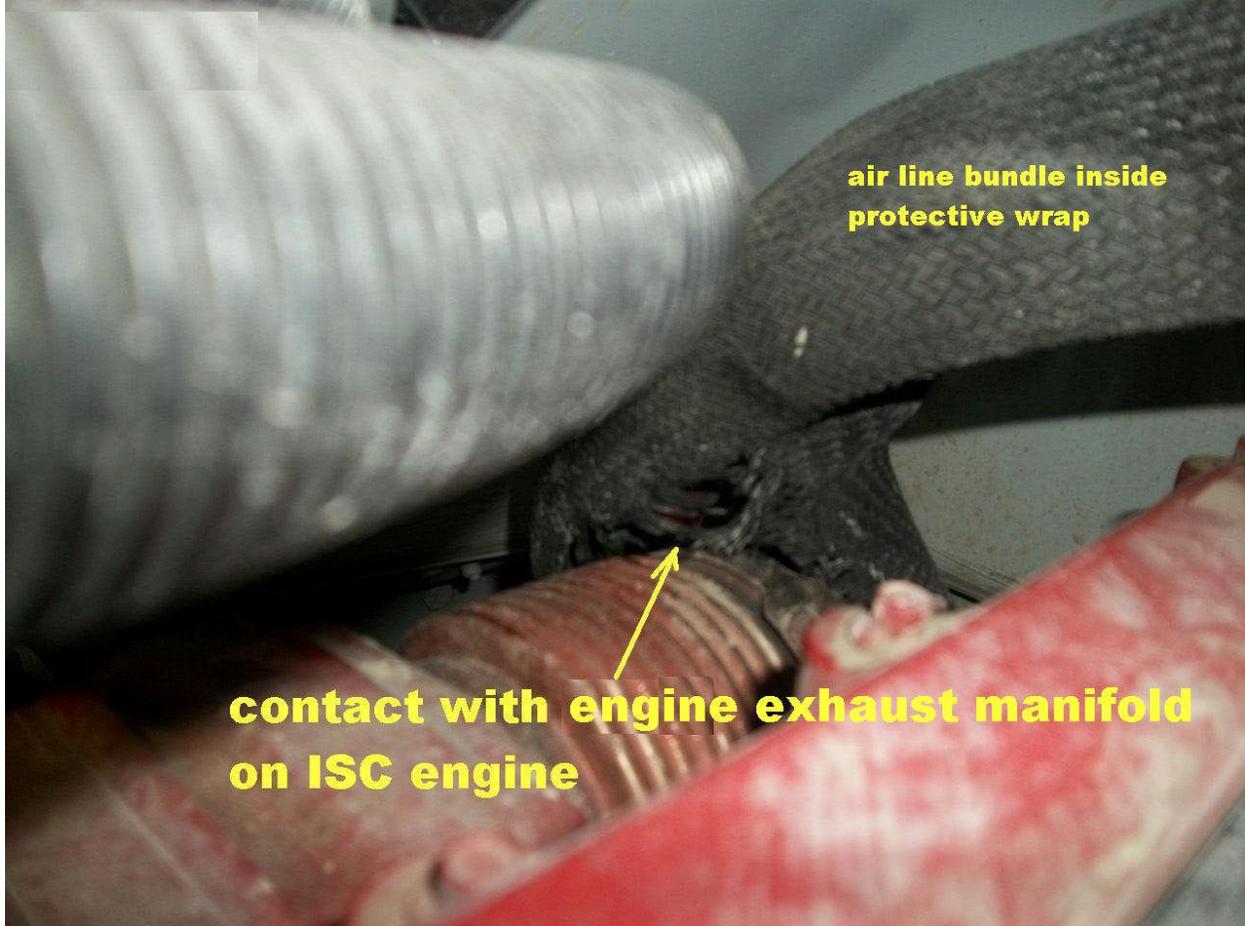
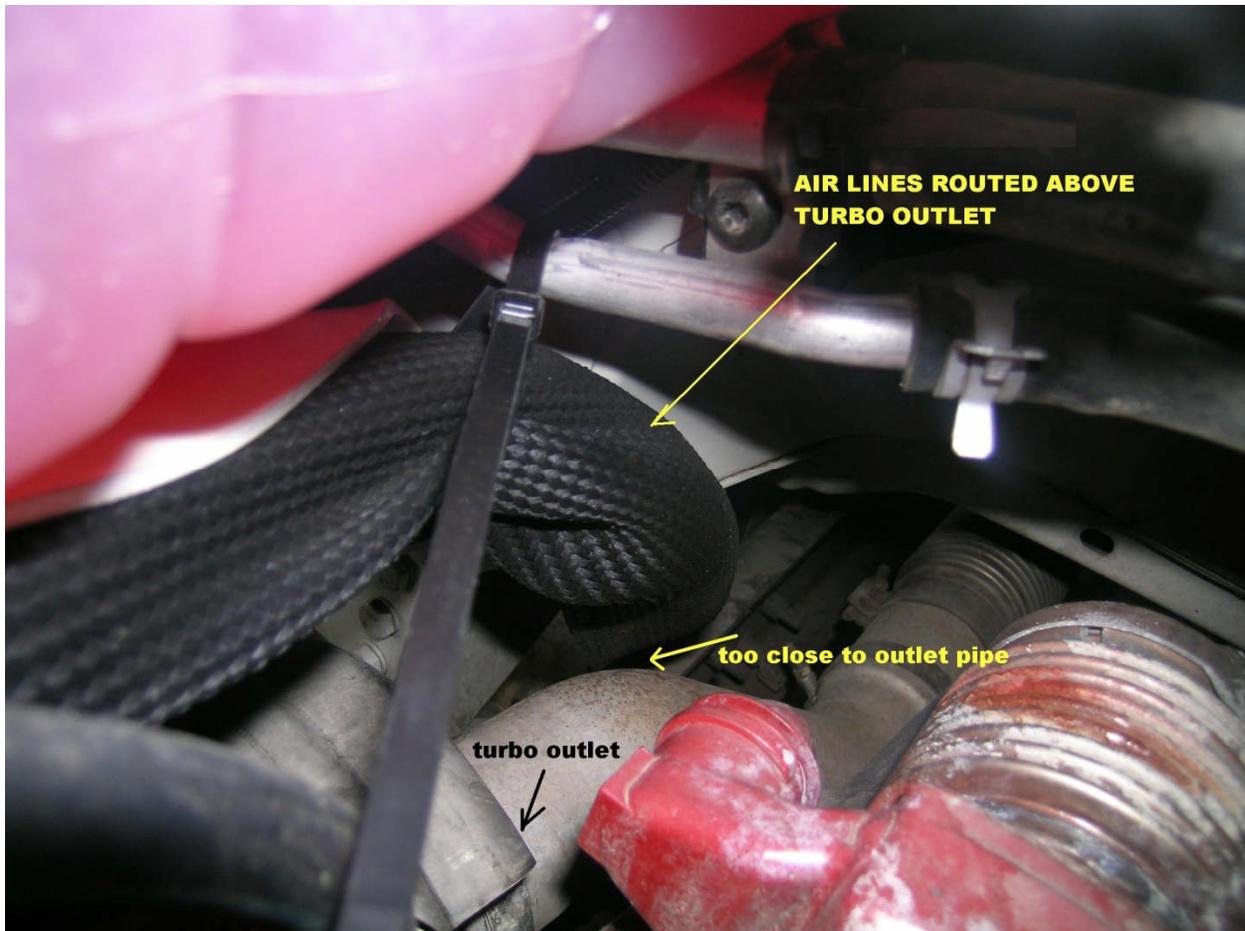
The air brake hoses installed by Fontaine Modification are the parts in question. Fontaine installs 4 air lines per truck, from the OEM (Freightliner) brake valve on the firewall over to the Fontaine installed RH side foot brake. Routing of the hoses was found to be too close to the turbo outlet or the engine exhaust manifold (top of engine) on some trucks.

The cause of the melted air brake hoses was found to be miss-routing of the hoses by installers. The hoses on some trucks were not installed to ensure clearance from the turbo outlet piping, and in some cases the hoses were routed too close to the exhaust manifold on the top RH side of the engine.

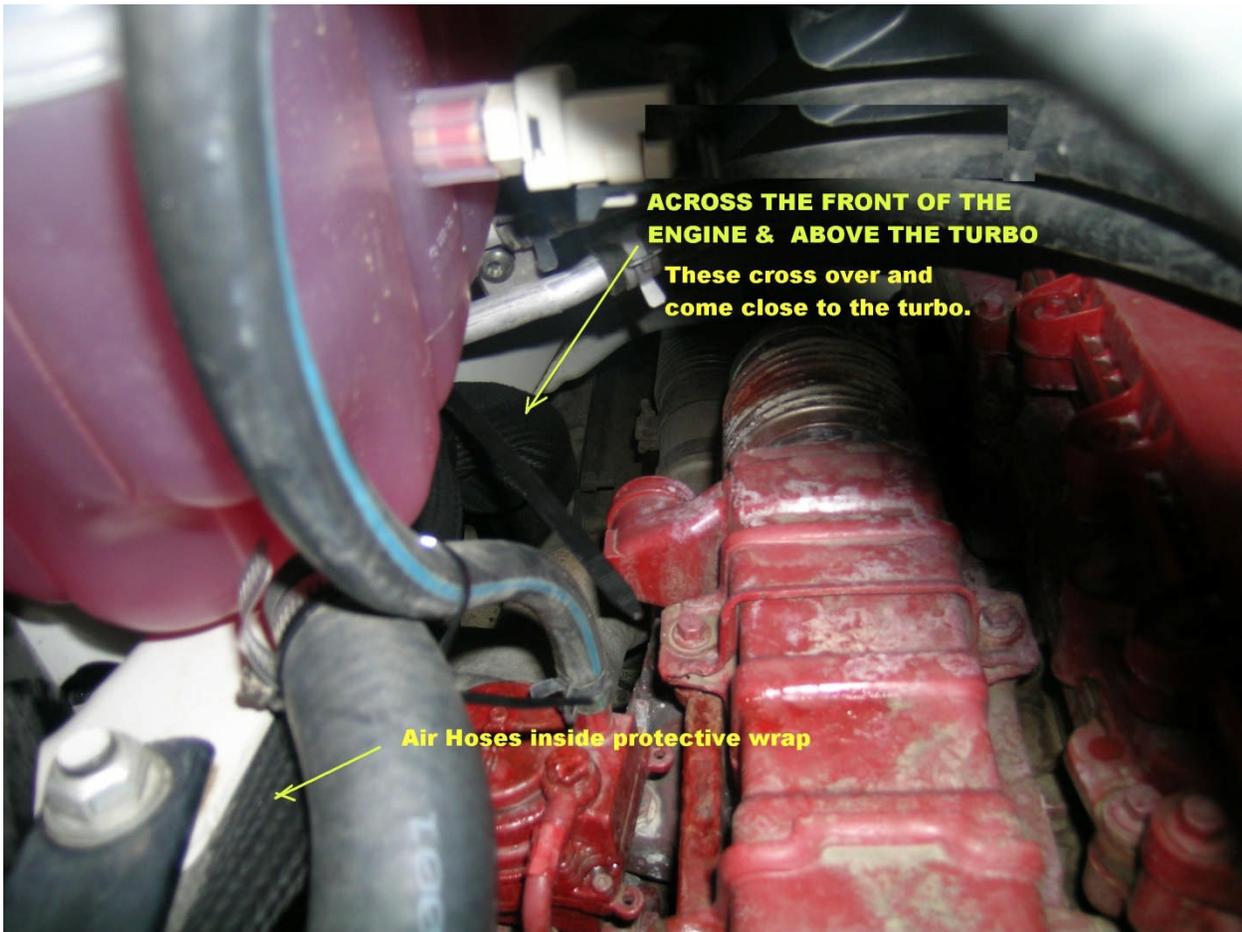
**ACROSS THE FRONT OF THE
ENGINE & ABOVE THE TURBO**

**These cross over and
come close to the turbo.**

Air Hoses inside protective wrap

V. Identify the Remedy: *The remedy for any melted air hoses is to remove the affected hoses, contact Fontaine Modification for parts, and replace with new hoses and thermal wrap as shown below. For Air Hoses that are improperly routed, the remedy is to route per the enclosed photos away from hot exhaust components.*

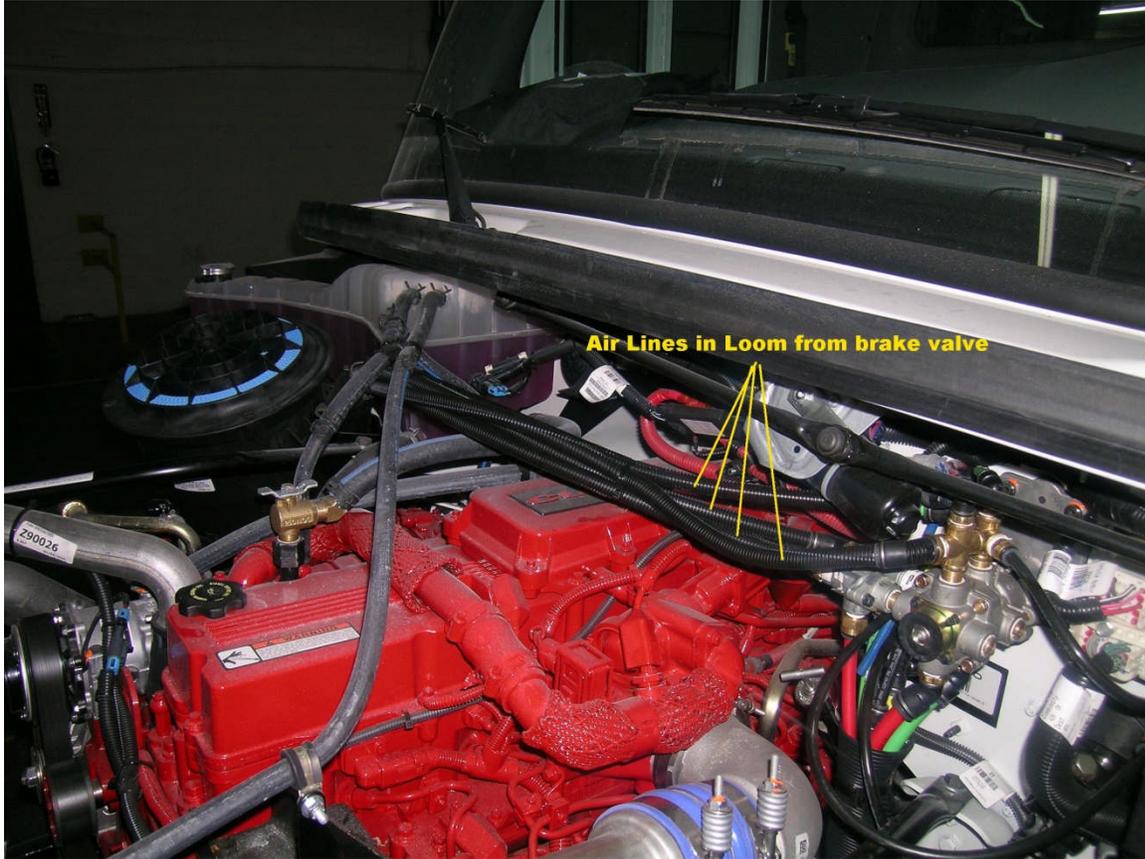
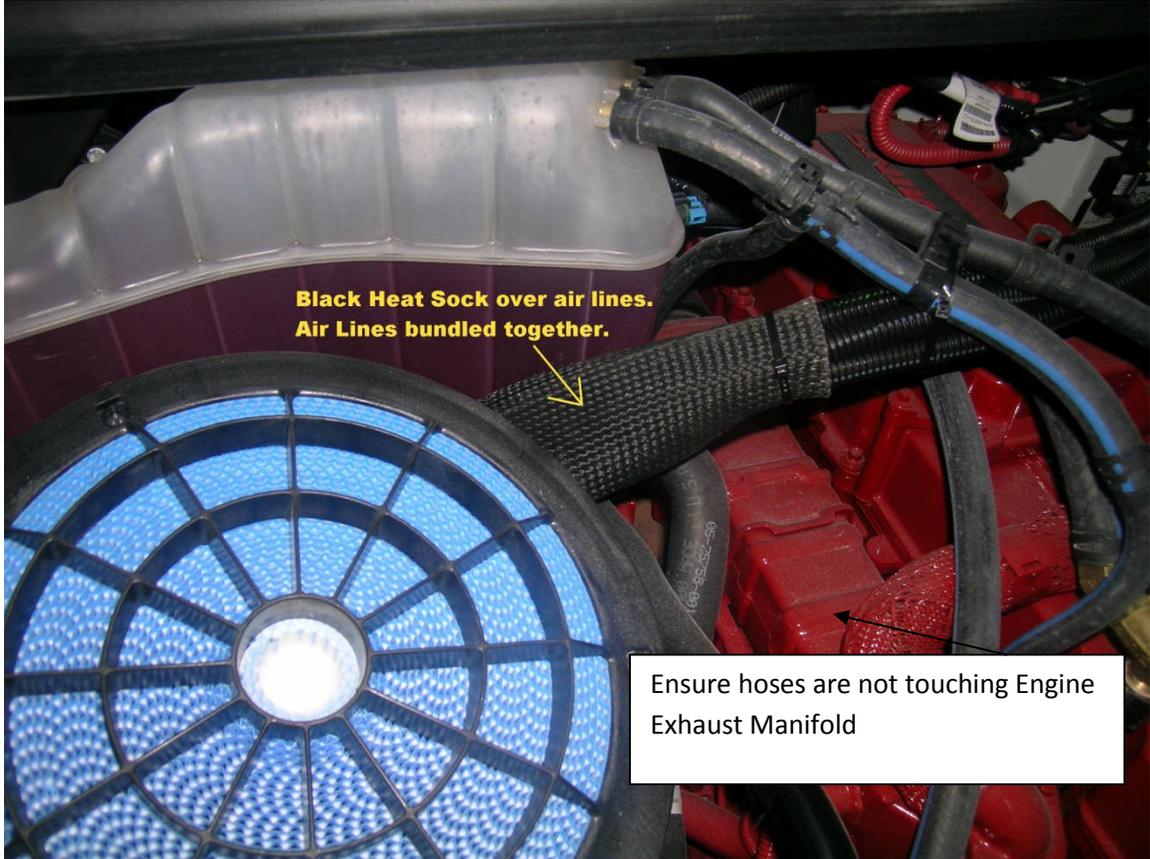
**Black Heat Sock over air lines.
Air Lines bundled together.**

Ensure hoses are not touching Engine
Exhaust Manifold

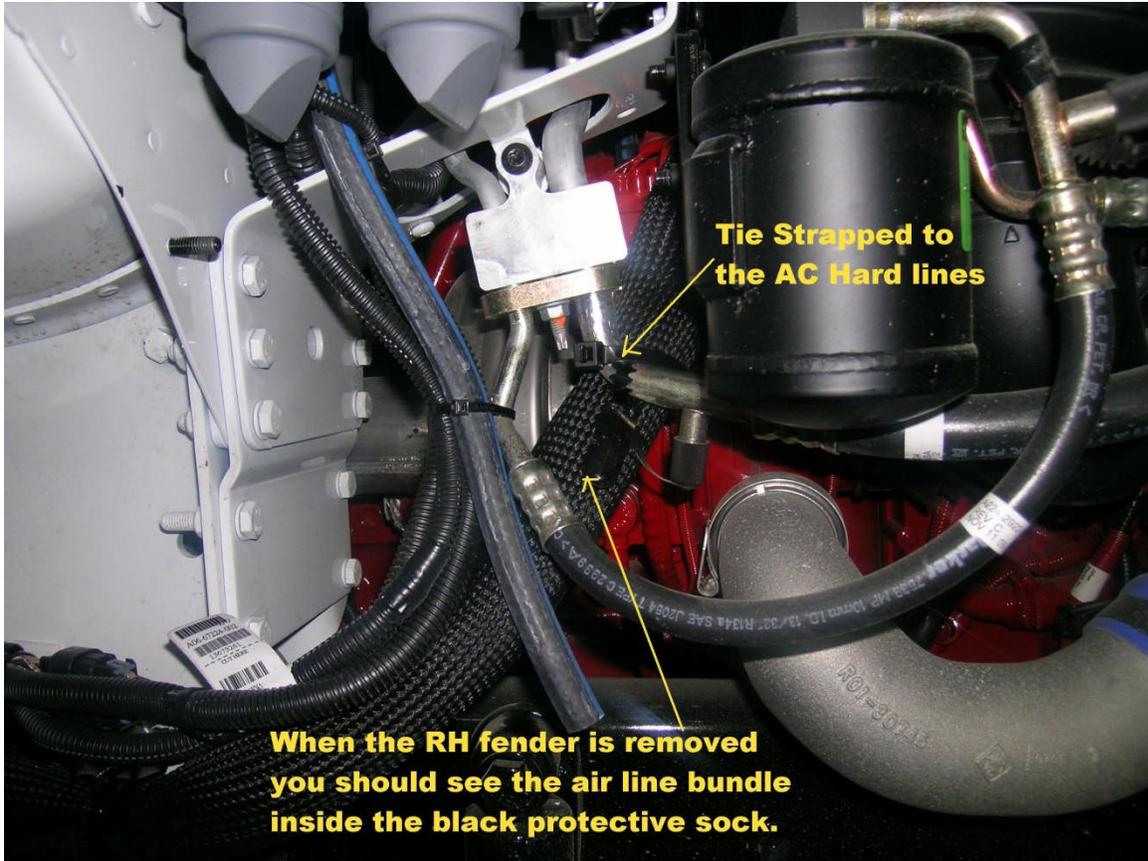
**Tie Strapped to
the AC Hard lines**

**When the RH fender is removed
you should see the air line bundle
inside the black protective sock.**

MOST CRITICAL ROUTING STEP

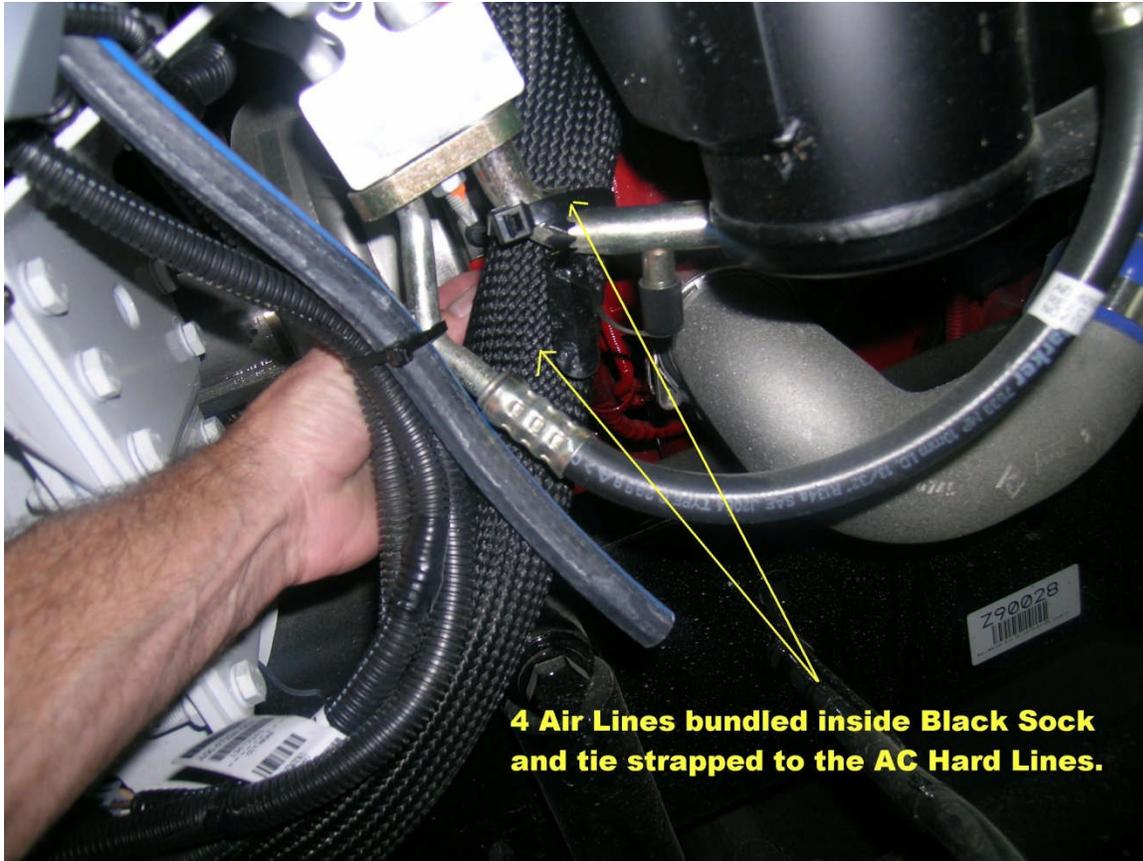
4 Air Lines bundled inside Black Sock and tie strapped to the AC Hard Lines.

REMOVE RH SIDE FENDER TO GAIN ACCESS TO THE AIR LINES. SOCK MAY BE SILVER OR BLACK.
