This Service Information bulletin supersedes SI B34 04 10 **dated March 2011**.

Recall Campaign 10V- 446: Inspect Brake Booster Vacuum Supply Line

E60 (5 Series) with N62 or N62TU engines produced from August 8th, 2003 to November 30th, 2009

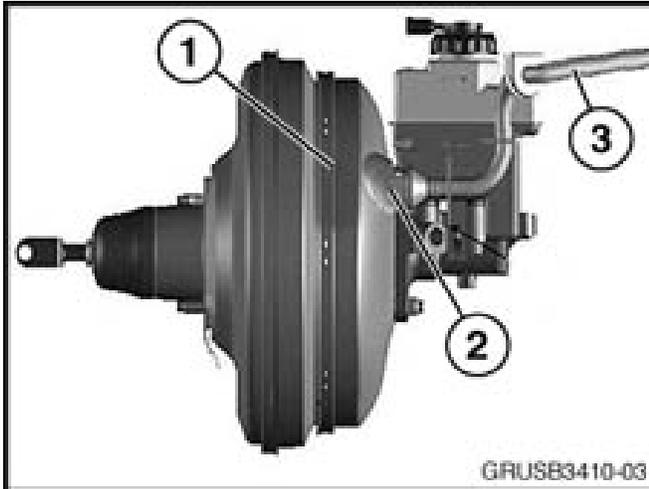
1. Remove the brake booster vacuum supply line (3) together with the non-return valve (2) from the brake booster (1).

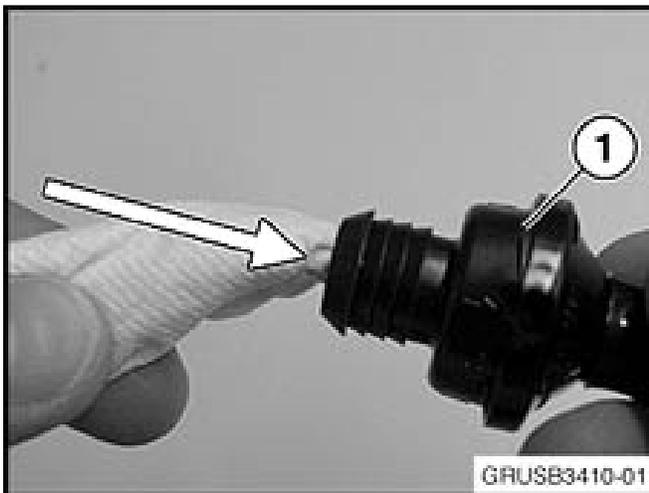
2. Check the brake booster vacuum supply line at the non-return valve upstream from the brake booster for contamination of oil. Insert a tightly rolled up corner of a non-reusable lint free white shop towel (see arrow) into the non-return valve (2). If the towel does not indicate any engine oil residue, proceed to step 4.

3. If the line exhibits contamination with engine oil, proceed to step 5.
