Recall Bulletin

File In Section: Product Recalls
Bulletin No.: 10312A
Date: November 2010

SUBJECT: Front Safety Belt Anchor Pretensioner Installation

MODELS: 2009-2010 Chevrolet Impala

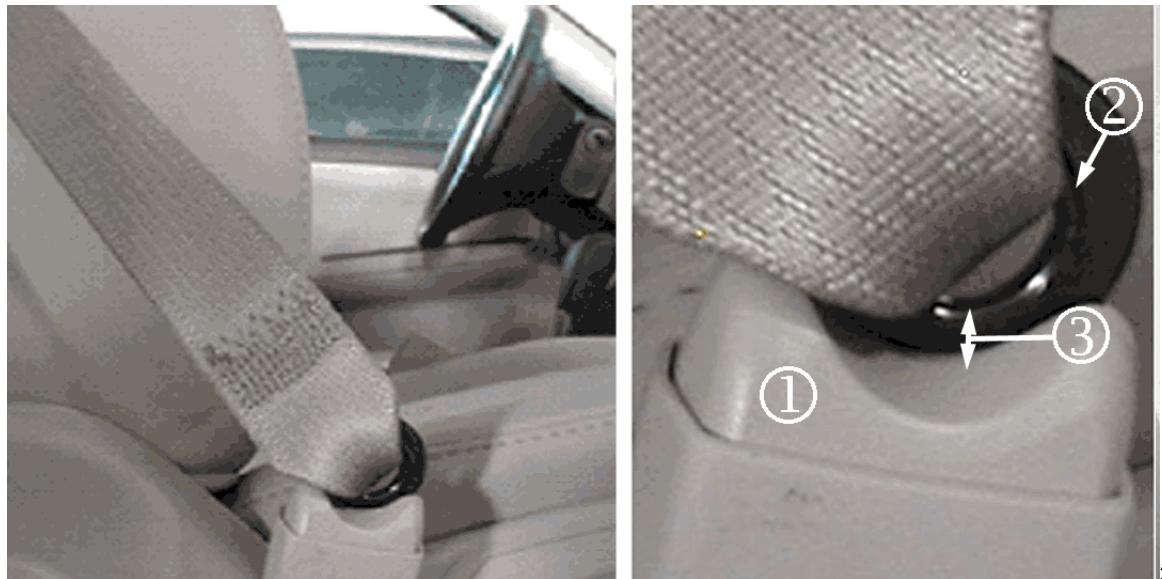
Seat Belt and Anchor Pretensioner Correctly Installed

There is a small gap (3) between the anchor linkage plate ring (2) and plastic cover (1). You should only see the anchor linkage plate ring and a small portion of black metal between the bottom of the anchor linkage plate ring and plastic cover.

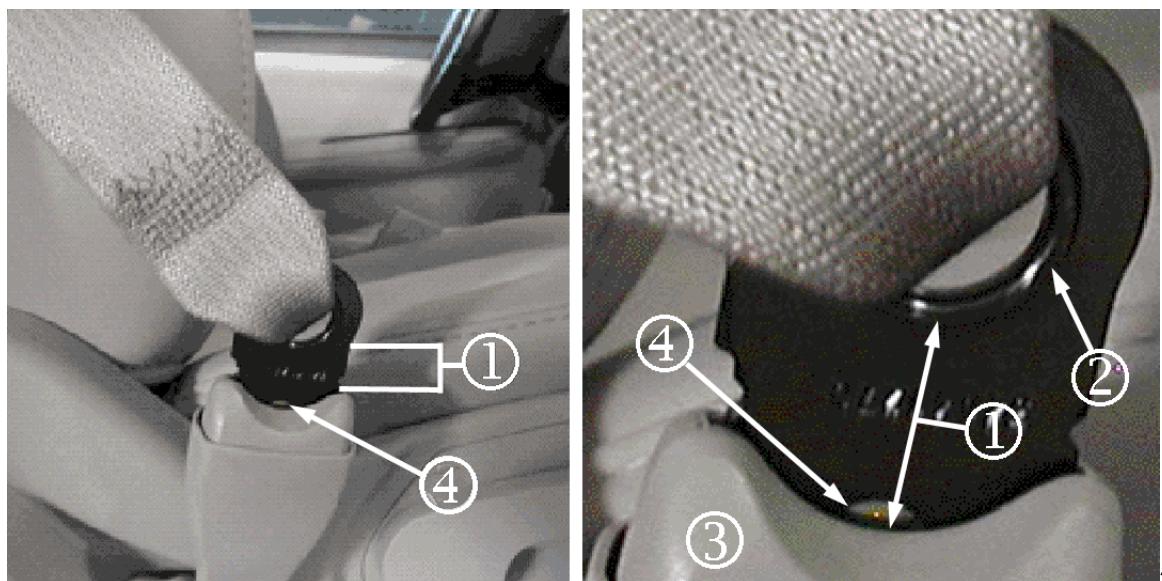
Seat Belt and Anchor Pretensioner Incorrectly Installed

There is a large gap (1) between the anchor linkage plate ring and plastic cover. A portion of the anchor plate hole (4) may be visible. There will be approximately 19 mm ($\frac{3}{4}$ in) of black metal visible between the bottom of the anchor linkage plate ring (2) and plastic cover (3).

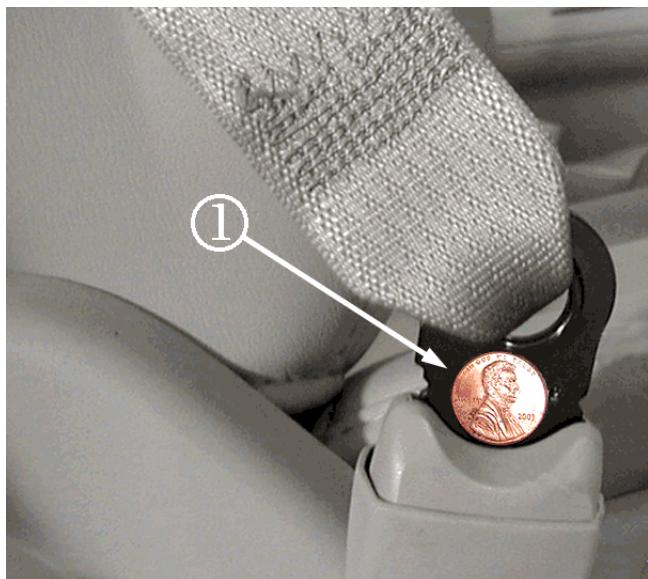
2536201

If you can stick a penny (1) between the anchor linkage ring and plastic cover, the seat belt and anchor pretensioner are incorrectly installed.

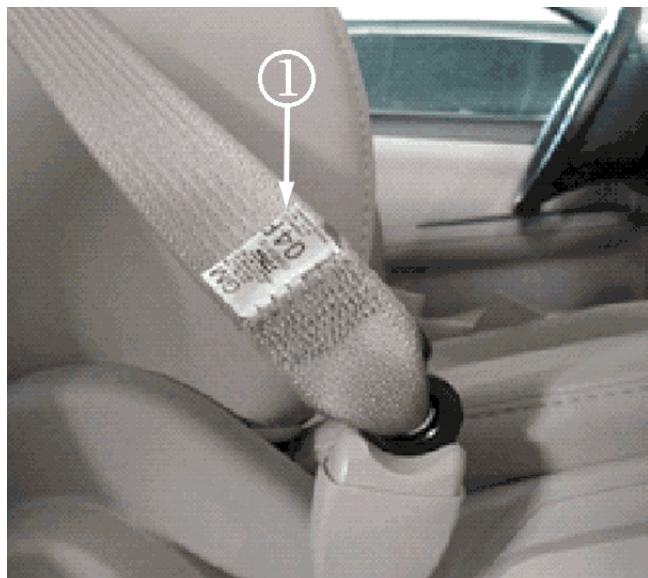
2533580

Seat Belt and Anchor Pretensioner Incorrectly Installed

Label Facing Door

If the seat belt label (1) is facing the front door of the vehicle, the seat belt and anchor pretensioner are incorrectly installed. The seat belt label must face the seat back.

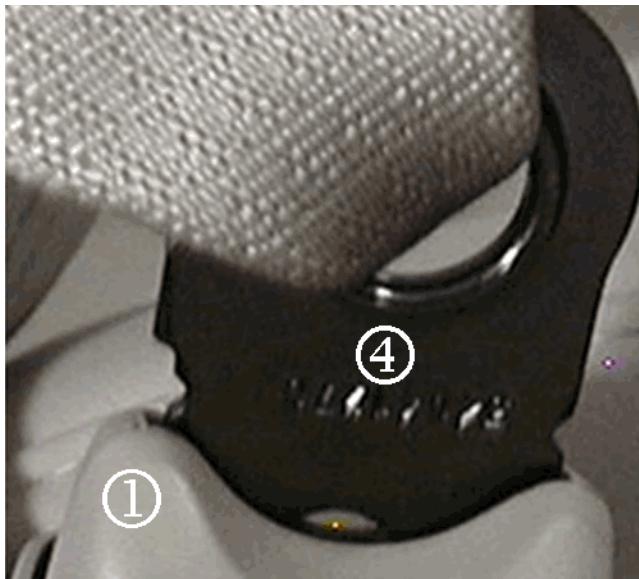
4. Determine the condition of the anchor linkage plate and seat belt.

- If the anchor linkage plate (4) is not fully installed and the seat belt is also twisted, remove it from the anchor linkage cover (1) and rotate the anchor linkage plate (4) so that the seat belt has no twists and the label faces the seat back. Reinstall the anchor linkage plate (4) into the anchor linkage cover (1). Ensure the anchor linkage plate (4) is fully seated. Insert linkage cover screw and tighten to 8 N·m (71 lb in).

- If the anchor linkage plate (4) and seat belt are correctly oriented but the anchor linkage plate (4) is NOT fully installed, push the anchor linkage plate (4) down until it is fully seated. Insert the linkage cover screw (3) and tighten it to 8 N·m (71 lb in).

- If the anchor linkage plate (4) was fully installed but the label is facing the door, remove the anchor linkage plate (4) from the anchor linkage cover (1) and rotate the anchor linkage plate (4) so that the seat belt has no twists and the label faces the seat back. Reinstall the anchor linkage plate (4) into the anchor linkage cover (1). Ensure the anchor linkage plate (4) is fully seated. Insert the linkage cover screw and tighten to 8 N·m (71 lb in).
