CERTAIN 2005 THROUGH 2006 MODEL YEAR F-150 VEHICLES BUILT AT NORFOLK ASSEMBLY PLANT — CLOCKSPrING TO DRIVER SIDE FRONTAL AIR BAG WIRE HARNESS REPLACEMENT

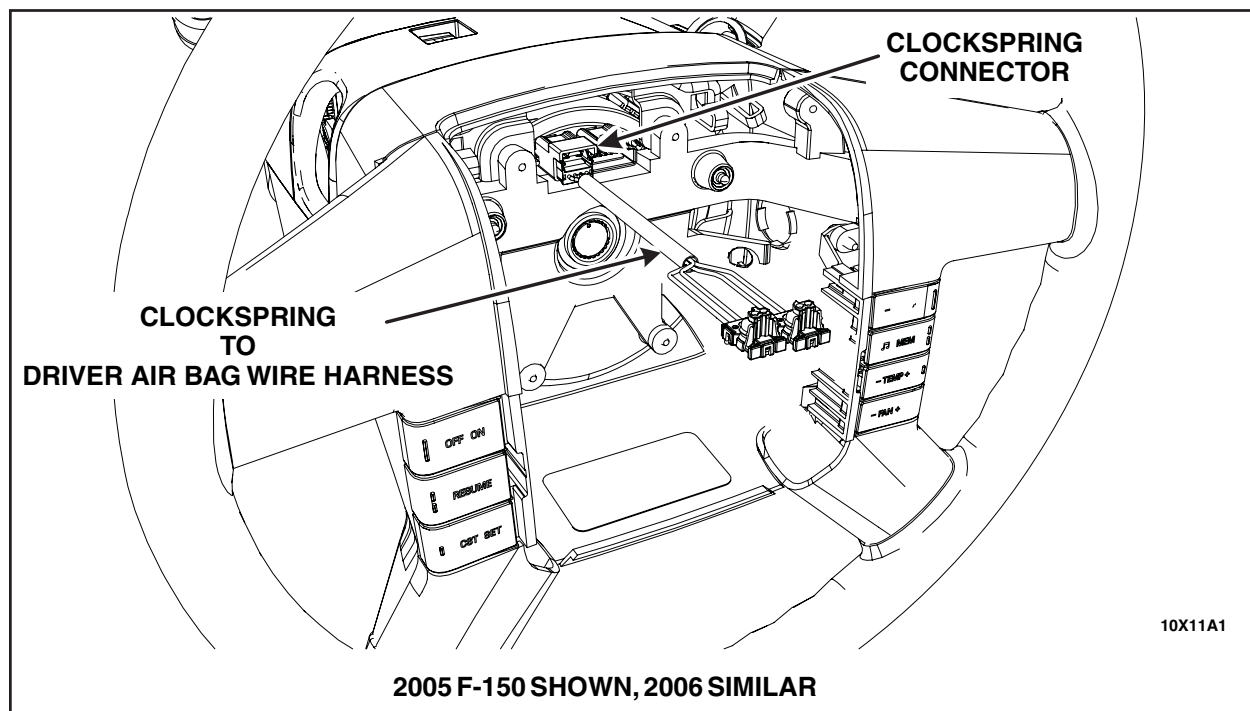
FIGURE 1

1. Remove the driver air bag. For additional information, refer to the appropriate WSM, Section 501-20B.
2. Release the clockspring connector lock and disconnect the harness from the clockspring. See Figure 1.

3. Install the **new** clockspring to driver air bag wire harness using the following sequence:
 1. Connect the harness to the clockspring.
 2. Make sure the harness lock at the clockspring is seated.
 3. Connect the harness to the air bag.
4. Install the driver air bag. For additional information, refer to the appropriate WSM, Section 501-20B.
