Safety Recall Trucks

Date	Group.	No.	Page
06.11	SC0349		1(5)

Power Mirror Switch Failure

LEU

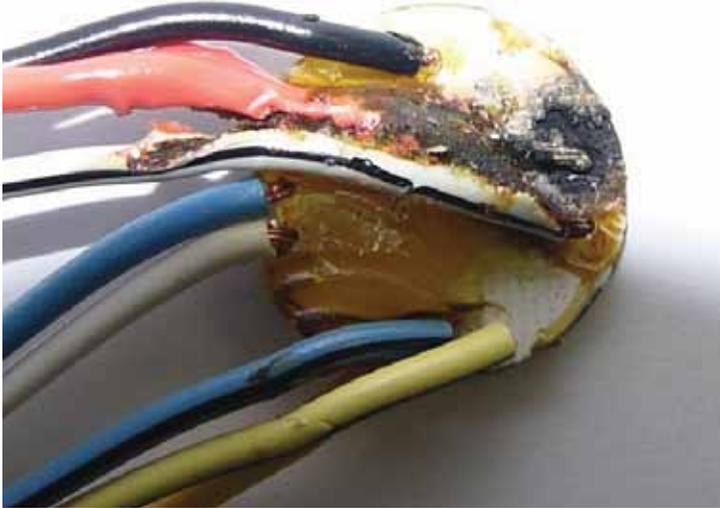
3. Inspect the rear of the mirror switch for signs of overheating. If the switch shows signs of overheating, such as wire insulation melted or discolored, replace the switch with part number 25165161.
