**RE: Defect Information Report – Supplemental Report No. 4
11V-330, FL-609, Starter Cable Isolator Bolts
Dealer Notice**

Subject: Starter Cable Isolator Bolts

Models Affected: Specific Freightliner Cascadia, Century Class S/T, Columbia, and Coronado vehicles; Sterling A/L-Line vehicles; and Western Star 4900 and 6900 vehicles manufactured January 14, 2008, through June 15, 2011, with a Detroit Diesel DD15 or DD16 engine and a certain rubber isolator.

December 2011
FL609A
NHTSA #11V-330
Transport Canada #11-236

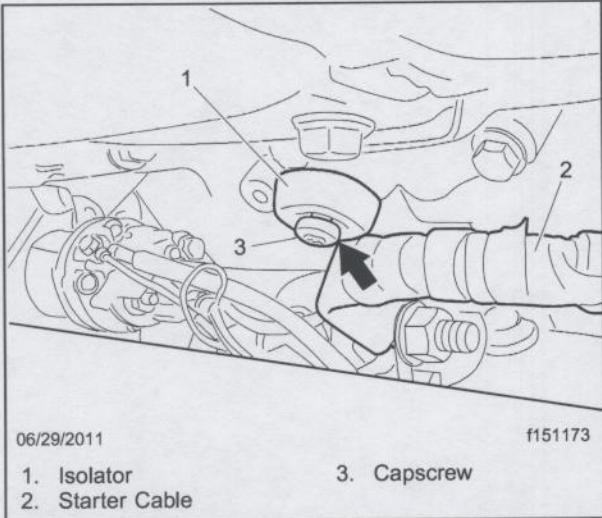
On some vehicles equipped with a Detroit Diesel DD15 or DD16 engine, the bolt attaching a rubber isolator to a support bracket may become loose and back out, potentially contacting an un-fused starter cable and creating a short circuit. A short circuit between an un-fused starter cable and chassis ground could result in a vehicle fire.

Fig. 1, Installation that Requires Replacement

4. Remove the capscrew, washer, and isolator from the side of the engine, then discard them. See **Fig. 1**.

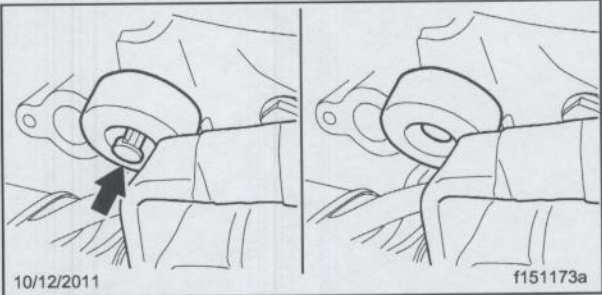
Fig. 2, Installing Isolator with Nylon Push-Rivet

5. Install the new isolator using the nylon push-rivet from the kit. See **Fig. 2**. There must be approximately 1/2-inch (13 mm) of clearance between the isolator and the starter cable.
6. Connect the batteries.
7. Clean a spot on the base label (Form WAR259) and attach a completion sticker for Recall FL609 (Form WAR260) to the base label.
