SUBARU

REPAIR INSTRUCTIONS

APPLICABILITY: 2011MY Legacy & Outback with Moonroof **DATE:** September 9, 2011
SUBJECT: Interim Inspection and Repair Procedure
for Moonroof Glass WW-33 Stop Sale /
Recall

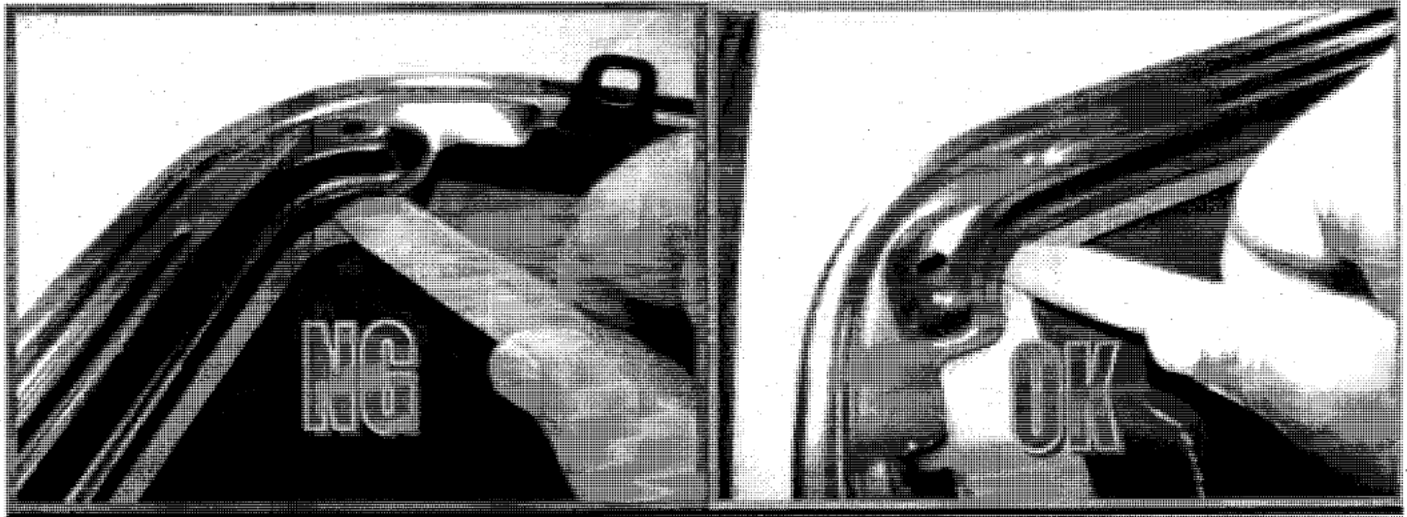
Insert the plastic trim tool between the frame and glass starting at the front left corner. Using a reasonable amount of force, attempt to rotate the plastic trim tool up to 90 degrees from the surface of the glass. While rotating the plastic trim tool, listen, look and feel for any separation of the glass from the frame. If adhesion is inadequate the frame will move easily. If adhesion is adequate there will be little to no movement. Check the remaining three corners. If any separation occurs at any of the four corners, the moonroof glass and frame will need to be replaced. Refer to the applicable Subaru Service Manual for the replacement procedure.

No Good, unacceptable

Okay, acceptable
