Recall Campaign 11V-476: Replace Front Driveshaft Screws

E90 xDrive vehicles produced from 2/8/2011 to 7/29/2011

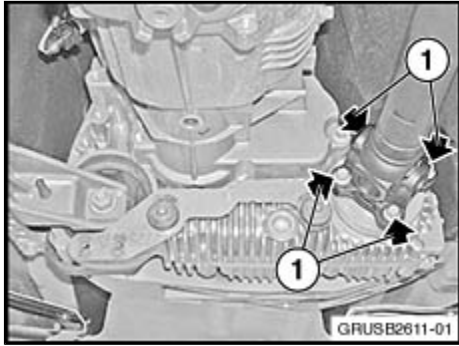
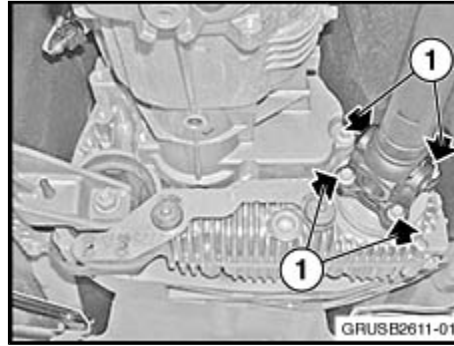
The front driveshaft screws, which hold the driveshaft to the transfer case and also to the front differential, may have been improperly torqued during assembly.

Replace the driveshaft screws securing the front driveshaft to the transfer case (1) and the front differential (2). The replacement screws require a 20Nm jointing torque, followed by an angle torque of 45°. Refer to Repair Instruction RA 26 20 000.
