Recall Bulletin

PRODUCT SAFETY RECALL

SUBJECT: Shift Lever Indicator May Not Display Correct Gear

MODELS: 2008-2010 Chevrolet Malibu
2008-2010 Pontiac G6
2007-2010 Saturn AURA
Equipped with 4-Speed Automatic Transmission (ME7/MN5)

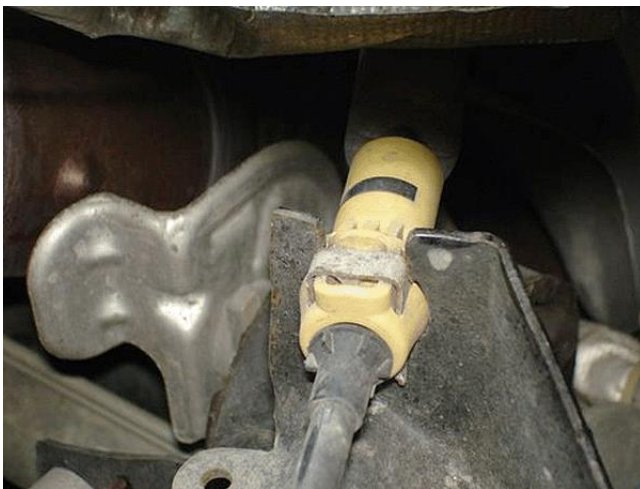
3256032

Note: Perform the service repair procedure in this bulletin on second design transmission shift cables only. First design transmission shift cables do NOT require a repair. Refer to the illustration to view a first design shift cable. Refer to *Transmission Shift Cable Kit Installation Procedure* in this bulletin to view the second design transmission shift cable.

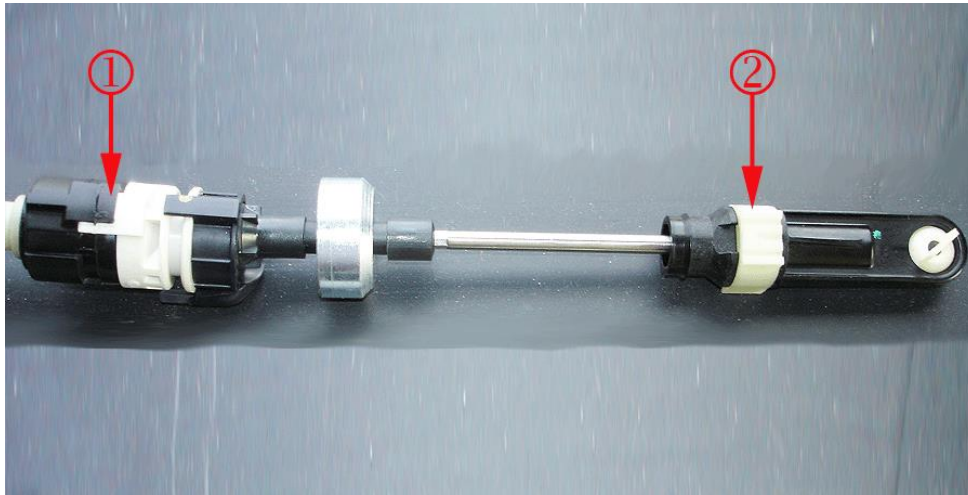
2269489

- (1) Shift Cable Locking Tabs
- (2) Shift Cable Adjuster Locking Clip

1. Open the hood and locate the transmission shift cable.
2. Determine if the transmission shift cable locking tabs are fractured and separated.

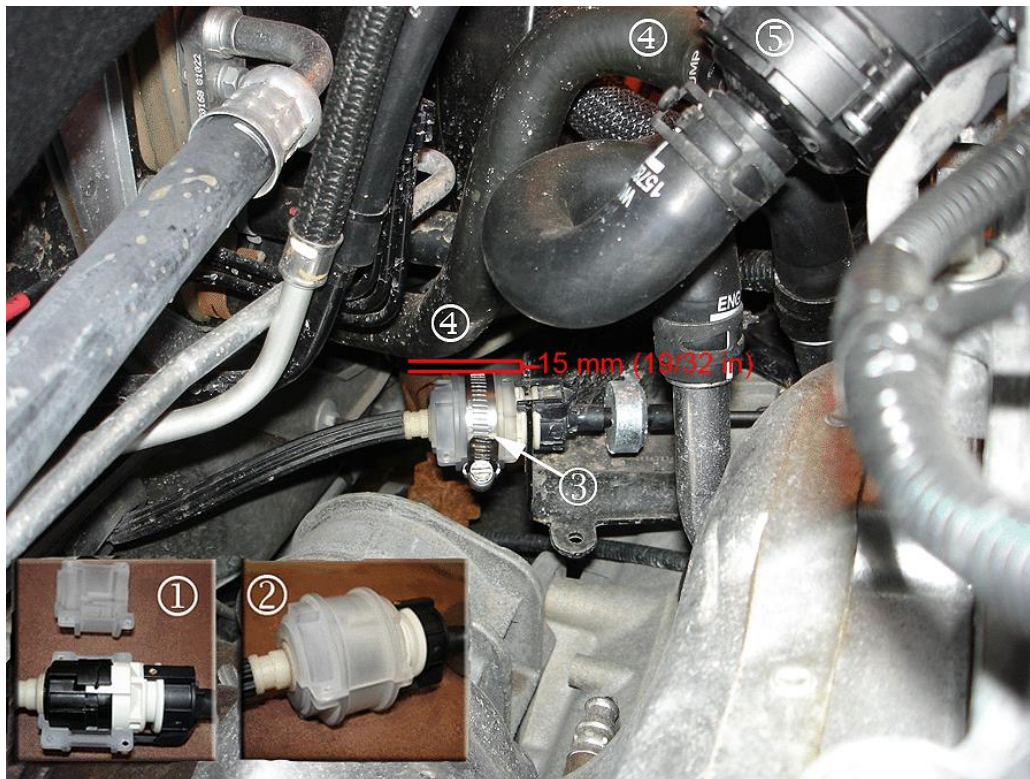
2269484

- (1) Clam Shell in Two Pieces
- (2) Clam Shell Around Shift Cable Locking Tabs
- (3) Clamp on Clam Shell
- (4) Inlet Coolant Hose and
- (5) Heater Cooler Pump.

3. Install the clam shell (1) (2) over the shifter cable locking tabs.
4. Install the service clamp over the clam shell (3). Position the clamp fastener head away from the inlet coolant hose (4). **Tighten the clamp to 4 N·m (35 lb-in).**
5. Ensure that there is 15 mm (19/32 in) of clearance between the inlet coolant hose (4) and the clam shell (3). On hybrid equipped vehicles, it may be necessary to reposition the inlet coolant hose (4) to achieve the required 15 mm (19/32 in) of clearance. **To reposition the inlet coolant hose (4) on hybrid equipped vehicles, locate the heater cooler pump (5) and perform Steps 5.1-5.4.**

Caution: Do not kink or damage the inlet coolant hose (4) when repositioning the hose to obtain the 15 mm (19/32 in) clearance. To avoid damaging the hose clamp, use J-38185 or equivalent hose clamp pliers to loosen the hose clamp.

- 5.1. Using J-38185 or equivalent hose clamp pliers, loosen the inlet coolant hose (4) connected to the heater cooler pump (5). Note the location of the clamp on the inlet coolant hose (4).
- 5.2. Rotate the inlet coolant hose (4) clockwise until 15 mm (19/32 in) of clearance between the inlet coolant hose (4) and clam shell (3) is achieved.
- 5.3. Ensure that the inlet coolant hose clamp is secure on the inlet coolant hose (4) in the production location.
- 5.4. Install the generator control module cover. Refer to *Generator Control Module Cover Replacement* in SI.

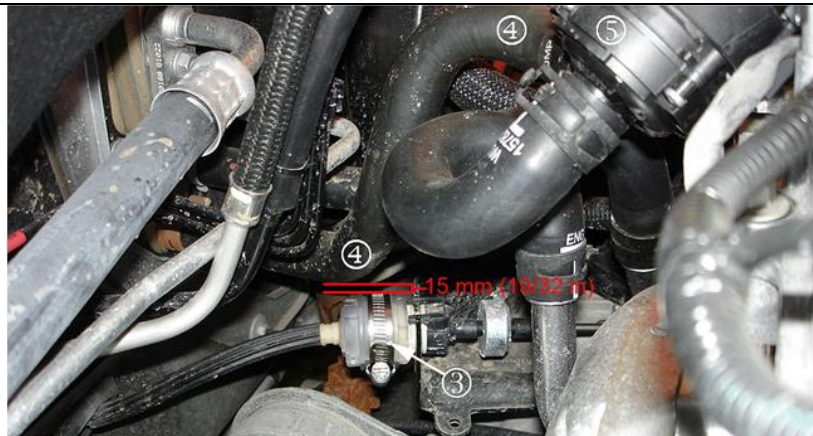
- (1) Clam Shell in Two Pieces
- (2) Clam Shell Around Shift Cable Locking Tabs
- (3) Clamp on Clam Shell
- (4) Inlet Coolant Hose and
- (5) Heater Cooler Pump.
