**REDESIGNED AIR BAG SPECIAL STUDY  
DRIVER FATALITY INVESTIGATION**

**VERIDIAN CASE NO. 2000-12-078A**

**VEHICLE: 2000 GMC K2500 PICK-UP**

**CRASH DATE - MAY 2000**

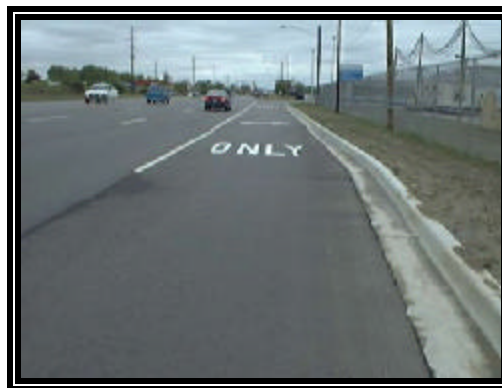
**Figure 1:** Westbound view approaching the point of impact.

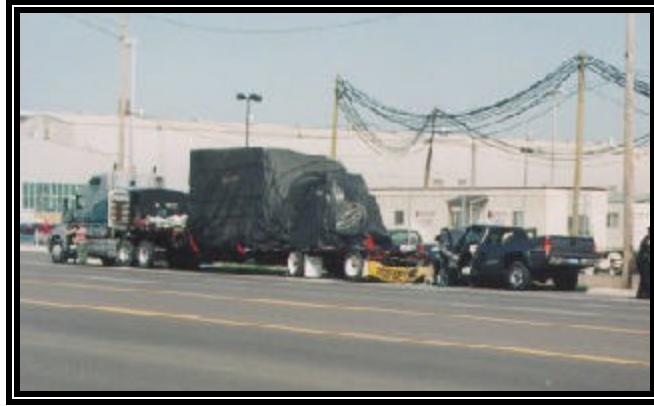
Figure 2: Police photograph of the crash scene.

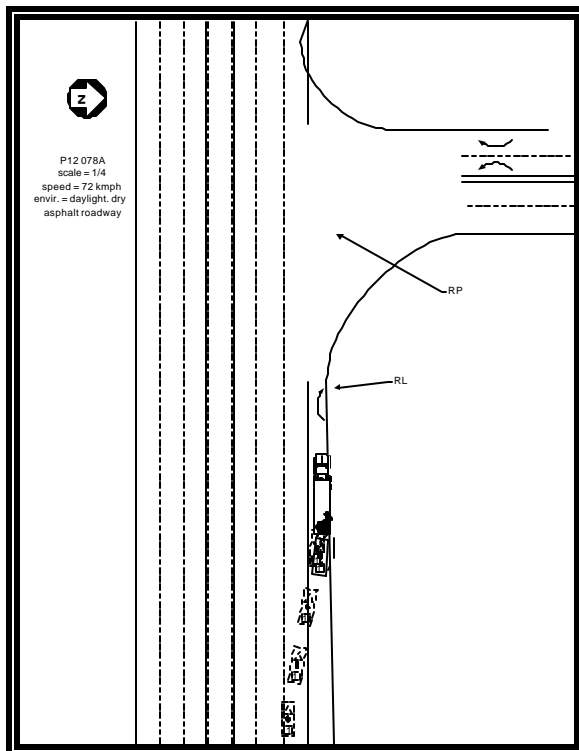
Figure 3 is a schematic of the crash scene. Inspection of the scene identified an area of gouge marks and a fluid spill at the point of impact. The

Figure 3: Crash schematic

gouge marks were attributed to undercarriage contact as the GMC impacted and under-rode the trailer. Immediately east of the point of impact, a 3 m (10 ft) scuff mark of the north curb face was identified. The scuff was attributed to the right front tire and was an indication the GMC had fully traversed the width of the outboard lane at impact. No skids marks were identified at the scene.

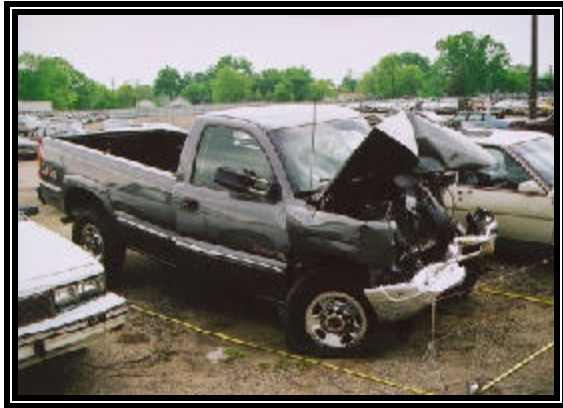
**Figures 4 and 5** are the right front and left lateral views of the GMC. The force of the collision compressed the frontal structures of the vehicle rearward into the engine compartment and firewall. The direct contact damage to the GMC extended across the full 165 cm (65 in) width of the front plane. The deformation was biased to the left corresponding to the slight angular trajectory (<10 deg) of the GMC relative to the tractor trailer. The vehicle's crush profile was measured at the elevation of the front bumper and across the upper radiator support. The under-ride characteristics of the impact resulted in greater deformation at the upper radiator elevation. The average crush profile was as follows: C1=84 cm (33.0 in), C2=80 cm (31.5 in), C3=80 cm (31.5 in), C4=66 cm (26.0 in), C5=53 cm (20.9 in), C6=46 cm (18.1 in). The hood buckled, shifted rearward and impacted the lower aspect of the windshield. The windshield was fractured. The left door was jammed shut by the impact and was opened during extrication. The right door was operational but restricted. The left and right wheelbase were foreshortened 38 cm (15 in) and 15 cm (6 in), respectively. The upper aspect of the left A-Pillar deformed causing the roof to buckle. The lower aspect of the A-pillar deformed and shifted rearward approximately 15 cm (6 in). The left sill was buckled immediately aft of the left A-Pillar. The compressive force of the crash caused contact between the back of the cab and the forward aspect of the pick-up bed.

**Figure 4:** Right front view of the GMC.

The Collision Deformation Classification (CDC) of the damage was 12-FDEW-04. Reconstruction of the crash through the use of the Barrier Model of the WINSMASH program determined a barrier equivalent delta V of 53.4 km/h (33.2 mph). The longitudinal and lateral components were -52.6 km/h (-32.7 mph) and -9.3 km/h (-5.8 mph), respectively. This calculation appeared to be underestimated based on SCI experience.

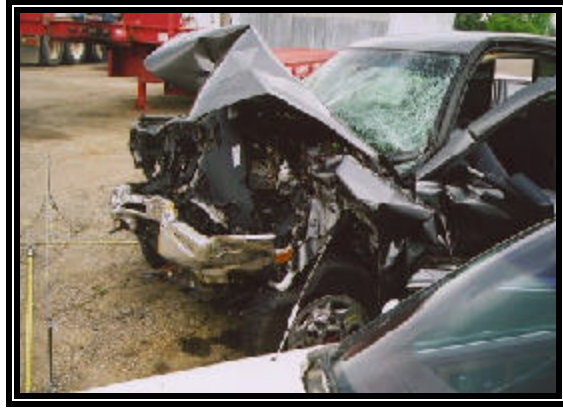
**Figure 5:** Left lateral view across the front plane.

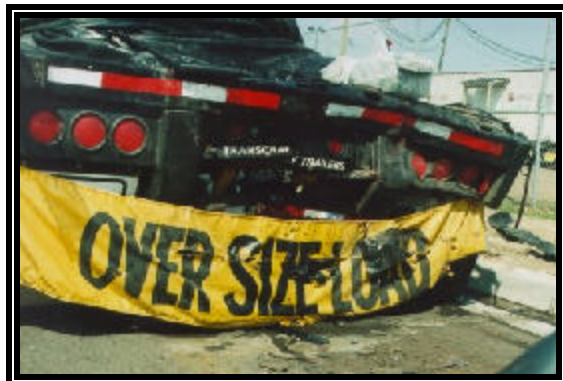
**Figure 6** is a view of the damaged trailer. The trailer sustained approximately 178 cm (70 in) of direct contact during the impact sequence.. The bed was buckled down and the under-ride guard was damaged. The right rear trailer tire had aired out indicating possible damage to the rear suspension. The trailer deformation indicated a portion of the GMC's pre-impact energy was absorbed in the crash. All the above factors indicate the severity of the subject crash was underestimated by WINSMASH model. Conservation of Energy principles applied to the crash scenario indicated the approximate delta V of the crash was 80 to 89 km/h (50 to 55 mph).

**Figure 6:** View of the trailer damage.

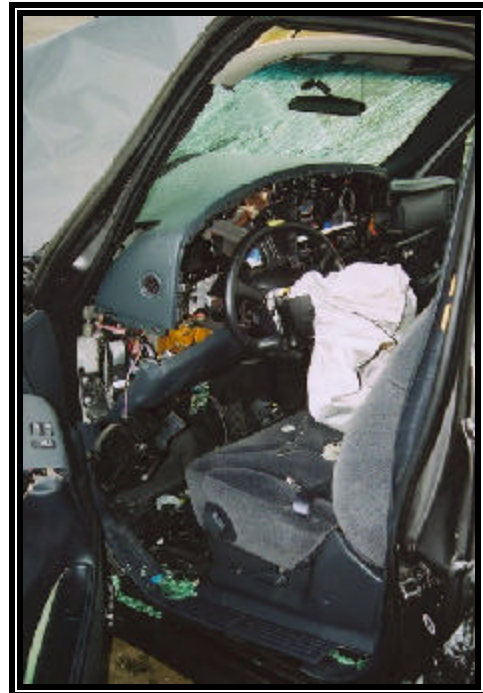
The interior damage to the 2000 GMC K2500 resulted from the exterior force of the crash in addition to the deployment of the driver air bag and occupant contacts within the compartment. **Figure 7** is a left interior view of the driver's position. The left A-pillar and left corner of the instrument panel intruded longitudinally rearward approximately 15 cm (6 in). The left toepan buckled and intruded rearward approximately 24 cm (9 in). The lower aspect of the windshield was fractured due to contact from hood. The center aspect of the windshield's interior surface directly forward of the driver's position was fractured from head contact. Tissue was observed in the fracture site.

**Figure 7:** Left interior view of the driver's position.

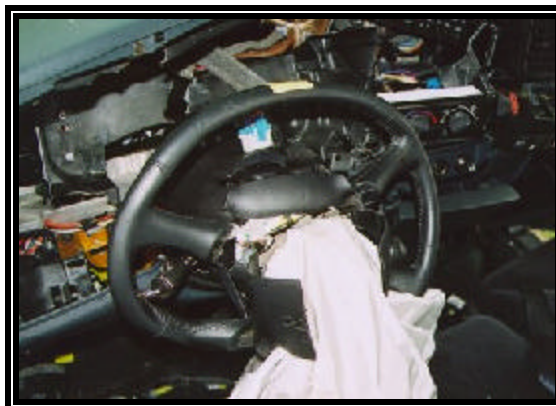
The tilt mechanism of the steering wheel was adjusted to the center position and was fractured. The steering wheel rim, **Figure 8**, was completely distorted and deformed forward about the center hub. The rim was fractured in the 6 o'clock sector. The steering column was completely displaced from the shear capsules. The steering wheel rim deformation and shear displacement resulted from the loading of these components by the driver's arms and chest during his forward kinematic displacement. It should be noted the driver was restrained by the integrated 3-point lap and shoulder belt system.

**Figure 8:** View of the deformed steering wheel.

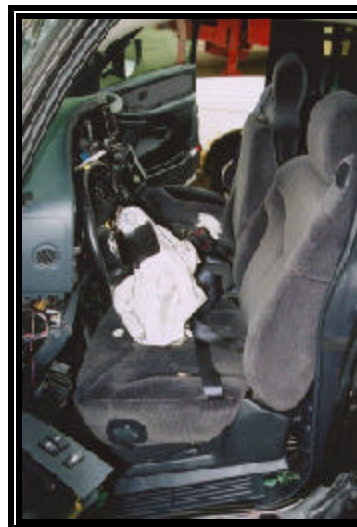
The manual restraint system in the 2000 GMC K2500 was an integrated seat belt system, **Figure 9**. The inertial retractor and D-ring were integrated into the outboard aspects of the seat backs. The lap portion of the webbing was anchored to the outboard aspect of the seat cushion. The inboard buckle anchor was attached to the inboard aspect of the cushion. In this manner, the manual restraint can give the occupant a consistent fit, regardless of seat track position.

Upon inspection, the sliding latch plate was inserted and latched to the buckle anchor. The webbing had been cut by the EMS personnel during extrication. The lap portion of the cut section was on the seat. The shoulder portion of the webbing had spooled back into the retractor and could not be accessed. Examination of the webbing and hardware surfaces of the latch plate revealed transfer marks and contact evidence. These evidences were consistent with proper belt use in this crash.

**Figure 9:** View of the integrated left front restraint.
