**VERIDIAN REMOTE REDESIGNED AIR BAG RELATED CHILD PASSENGER
SERIOUS INJURY INVESTIGATION
SCI TECHNICAL SUMMARY REPORT**

NASS/SCI COMBO CASE NO. 00-12-133J

VEHICLE - 1998 HYUNDAI ELANTRA

CRASH DATE - AUGUST 2000

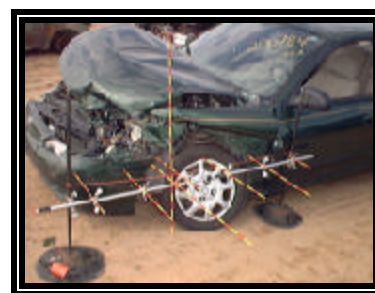
The 1998 Hyundai Elantra sustained moderate damage as a result of the impact with the heavy truck. The direct contact damage began at the front left bumper corner and extended rearward 127 cm (50") along the left side of the vehicle (**Figures 4 and 5**). The vertical location of the damage was approximately 45 cm (18") above the ground. The combined direct and induced damage also began at the front left bumper corner and measured 131 cm (52") rearward along the left side. The maximum crush was located between C4 and C5 and measured 41 cm (16"). The left front fender had been crushed laterally to the right and separated from the front left bumper fascia.

The hood was displaced upward and laterally to the right and had buckled rearward at the designated fold points. The top aspect of the left front wheel was displaced to the right and was deflated. Abrasions from the front bumper of the truck were noted on the left front corner of the hood, the left front aspect of the fender, and the left front bumper corner. The Collision Deformation Classification for this impact with the truck was 10-LFEW-3. Six crush measurements were taken by the NASS researcher at the mid-door level and were as follows: C1 = 1 cm (.5"), C2 = 11 cm (4"), C3 = 28 cm (11"), C4 = 37 cm (15"), C5 = 14 cm (6"), C6 = 17 cm (7").

Figure 4. Left front side damage to the Elantra

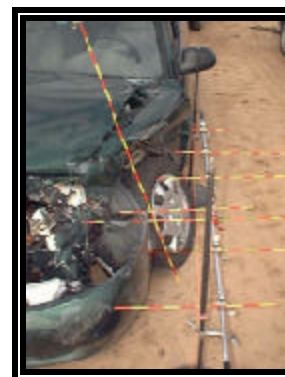
Figure 5. Longitudinal view of damage

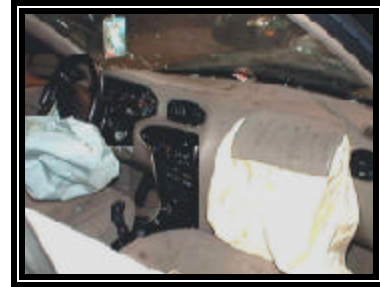
Interior damage was minor and was attributed to occupant contact (**Figure 6**). There was no passenger compartment integrity loss. The windshield glazing was cracked from impact forces and the front right passenger's air bag cover flap. The left front door glazing disintegrated from impact forces. There were no measured intrusions. There was no deformation of the steering wheel rim and no identifiable contact to the knee bolster. The left front interior door surface was deformed from occupant contact. Both front seat backs were deformed forward toward the outboard sides from contact by the rear seat occupants.

Figure 6. Interior view of the Hyundai Elantra

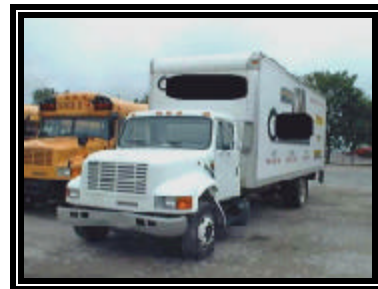
The 1999 International heavy truck was a straight truck with a medium-heavy cube (**Figure 7**). It sustained minor damage as a result of the impact with the Hyundai Elantra. The direct contact damage was concentrated at the center of the front bumper. The direct and induced damage involved the entire frontal width of the truck. The center area of the bumper was crushed rearward approximately 5 cm (2"). The rear aspect of the left front fender was displaced. The bumper height above the ground was 45 cm (18").

Figure 7. Frontal damage to the heavy truck

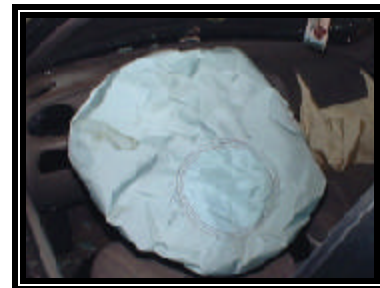
The 1998 Hyundai Elantra was equipped with redesigned air bags for the driver and front right passenger positions which deployed as a result of the impact with the heavy truck. The driver's air bag was housed in the center of the steering wheel with asymmetrical H-configuration module cover flaps. The NASS researcher measured the top cover flap as 16 cm (6") in width and 4 cm (2") in height. The bottom flap measured 16 cm (6") in width and 7 cm (3") in height. The driver's air bag measured 62 cm (24") in diameter in its deflated state. The air bag was tethered by two internal straps and vented by 2 ports located at the 10 and 2 o'clock positions. There was no damage noted to the air bag or module cover flaps. Blood spattering was documented on the driver's air bag.

Figure 8. Driver's redesigned air bag

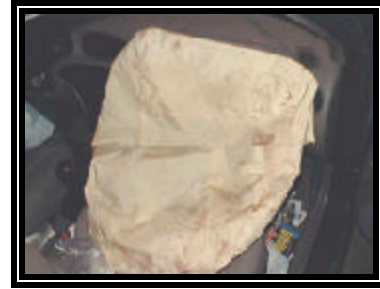
The redesigned front right passenger’s air bag deployed from the mid-instrument panel area with a single cover flap design hinged at the top aspect (**Figure 9**). The cover flap was rectangular in shape and measured 31 cm (12") in width and 18 cm (7") in height. The air bag measured 45 cm (18") in width and 58 cm (23") in height. The air bag was vented by two ports located at the 10 and 2 o’clock positions. There was no damage noted to the air bag or module cover flaps. Blood spattering was documented on the front right passenger’s air bag. A piece of chewing gum was found stuck to the rear aspect of the air bag on the lower right corner.

Figure 9. Front right passenger’s redesigned air bag

A piece of chewing gum was identified on the rear aspect of the air bag on the bottom right corner. It was unknown if the 5-year-old front right passenger was chewing it prior to the crash.
