Remote, Redesigned Air Bag Special Study

Dynamic Science, Inc., Case Number (2000-48-061K)

1998 Mercedes ML320

Alabama

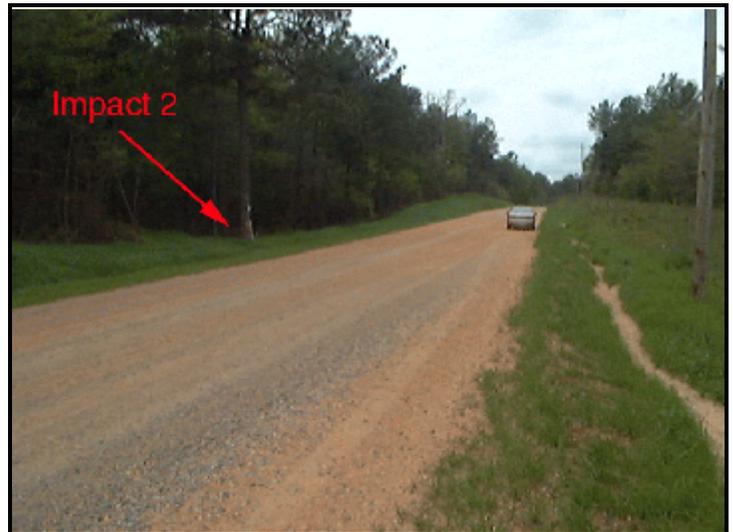
Figure 1. Overview showing path of travel and impact with tree (impact 2)

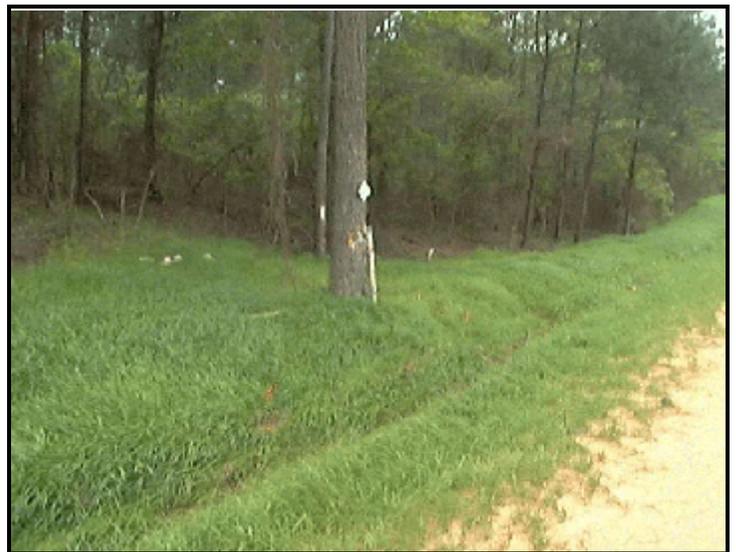
Figure 2. Impact with tree (impact 2)

The driver lost control of the vehicle in the curve and departed the roadway on the right. The driver overcorrected to the left, departed the roadway, struck an embankment (unknown CDC), and then struck a tree with its front end (01FYEW2). Vehicle 1 sustained a longitudinal delta v of -18 km/h (-11 mph). Both front air bags deployed at this time. Vehicle 1 then rotated out in a counterclockwise direction and struck an additional tree with its left side (09LPAN3).

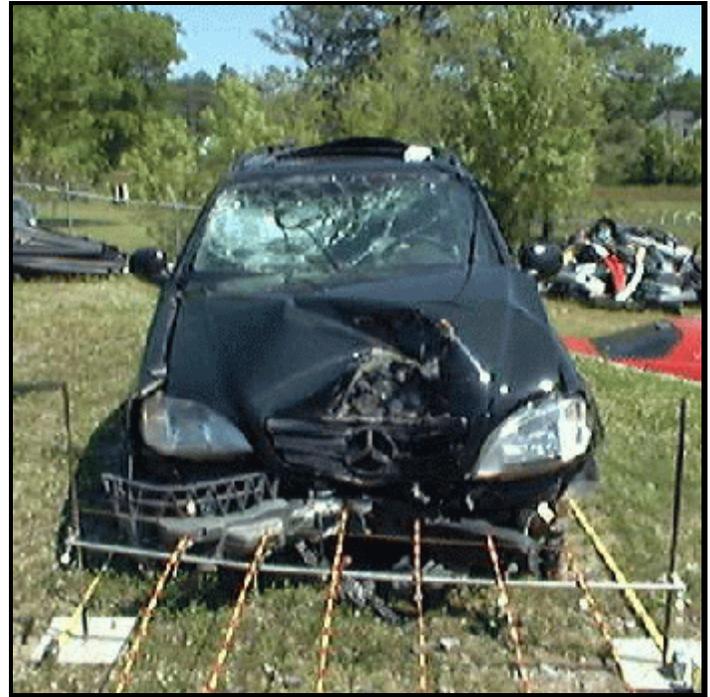
Figure 3. Front view, Vehicle 1

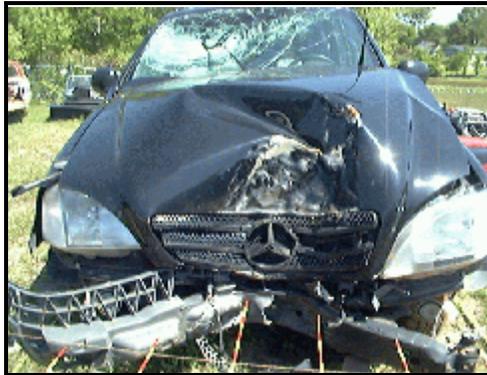
Figure 4. Front view, Vehicle 1, closeup

Plane of Impact	Field L cm/in.	C1 cm/in.	C2 cm/in.	C3 cm/in.	C4 cm/in.	C5 cm/in.	C6 cm/in.
Bumper	158	0	7	24	30	5	0
	62.2	0	2.8	9.4	11.8	2	0

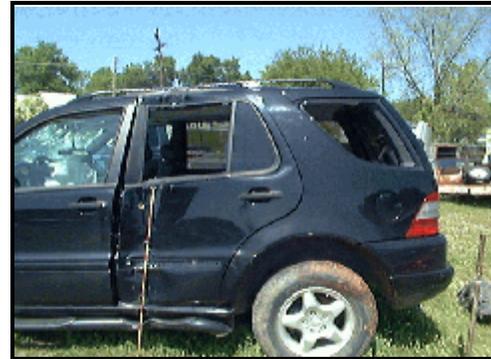
Figure 5. Left side view, Vehicle 1 (impact 3)

The left rear side glass was broken out and there was intrusion through the left side (see Table 4).

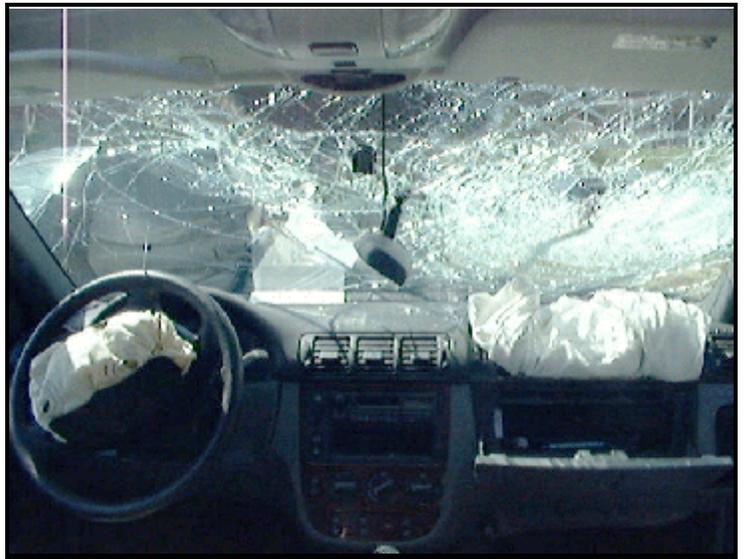
Vehicle 1 was equipped with bucket seats in both outboard front seating areas. The front left seat track was adjusted to between the middle and rear most position. The front right seat track was adjusted to the rear most track position. There were no seat performance failures. Both front seats were equipped with adjustable head restraints that were not damaged.

Figure 6. Overview of front right and front left seating positions

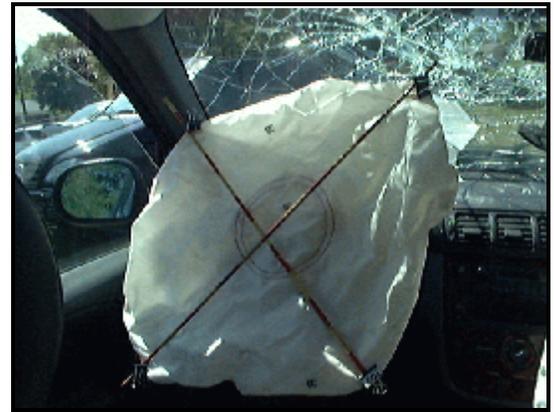
The driver’s air bag was housed in the steering wheel hub and was concealed by asymmetrical H-configuration cover flaps which were not damaged in the crash. The circular air bag was equipped with four tether straps and two vent ports. The bag was not damaged.

Figure 7. Driver’s air bag

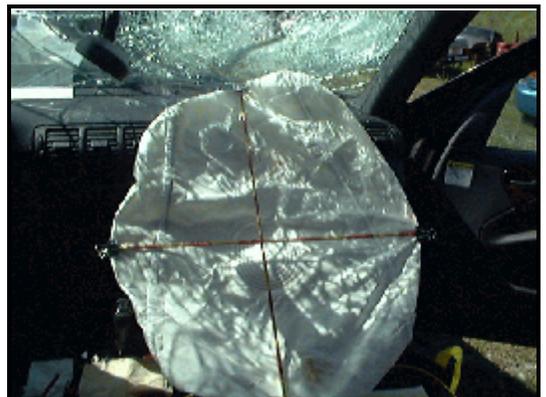
The front right air bag was housed in the top-instrument panel position and was concealed by a single rectangular shaped cover flap; the flap was no longer attached to the vehicle at the time of the vehicle inspection. The rectangular air bag was equipped with two tether straps and one vent port. The bag was not damaged.

Figure 8. Front right passenger’s air bag
