## SCI/NASS COMBINATION CASE REPORT

CASE NUMBER - NASS-2000-48-088C

VEHICLE - 2000 OLDSMOBILE ALERO

CRASH DATE - May 2000

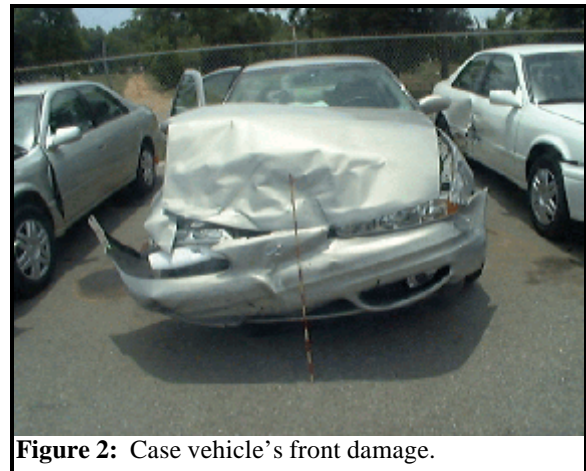
The case vehicle sustained direct contact damage across almost the entire front from the initial impact. The bumper cover was dislodged and shifted rightward, but not separated (the elastic rebound of the vinyl bumper cover conceals the actual crush to the bumper); the hood was bent upward and rearward, more so on the right; and the leading edge of the right fender was bent downward and rearward; the leading edge of the left fender was bent inward and rightward. The right headlight assembly was broken apart, but the lenses were not shattered (**Figures 2 and 3**). The right and left fenders sustained indirect damage and were bent and misshapen. The second (sideslap) impact caused very minor damage on the left front door. All the doors remained closed and operational and there was no glazing damage. The NASS researcher found no evidence of any intrusion.

The CDC for the case vehicle's most severe impact was determined to be **11-FDEW-2 (340)**. The WinSMASH reconstruction program, damage-only algorithm based on the measured crush profile from the other vehicle and a CDC-only estimated crash profile for the case vehicle, was used on the case vehicle's most severe impact. The calculated estimates for Total, Longitudinal and Lateral Delta V are, respectively: 35 km.p.h. [22 m.p.h.], -33 km.p.h. [-21 m.p.h.] and 12 km.p.h. [8 m.p.h.]. These results closely match the EDR information. This was a crash of moderate severity for the case vehicle. The case vehicle was towed from the scene due to disabling damage.

Figure 2: Case vehicle's front damage.

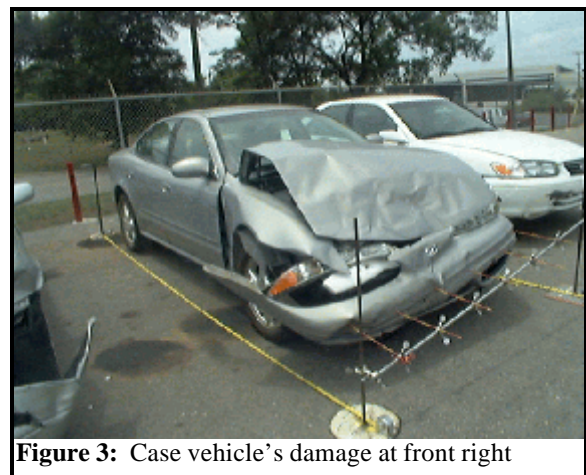
Figure 3: Case vehicle's damage at front right

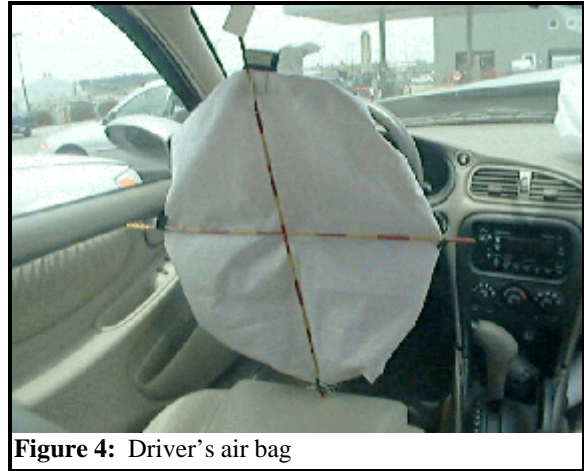
The driver's air bag was mounted in the steering wheel hub (**Figure 4**). The air bag was round with diameter 53 centimeters [20.9 inches]. The module cover flaps were arranged in a symmetrical "I" configuration, with each half 13 centimeters [5.1 inches] horizontally and 7 centimeters [2.8 inches] vertically. The air bag had two vent ports at the 11 and 1 o'clock positions, and two tethers. The driver's air bag showed black scuffing from the module cover flaps on the front and back, and no other evidence of contact.

**Figure 4:** Driver's air bag

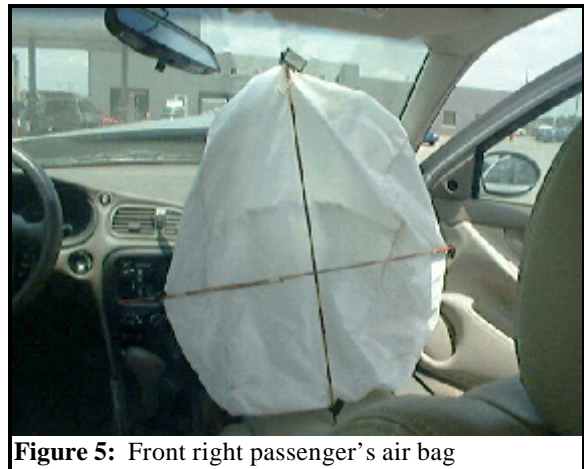
The front right passenger's air bag was mounted in the top of the instrument panel (**Figure 5**). The air bag was rectangular, measuring 67 centimeters [26.4 inches] vertically and 53 centimeters [20.9 inches] horizontally. The single module cover flap was a rectangle with rounded corners measuring 33 centimeters [13.0 inches] horizontally and 16 centimeters [6.3 inches] vertically. The air bag had no vent ports and no tethers. It showed black scuffing from the cover flap on the left edge, and there was a small spot of blood above and to the right of the center.

**Figure 5:** Front right passenger's air bag

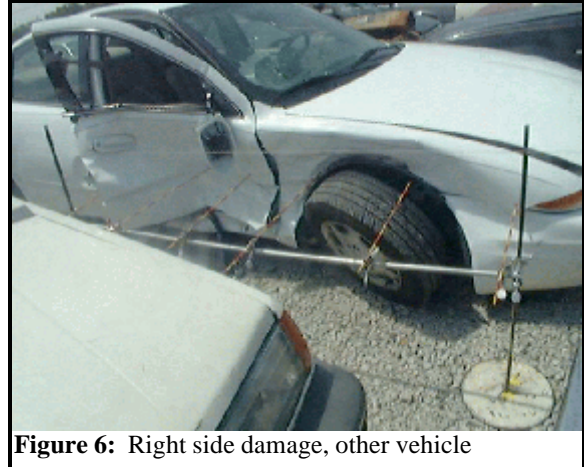
The other vehicle sustained direct contact damage along the right side, from the front wheel rearward to the middle of the front door (**Figure 6**). The wheel was tilted and suspension components were probably broken; the lower A-pillar showed moderate crush; the middle of the front door panel was crushed into a moderately deep "V" (**Figure 7**); the front door window glazing was shattered; the front door window frame was bent outward; both the front and back doors were jammed shut; and the outside

rearview mirror was broken loose. The front door was forced open by rescue personnel, leaving pry marks.

The CDC for the other vehicle's impact with the case vehicle was determined to be **01-RYEW-3 (40)**. The WinSMASH reconstruction program, damage only algorithm with the measured crush profile from the other vehicle and a CDC-only estimated crush profile for the case vehicle, was used on this vehicle's impact with the case vehicle. The calculated estimates for Total, Longitudinal and Lateral Delta V are, respectively: 35 km.p.h. [22 m.p.h.], -27 km.p.h. [-17 m.p.h.] and -23 km.p.h.[-14 m.p.h.]. The other vehicle was towed from the scene due to disabling damage.

**Figure 6:** Right side damage, other vehicle

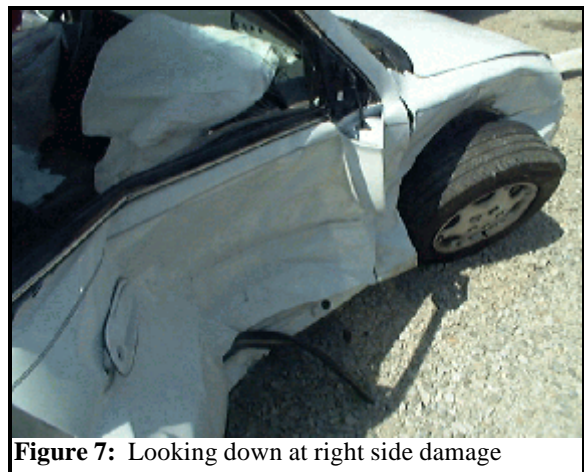
**Figure 7:** Looking down at right side damage

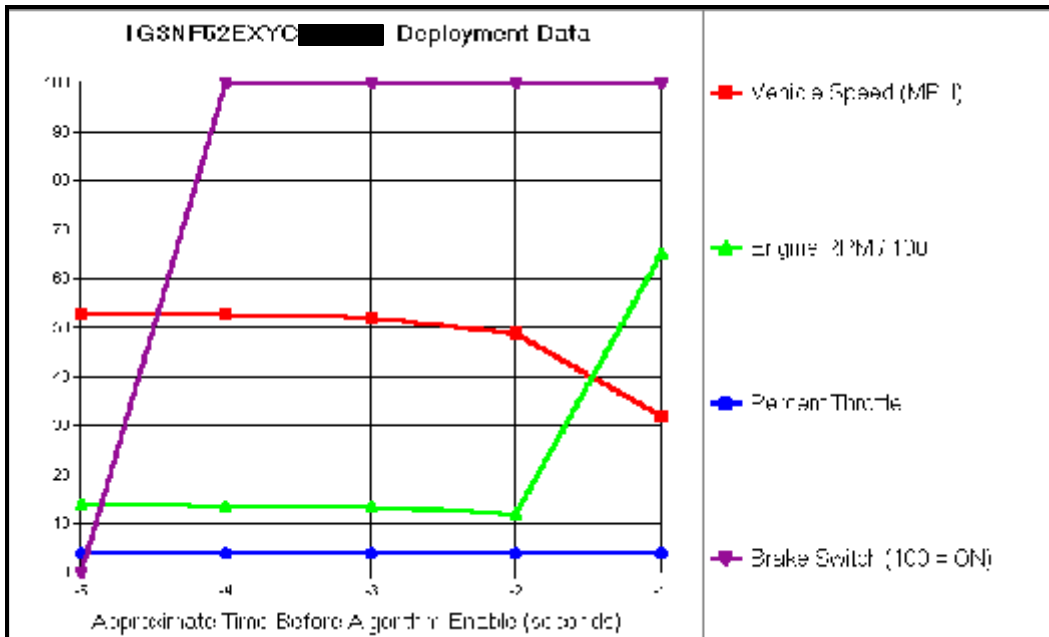
The case vehicle's EDR was downloaded (see **Figures 8, 9 and 10**, at end). The deployment occurred on ignition cycle 1,391. The Supplemental Inflatable Restraint (SIR) warning lamp was off, indicating no problems with the air bag system, and the driver's safety belt was recorded as buckled. The EDR pre-crash data (**Figures 8 and 10**) indicate that the case vehicle was traveling 85 km.p.h. [53 m.p.h.] five seconds before the device detected the impact ("algorithm enable"). Recall that the case vehicle was traversing a gentle curve to the right with a negative slope. The pre-crash data show that the throttle was at 4 per cent, that is, the driver's foot was probably off of the accelerator. The driver apparently braked lightly as the vehicle was rounding the curve, with the EDR pre-crash data showing the brake light switch circuit "on" at four seconds prior to algorithm enable. The case vehicle's travel speed slowed slightly to 79 km.p.h. [49 m.p.h.] over the next two seconds (from -4 to -2 seconds, see **Figures 8 and 10**). At approximately two seconds prior to algorithm enable, the driver apparently braked hard because the travel speed dropped steeply to 51 km.p.h. [32 m.p.h.] in the interval between -2 and -1 seconds.

**Figure 8:** Graph of case vehicle’s pre-crash conditions (data presented in Figure 10). Note that engine rpm’s jump to 6500 between -2 and -1 seconds; this is thought to be an error in the EDR or the download.

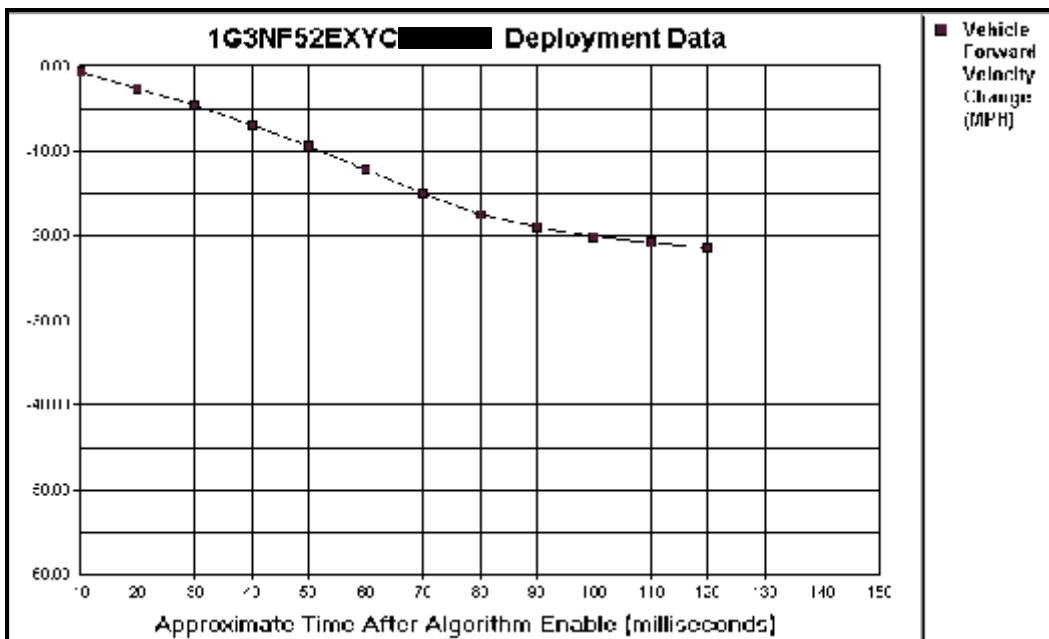
The EDR deployment data (**Figures 9 and 10**) indicate longitudinal Delta V of -34.41 km.p.h. [-21.38 m.p.h.] during the 120 milliseconds [0.12 seconds] after algorithm enable (the EDR did not record deployment data beyond 120 milliseconds). The WinSMASH calculated estimate for longitudinal Delta V was -33 km.p.h. [-21 m.p.h.], indicating close agreement between the recorded data and the calculated estimate.

**Figure 9:** Graph of case vehicle’s longitudinal Delta V following air bag deployment (data presented in Figure 10)
