**REDESIGNED AIR BAR SPECIAL STUDY
NASS/SCI COMBINED DRIVER FATALITY INVESTIGATION**

VERIDIAN CASE NO. 2000-49-254A

VEHICLE - 2000 DODGE RAM 3500 PICKUP TRUCK

CRASH DATE - NOVEMBER 2000

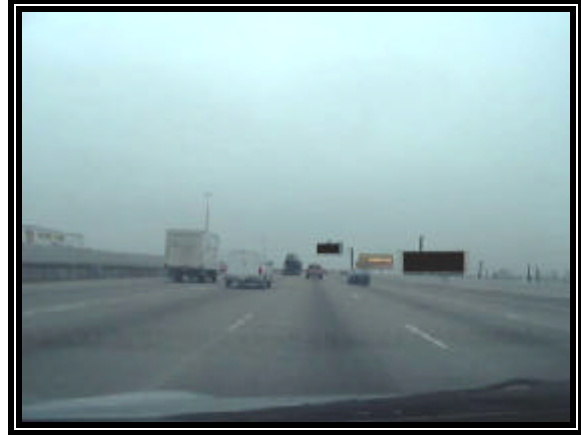
speed limit in the area was 89 km/h (55 mph). **Figure 1** is an eastbound trajectory view near the area of impact.

Figure 1: Eastbound trajectory view near the area of impact.

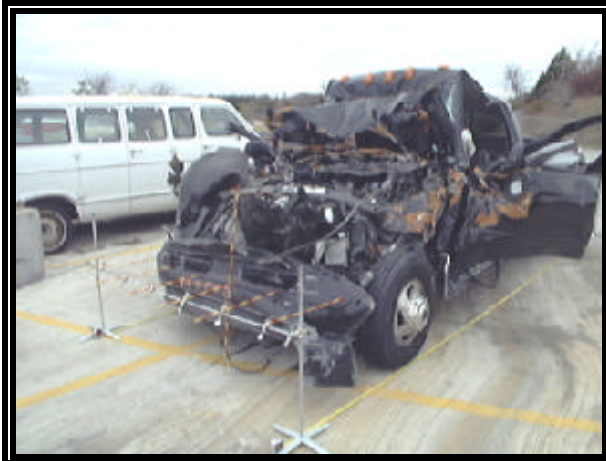
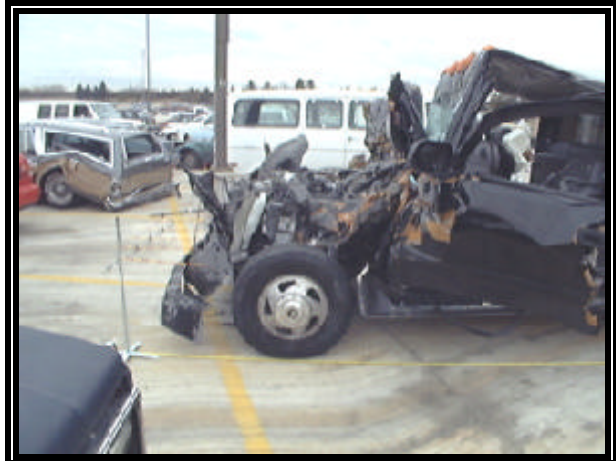
Figures 2 and 3 are the left front and left side views of the Dodge Ram, respectively. As a result of the crash, the Dodge sustained moderate damage at the bumper elevation and severe above bumper damage, as a result of the underride. The width of the direct contact damage extended across the full frontal width of the vehicle. Crush measurements were taken along the bumper elevation and the upper radiator support. The average profile of the crush measurements was as follows: C1=56.0 cm (22.0 in), C2=49.0 cm (19.3 in), C3=46.0 cm (18.1 in), C4=43 cm (16.9 in), C5=36 cm (14.2 in), C6=36 cm (14.2 in). The maximum crush at the bumper elevation was located at C1 and measured 28.0 cm (11.0 in). The maximum above bumper crush was 84.0 cm (33.1 in) at the C1 location. The energy of the crash was managed primarily by the vehicle's component above the level of the bumper. There was no measurable change in either wheelbase dimension.

Figure 2: Left front view of the Dodge.

Figure 3: Left side view.

The longitudinal extent of the direct contact, as a result of the underride of the inverted step profile of the box trailer, measured approximately 180 cm (71 in). This measurement was taken from the front plane and terminated at the front aspect of the roof. The hood and upper fenders buckled and deformed rearward into the A-pillars and cowl. The windshield and windshield header impacted the each plane box trailer. The post-impact rake angle of the A-pillar was approximately 10 degrees. The Collision Deformation Classification (CDC) of the Dodge was 12-FDAA-7.

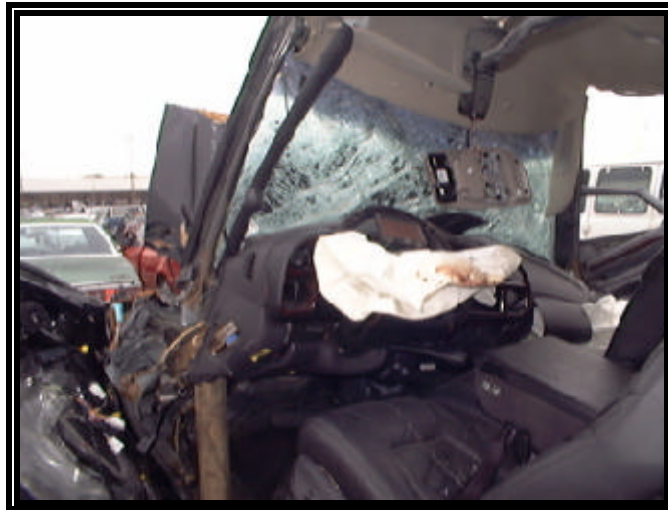
The interior of the Dodge sustained severe damage and intrusion as a result of the exterior forces of the crash. **Figure 4** is a left view of the driver's interior taken during the NASS inspection. The measured intrusion of the windshield header and base of the windshield, along the vehicle's centerline, was 23 cm (9 in) and 57 cm (22 in) respectively. The longitudinal intrusion of the left side of the instrument panel measured 44 cm (17 in). There was 18 cm (7 in) of intrusion at the driver's toe pan. Contact scuffs to the knee bolster and left lower outboard aspect of the instrument panel from the driver's left lower extremity were documented. The driver was trapped by the intruded components and required extrication. A temporary wedge holding up the instrument panel is visible in the lower aspect of Figure 4.

Figure 4: Left interior view.

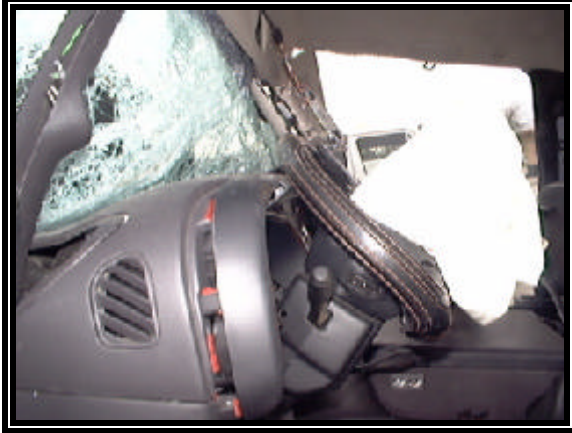
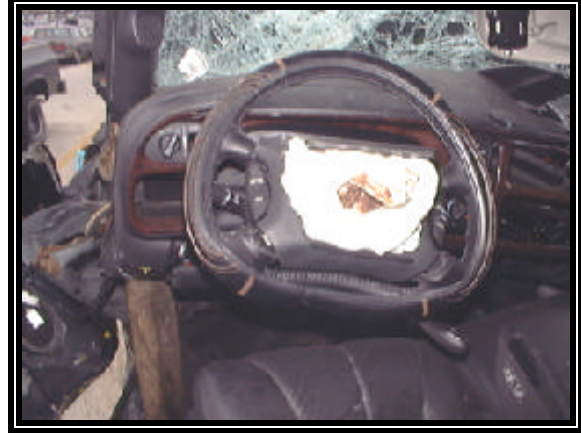
Figures 5 and 6 are views of the 4-spoke steering wheel rim. The tilt mechanism of the steering wheel was adjusted between full up and center, based on the NASS investigation and appeared to be fractured. The plane of the steering wheel rim was loaded by the driver's abdomen during the crash and deformed. The upper aspect of the column was in a near vertical position. The upper aspect of the steering wheel rim contacted and fractured the horizontal surface of the instrument panel. Shear capsule displacement was not recorded.

Figure 5: Left lateral view of the steering wheel rim.

Figure 6: Forward view of the steering wheel rim.

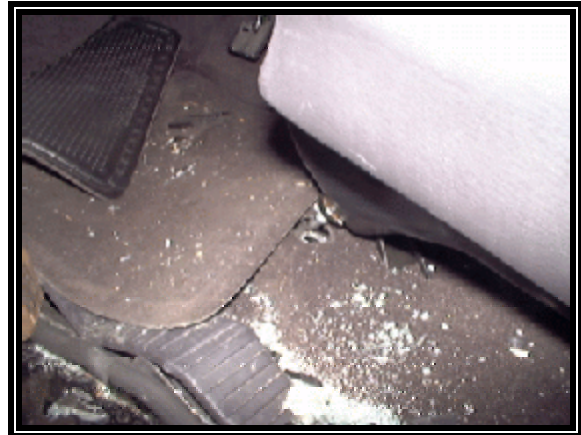
Figure 7 is a view of the separated left front seat anchor that initiated the Potential Safety Problem Bulletin from the NASS Zone Center. The hold down fastener appeared to have pulled through the floor during the crash sequence. This type of failure occurs by the application of a tensile force to the seat and fastener, reacted by the floorpan. During the crash sequence, the front seat anchors are placed in compression by the forward kinematic sequence of the driver. The rear seat anchors are placed in tension. If failure would have occurred as a result of the driver's inertial loading, that failure would have first occurred at the rear anchors. Referring to Figure 7, the buckling of the floorpan is very evident in the area of the fastener. The failure of the anchor probably occurred as a result of the localized buckling in the area of the fastener widening the clearance hole in the floorpan sufficiently to cause the separation. This failure would have occurred late in the crash sequence and had no bearing on the driver's kinematics.

Figure 7: Buckled floor pan and left front seat anchor.

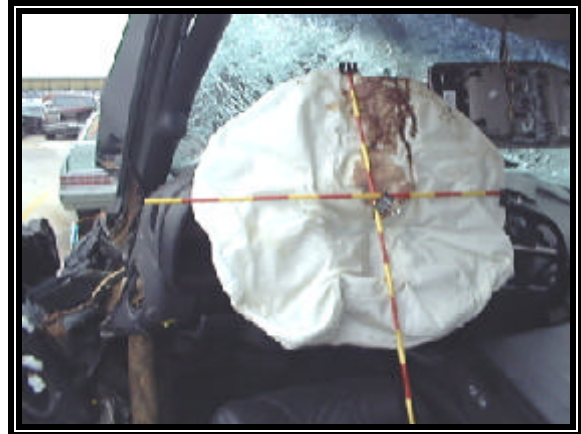
The Supplemental Restraint System in the Dodge Ram consisted of redesigned driver and front right passenger air bags that deployed as a result of the crash. The SRS was controlled by a single point sensing and diagnostic module located within the occupant compartment. The driver air bag, **Figure 8**, was designed in the typical manner and housed in an H-configuration module located in the center of the steering wheel rim. The cover flaps opened at the designated tear points and were not damaged. There was no evidence of occupant contact to the flaps. The driver air bag measured 59 cm (23 in) in diameter in its deflated state. It was tethered by two internal straps sewn to the face of the bag. There were no external vent ports. The bag vented internally back through the module. The only evidence of contact to the air bag was a post-crash blood stain. The blood pattern began at the perimeter seam and extended to the center of the bag in its 12 o'clock sector. The front right passenger air bag was a mid-mount design located in the right aspect of the instrument panel and had properly deployed as a result of the crash.

Figure 8: Driver air bag.
