## SCI/NASS COMBINATION CASE REPORT

CASE NUMBER - NASS-2000-73-160E

VEHICLE - 1999 KIA SPORTAGE

CRASH DATE - September 2000

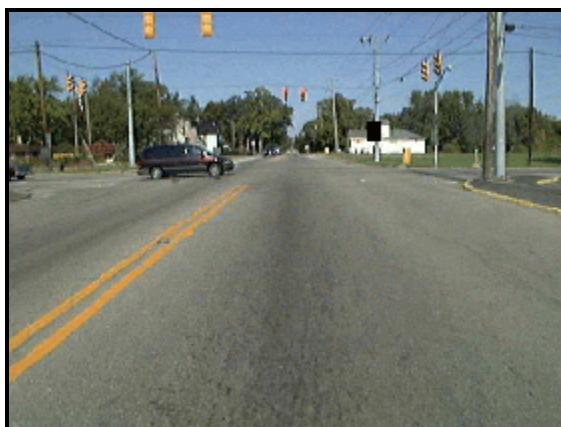
The case vehicle had been traveling north in the northbound lane of a two-lane, undivided local road and was in the process of executing a left turn onto an intersecting roadway, intending to travel west (**Figure 1**). The other vehicle was traveling east in the eastbound lane of the intersecting roadway, intending to pass through the intersection and continue east. It was daylight with no adverse weather conditions, both roadways were dry, straight and level, paved with asphalt and with no defects. The four-leg intersection was controlled by overhead automatic signals. Both roadways were undivided with one lane in each direction and solid double yellow painted lane separators, but both roadways were widened to four lanes to accommodate turning traffic in the intersection area. The speed limit for both roadways was 48 km.p.h. [30 m.p.h.]. The two vehicles entered the intersection simultaneously (**Figure 2**).

**Figure 1:** Case vehicle's northbound approach toward left turn at intersection

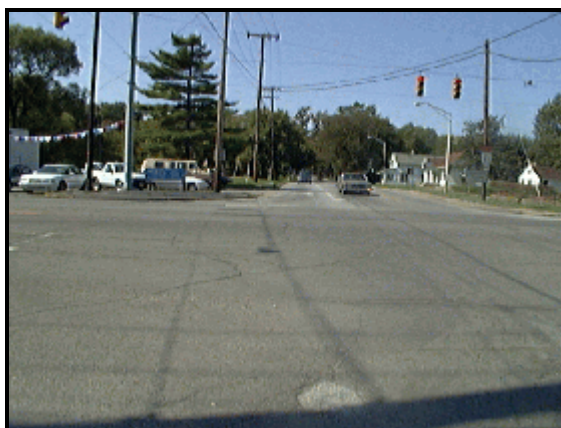
The crash occurred within the intersection. The front left corner of the case vehicle was impacted by the front right corner of the other vehicle, causing the case vehicle's driver and front right passenger front air bags and the driver's knee bolster air bag to deploy. The other vehicle was also equipped with front air bags that deployed. The case vehicle rotated clockwise, the other vehicle was displaced northeastward and both vehicles came to rest within the intersection, a short distance from the point of impact.

**Figure 2:** Area of impact approximately at the center of the intersection, looking west (lookback view of other vehicle's eastbound approach)

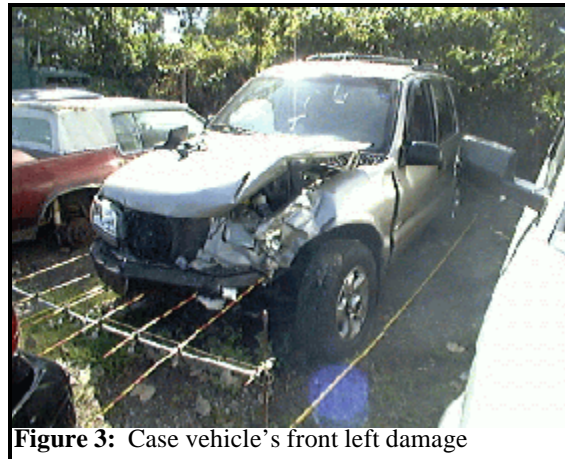
The case vehicle sustained direct contact damage beginning at the front left corner and extending 72 centimeters [28.3 inches] inward across the front, with maximum crush of 36 centimeters [14.2 inches] at the front left bumper corner (**Figures 3 and 4**). Direct damaged was confined to the area forward of the front axle: the bumper cover was torn off; the forward area of the left fender, the headlight assembly and the bumper were crushed rearward and inward; the front left corner of the engine hood was bent under and folded double; the grille was shattered; and the radiator and fan were displaced rearward. The NASS researcher indicated that the front left wheel was restricted by the bending of the left fender, but this is not apparent in the photographs. No tires were deflated and the wheelbase was essentially unchanged on both sides. There was no glazing damage, and no intrusions into the passenger compartment. The CDC was determined to be **10-FYEW-2 (310)**. The WinSMASH reconstruction program, damage only algorithm based on the measured crush profiles of the two vehicles, indicated Total, Longitudinal and Lateral Delta V's, respectively: 20 km.p.h. [12.4 m.p.h.], -13 km.p.h. [-8.1 m.p.h.] and +15 km.p.h. [+9.3 m.p.h.] for the case vehicle. These results appear somewhat low but basically reasonable, indicating that the crash was of low severity (14 - 23 km.p.h. [9 - 14 m.p.h.]) for the case vehicle.

**Figure 3:** Case vehicle's front left damage

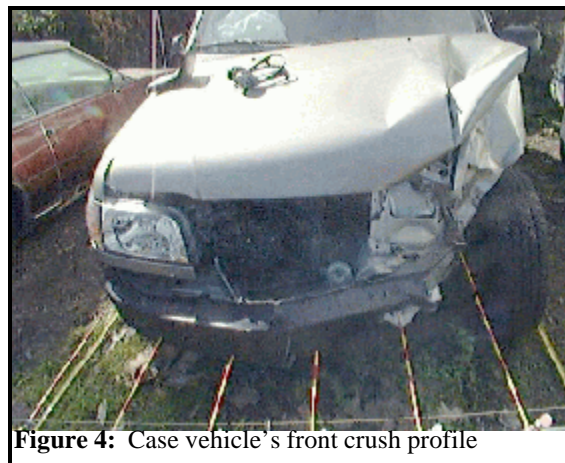
**Figure 4:** Case vehicle's front crush profile

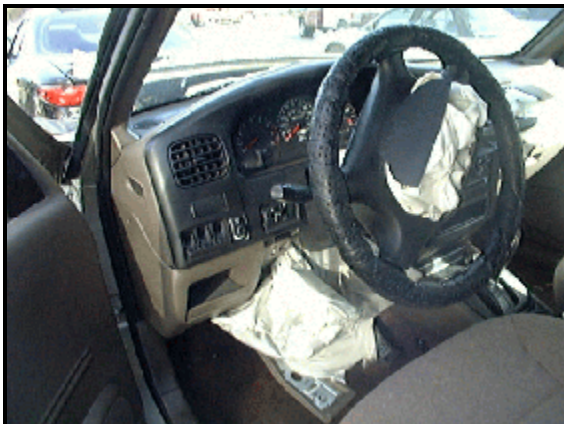
The driver's knee bolster air bag was mounted in the knee bolster, directly beneath the left instrument panel<sup>1</sup> (**Figure 5**). The module's one-piece cover flap was shaped so that it could fit around the steering column (**Figure 6**). The cover flap and the air bag were attached to each other. When the air bag deployed, the cover flap separated entirely from the module and rotated downward as the air bag inflated so that, when the air bag was fully deployed, the cover flap was on the bottom (**Figure 7**). The cover flap measured 32 centimeters [12.6 inches] horizontally and 31 centimeters [12.2 inches] vertically.

**Figure 5:** Driver's seat area showing general location of the driver's knee bolster air bag

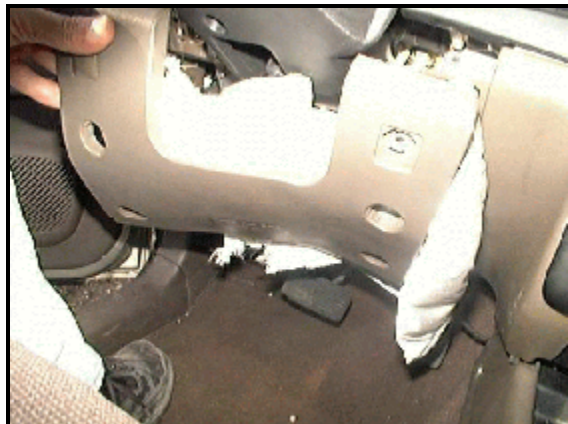
**Figure 6:** Knee bolster air bag cover flap held in place

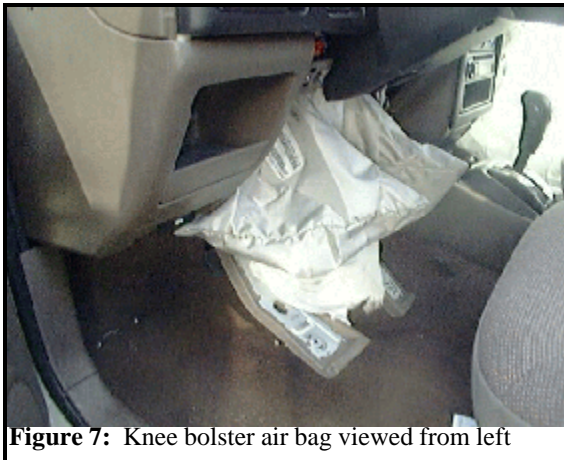
**Figure 7:** Knee bolster air bag viewed from left

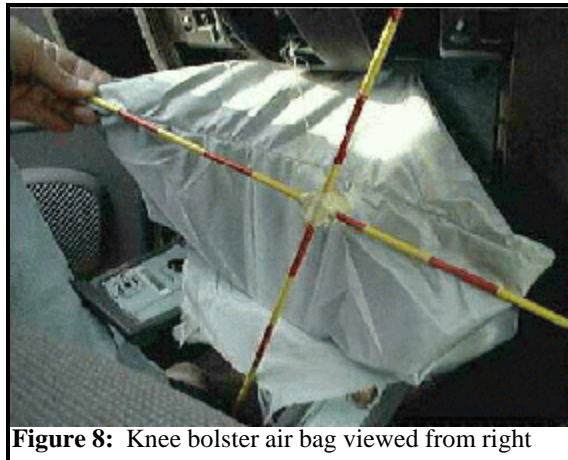
The deployed air bag measured 44 centimeters [17.3 inches] horizontally and 32 centimeters [12.6 inches] vertically (**Figure 8**). There was no evidence of damage to the knee bolster air bag nor its cover flap.

**Figure 8:** Knee bolster air bag viewed from right

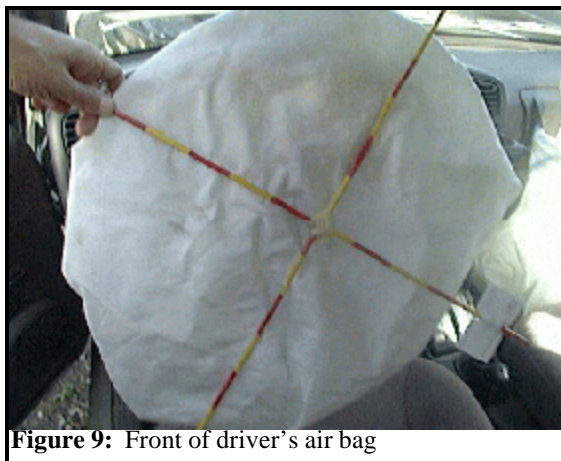
The driver's front air bag was mounted in the steering wheel hub (**Figure 9**). The deployed air bag was round with diameter 62 centimeters [24.4 inches]. There was one vent port at the 12 o'clock position on the back of the air bag, and no tethers. The module cover flaps opened at the designated tear points and there was no damage to the air bag or the cover flaps. There was no physical evidence of contact on the driver's air bag, except a smudge of dirt on the lower edge of the front.

**Figure 9:** Front of driver's air bag

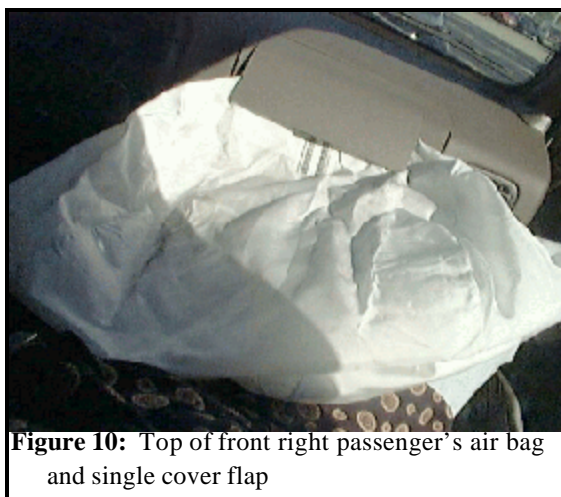
The front right passenger's front air bag was mounted in the mid-instrument panel (**Figure 10**). The deployed air bag was rectangular and measured 75 centimeters [39.5 inches] horizontally and 70 centimeters [27.6 inches] vertically. There were two tether straps and no vent ports. The module's single cover flap opened at the designated tear points and there was no evidence of damage to the air bag, the cover flap or the adjacent instrument panel. There was no occupant seated in the front right position and there was no evidence of contact, nor any other evidence, on the air bag.

**Figure 10:** Top of front right passenger's air bag and single cover flap

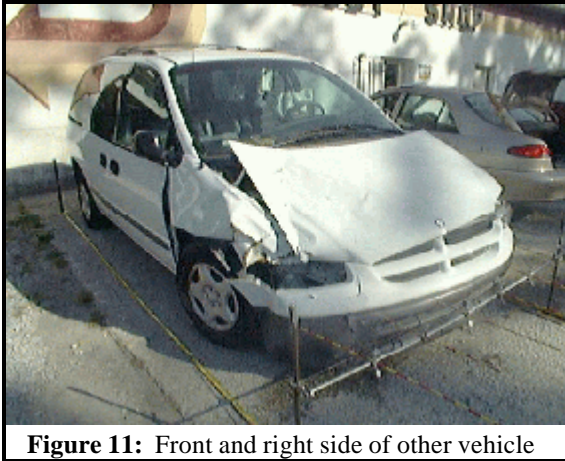
The Caravan sustained direct contact at the front right corner (**Figure 11**). The CDC was determined to be **12-FZEW-2 (10)**. The WinSMASH reconstruction program, damage only algorithm based on measured crush profiles from both vehicles, indicated Total, Longitudinal and Lateral Delta Vs, respectively: 20 km.p.h. [12.4 m.p.h.], -19 km.p.h. [-11.8 m.p.h.] and -3 km.p.h. [-1.9 m.p.h.].

**Figure 11:** Front and right side of other vehicle
