VERIDIAN ON-SITE AIR BAG DEPLOYMENT/CHILD FATALITY INVESTIGATION

CASE NO. CA00-001

VEHICLE - 1997 NISSAN SENTRA

CRASH DATE - DECEMBER 1999

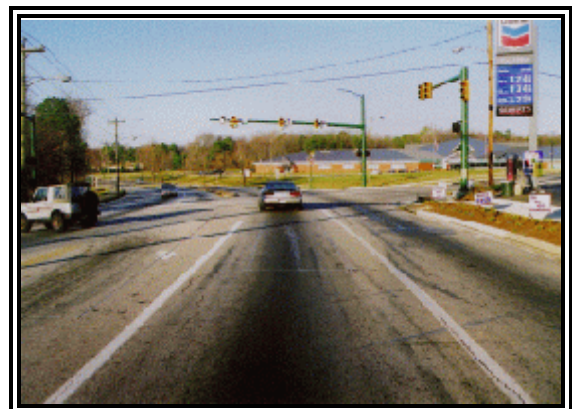
Figure 1: Westbound trajectory view approaching the intersection.

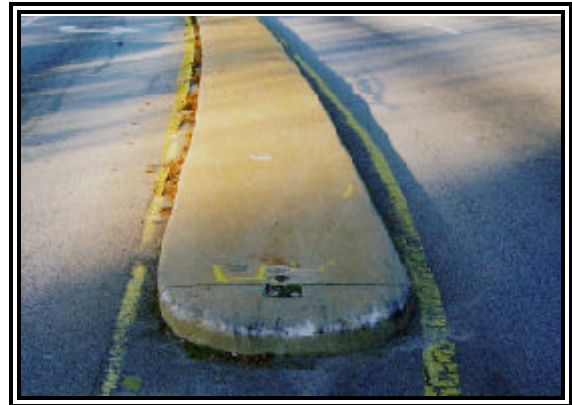
Figure 2 is a pre-crash trajectory view of the median, the point of impact. Note, the tire and scrape marks that developed as the vehicle mounted and overrode the median. The median appeared to have been struck numerous times by other vehicles. The divided traffic warning sign that marked the end of the median was missing. There appeared to be four different mounting locations for the warning sign. The sign was missing at the time of the crash. The speed limit in the area of the crash was 56 km/h (35 mph).

Figure 2: View of the raised median, west of the intersection.

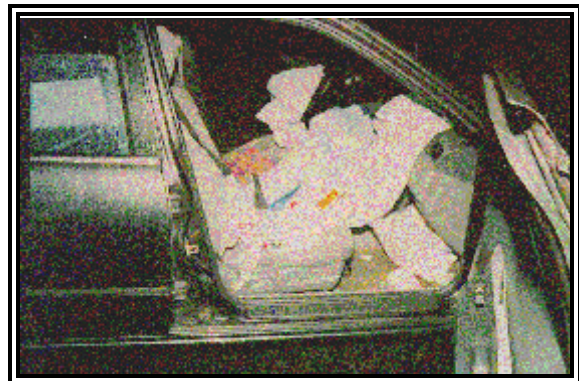
Figure 3: Post-crash view of the Child Safety Seat installation.

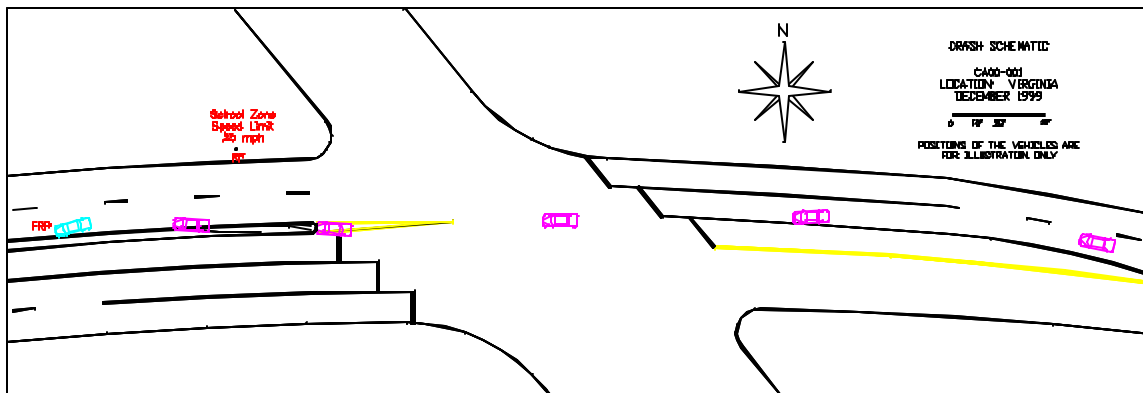
During the driver's distraction and inattention, the Nissan had entered and was traversing through the intersection. The vehicle had drifted to the left from its travel lane. The vehicle's trajectory was directed toward the nose of the raised concrete median, which began on the west side of the intersection. Refer to the crash schematic **Figure 4**.

Figure 4: Crash Schematic

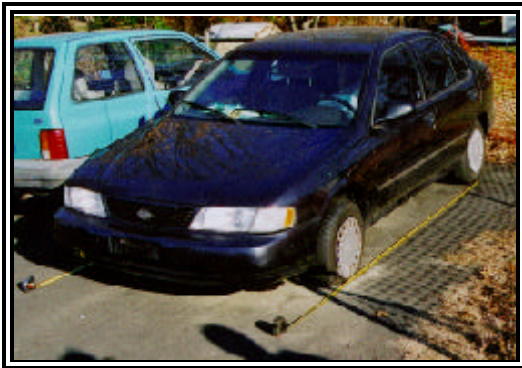
Figure 5 is an overall left front view of the Nissan Sentra. There was no direct contact nor damage to the vehicle's exterior body panels or uni-body structure. The vehicle's engine started and ran properly. The vehicle did sustain a direct impact to the left front wheel/suspension and associated contact to center and left regions of the undercarriage. The measurement of left wheelbase dimension indicated there was 5 cm (2 in) of residual rearward displacement. **Figure 6** is a view of the left front wheel depicting the deformation.

Figure 5: Left front view of the 1997 Nissan Sentra.

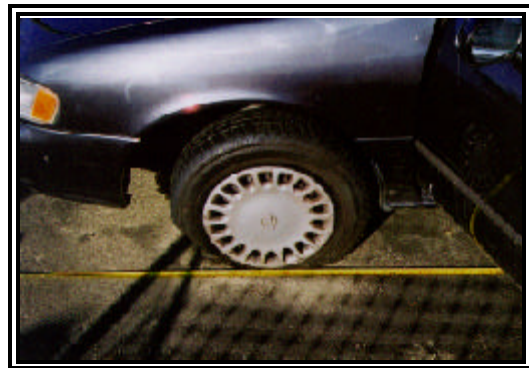
Figure 6: View of the left wheelbase displacement.

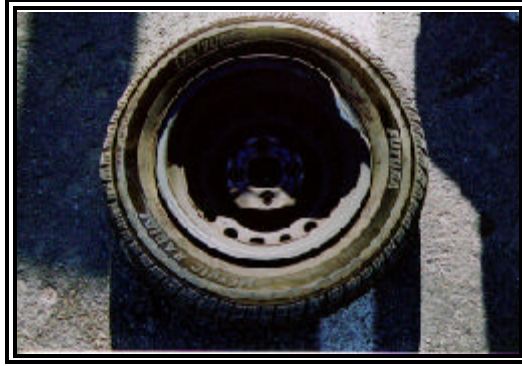
Upon completion of the exterior vehicle inspection, the Nissan was transported via a flatbed to a local garage. The vehicle was placed on a hydraulic lift in order to inspect the suspension and undercarriage. Removal of the left front tire revealed direct impact damage to the interior surface of the rim, **Figure 7**. The rim deformation caused the left front tire to deflate. Simultaneously with the rim impact, the lower control arm and forward undercarriage also impacted and overrode the median curb.

Figure 7: Left front rim deformation.

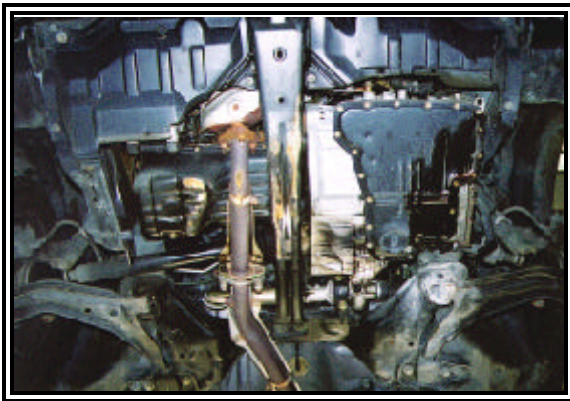
Figure 8 is an overall view of the forward undercarriage. Scraping-type damage was noted to the oil pan, exhaust system, engine cradle and transmission pan. The transmission was also note to have been leaking and was void of fluid. There was direct contact damage noted on the box-structure supporting the lower control arm. Refer to the top aspect of **Figure 9**. Surface stresses were noted on the exterior surfaces of trailing arm (refer to the arrow in center of Figure 9). These stresses developed due to the bending moment induced by the offset impact force on the left front rim. Concrete residue was observed throughout this area and on the surfaces of the lower control arm

Figure 8: Overall view of the forward undercarriage.

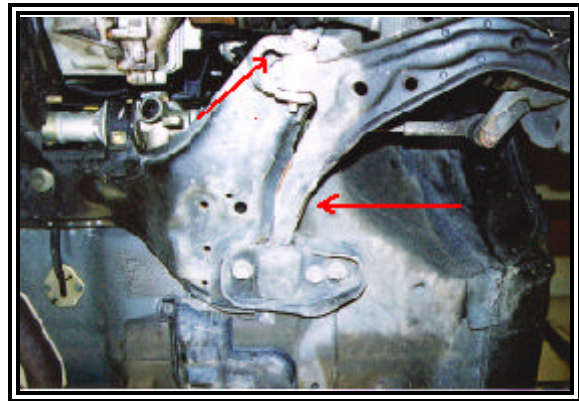
Figure 9: View of the lower control arm of the left front suspension.

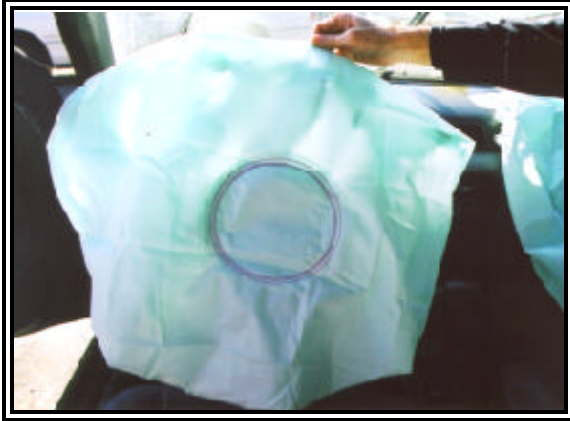
The diameter of the deflated driver air bag measured 66 cm (26 in). It was vented by two, 5 cm (2 in) diameter, ports located in the 11/1 o'clock sectors on the back side of the bag. The bag was tethered by four 6.4 cm (2.5 in) wide straps sewn to the face of the bag. The surfaces of the air bag fabric were free of any contact evidence. Refer to **Figure 10**. The following nomenclature was located on the back side of the bag in its 12 o'clock sector:

Figure 10: Driver air bag.

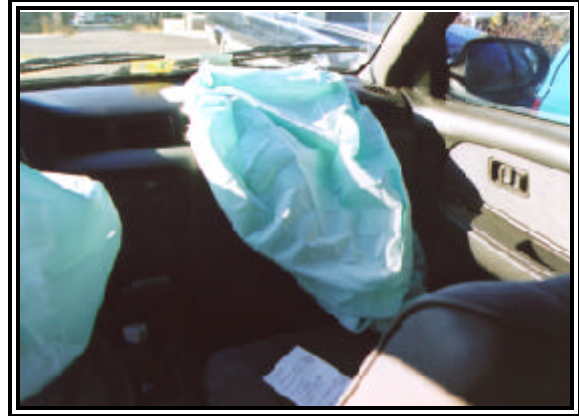
The front right passenger air bag, **Figure 11**, was a top-mount design located in the typical manner in the right aspect of the instrument panel. The H-configuration module cover flaps were constructed of vinyl. The cover flaps center seam measured 125 cm (10 in). The height of the upper and lower flap measured 5.0 cm (2.0 in) and 4.6 cm (1.8 in), respectively. The passenger bag was not tethered. It was vented by two, 6.4 cm (2.5 in) diameter, ports located on the side panels of the bag. The face of the bag measured 38 cm x 40 cm (15 in x 16 in), width by height, and extended 50 cm (20 in) from the module, in its deflated state. No contact evidence was identified on the surfaces of the air bag.

Figure 11: Front right passenger air bag.
