**VERIDIAN ON-SITE FRONT DRIVER AIR BAG DEPLOYMENT/
FATALITY INVESTIGATION**

VERIDIAN CASE NO. CA00-006

VEHICLE - 1994 PONTIAC BONNEVILLE

CRASH DATE - FEBRUARY 2000

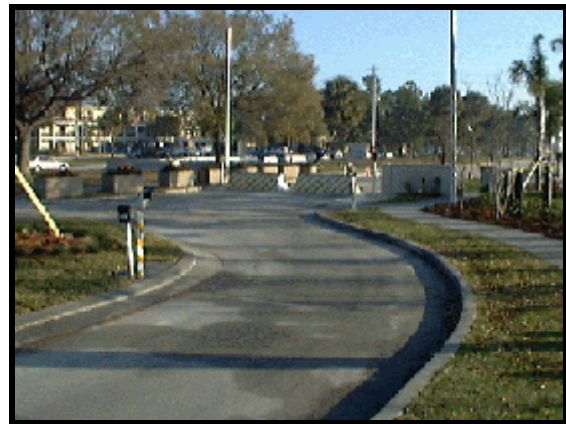
This single vehicle crash occurred during the morning hours of February 2000. At the time of the crash, it was daylight and the weather was not a factor. The crash occurred at the entrance to a secure compound on a US military installation, **Figure 1**. The access road to the compound was configured with two lanes, primarily north/south in direction. Traffic entering the compound was controlled by a retractable security barrier and a green/red traffic signal. The barrier retracted into the ground after access was granted via

Figure 1: Trajectory view at the security entrance.

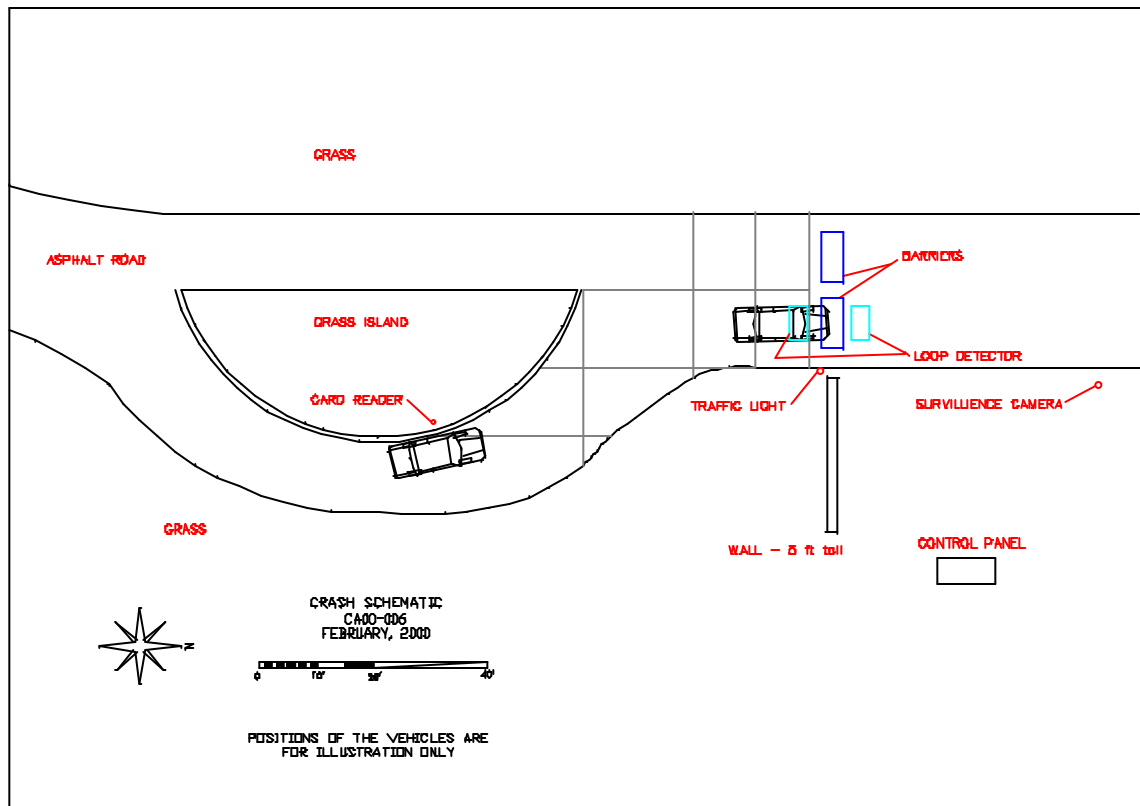
The driver accelerated the vehicle forward away from the card reader and maneuvered the vehicle through the right curve leading to the barriers, refer to the crash schematic **Figure 2** below. The vehicle was in motion for a period of 5 seconds and traveled approximately 20 m (67 ft) to impact with the barrier. A time/distance analysis based on the aforementioned parameters, assuming constant acceleration, determined the vehicle was traveling approximately 29 km/h (18 mph) at impact.

Figure 2: Schematic of the crash scene.

Approximately 1 sec prior to reaching the barrier, the barrier began to rise. Presumably, the traffic signal turned red. The vehicle's front bumper system and air dam passed over and cleared the rising barrier. However, as the vehicle continued forward and the barrier continued to rise, the forward cross-member of the Pontiac's undercarriage impacted the top plate of the barrier. The ground clearance of the Pontiac's cross-member measured 23 cm (9 in). The impact stopped the vehicle's forward momentum. The magnitude of the impact force was sufficient to warrant deployment of the Pontiac's SIR (air bag) system. The delta V of the impact was approximately (29 km/h) 18 mph.

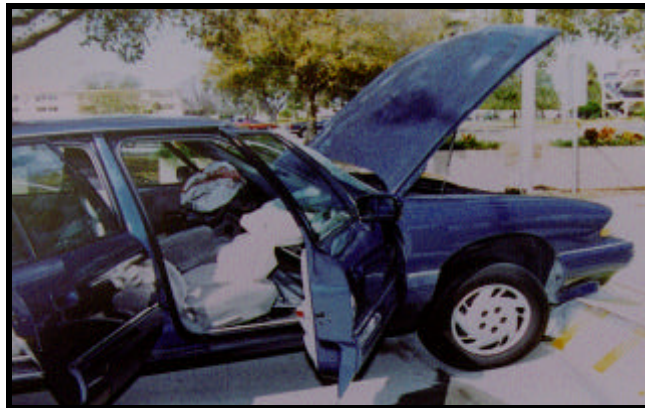
hydraulic system stopped its motion upon sensing the excess weight. The barrier stopped after rising an estimated 30 cm (12 in). **Figure 3** is an on-scene photograph taken of the vehicle at final rest. Inspection of the barrier revealed its top surface was constructed of 1/4 in steel diamond plate. A 56 cm (22 in) section of the top plate was deformed. The plate's maximum vertical deflection measured 4.6 cm (1.8 in).

Figure 3: On-scene view of the Pontiac at final rest.

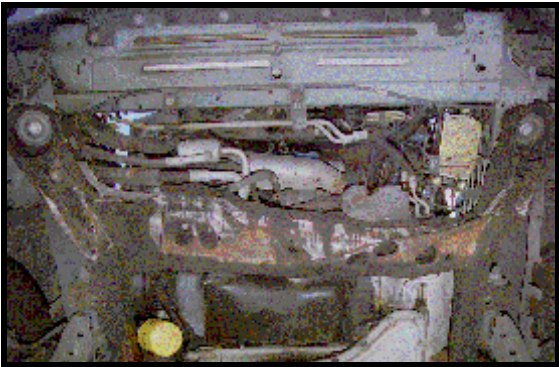
The Pontiac’s exterior damage consisted entirely of damage to the vehicle’s undercarriage, **Figure 5**. There was no direct damage above the level of the front bumper. The vehicle sustained direct contact damage across the full width of the forward cross-member. The greatest extent of residual displacement was biased to the left side of the cross-member and measured 10 cm (4 in). The force of the impact also caused induced damage to the left longitudinal uni-body rail, in the area of the left front suspension. **Figures 6 and 7** are views of the left front and right front suspensions, respectively. Note, the deformations of the left longitudinal rail (identified in Figure 6) as compared to the right. This deformation caused the left wheelbase dimension to be fore-shortened 4.2 cm (1.5 in), **Figure 8**. The Collision Deformation Classification (CDC) of the damage was 12-UFDW-01. The magnitude of the damage was consistent with reconstruction of the crash and warranted the deployment of the vehicle’s SIR system.

Figure 5: View of the forward undercarriage.

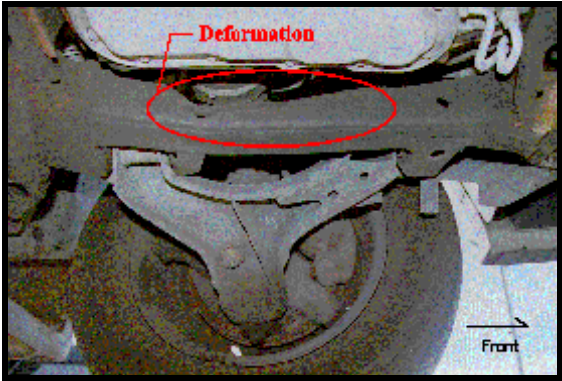
Figure 6: Left front suspension.

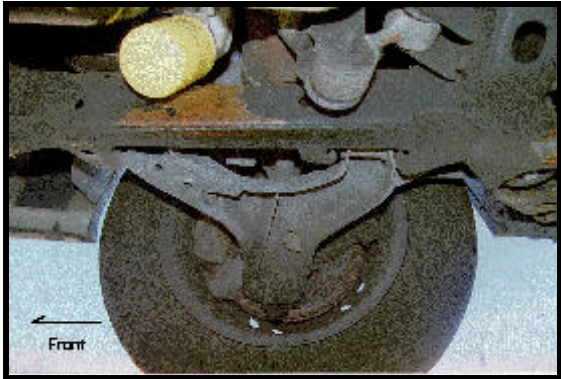
Figure 7: Right front suspension.

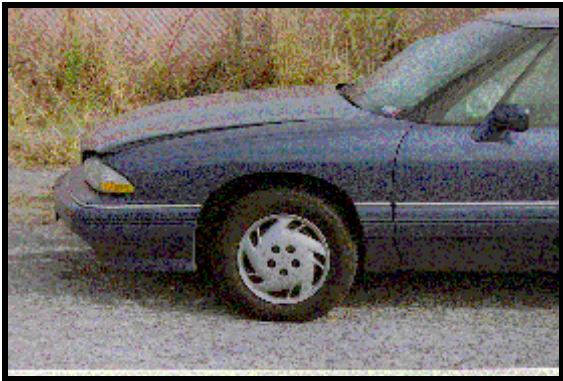
Figure 8: Close-up view of the left front wheel rearward displacement.

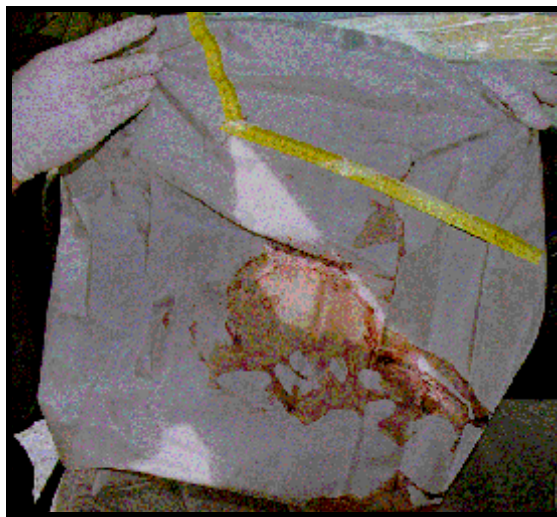
The diameter of the deflated driver air bag, **Figure 9**, measured 61 cm (24 in). It was vented by two, 2 cm (1 in) diameter, ports located in the 3/9 o'clock sectors on the back side of the bag. The bag was not tethered. The center aspect of the bag's face was heavily blood stained. Patterned vinyl transfers to the face of the bag were identified in the 8 to 11 o'clock

Figure 9: View of the driver air bag. Note, the steering wheel is rotated 135 degrees CW.

sector. These transfers resulted from frictional contact with the interior surfaces of the vinyl cover flaps. The frictional contact and transfers were indicative of the impeded deployment of the air bag.

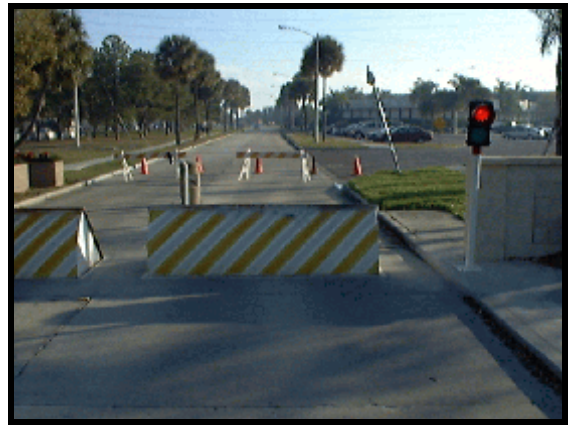
The security barrier was a Model TT207 Hydraulic Barricade System manufactured by Delta Scientific Inc., **Figure 11**. The barrier was a 274 cm (108 in) moving wedge, (81 cm) 32 in high. The barrier was of steel construction and was crash rated. It was installed and operational in May 1998. The barrier reportedly was maintained quarterly by the manufacturer.

Figure 10: Trajectory view of the security barrier.
