REMOTE AIR BAG REPORT

CASE NUMBER - IN00-009

VEHICLE - 1996 LEXUS ES300

CRASH DATE - October, 1999

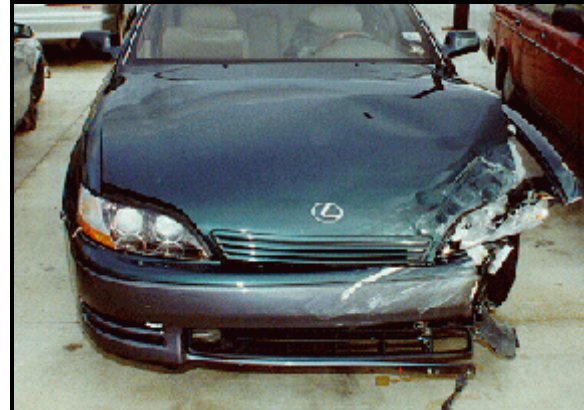
Figure 4: Case vehicle's front left damage viewed from front (case photo #08)

The case vehicle's contact with the Dodge involved the front left half. Direct damage began near the midline of the front bumper and extended along the bumper to the front left corner. Maximum crush was estimated as 18 centimeters (7.1 inches) at C₁. The case vehicle's front bumper, bumper fascia, grille, hood, front left headlight and turn signal assemblies, and left fender were directly damaged and crushed rearward. The case vehicle's left front tire, however, did not appear to be restricted, deflated, or otherwise damaged. Based on the available photographs, no other obvious damage was present.

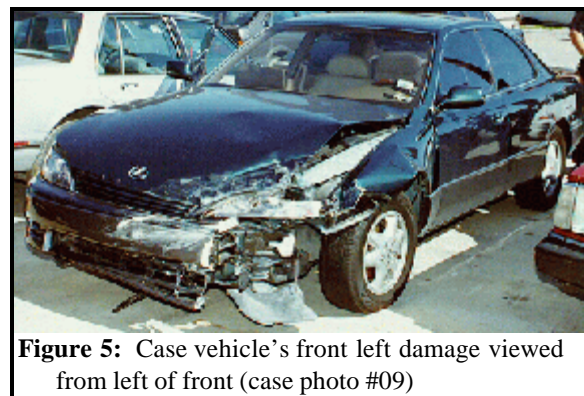
Figure 5: Case vehicle's front left damage viewed from left of front (case photo #09)

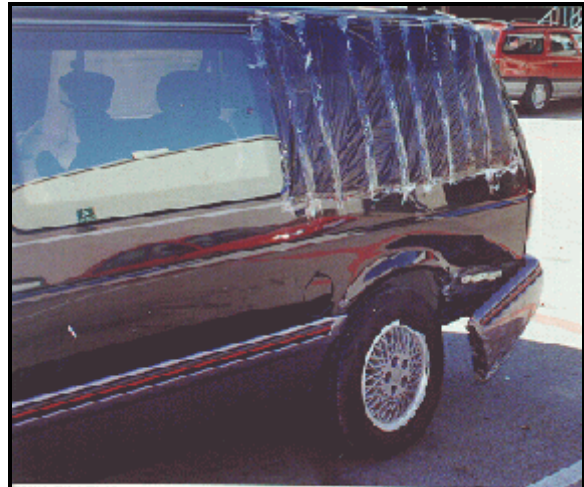
Figure 6: Damage to other vehicle's left quarter panel from impact with case vehicle; Note: left back glazing was shattered (case photo #45)

Based on the on-scene photographs, the CDC for the Dodge was estimated as: **11-LBEW-2 (320)** [maximum crush was estimated at 19 centimeters (7.5 inches)]. The WinSMASH reconstruction program, CDC only algorithm, was used on the Dodge's highest severity impact. The Total, Longitudinal, and Lateral Delta Vs are, respectively: 11.4 km.p.h. (7.1 m.p.h.), -8.8 km.p.h. (-5.5 m.p.h.), and +7.3 km.p.h. (+4.5 m.p.h.). Once again, this contractor feels these results are slightly low, and the reconstruction should be considered marginal. The Dodge was driven from the scene.

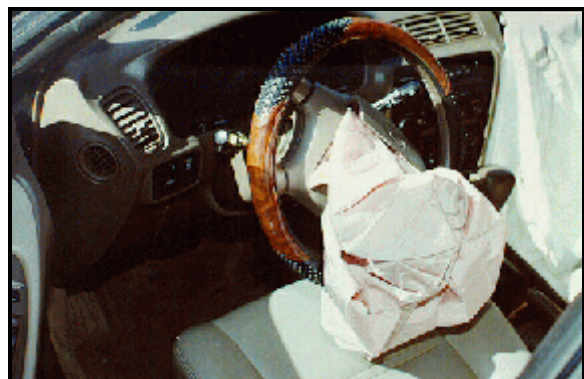
Figure 7: Case vehicle's driver seating area showing deployed driver air bag; Note: driver's seat is near its forward-most position (case photo #17)

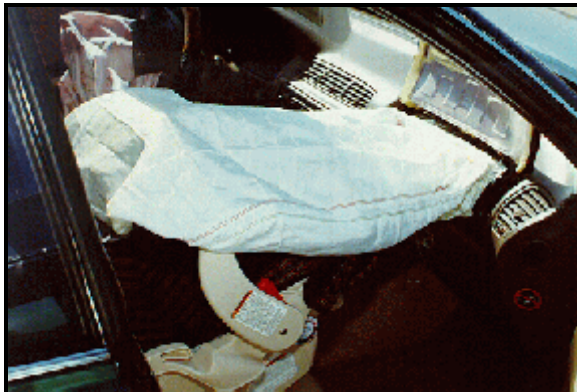
with the back of the rear facing child safety seat. Photographs of the front right air bag revealed that it had at least one vent port and was not tethered (Figure 9), and there was a blue cloth transfer on the top portion of the air bag's fabric (Figure 10) from its interaction with the back surface of the rear facing child safety seat.

Figure 9: Case vehicle's front right seating area showing deployed, untethered, front right passenger air bag extended over Rear Facing Child Safety Seat (case photo #23)

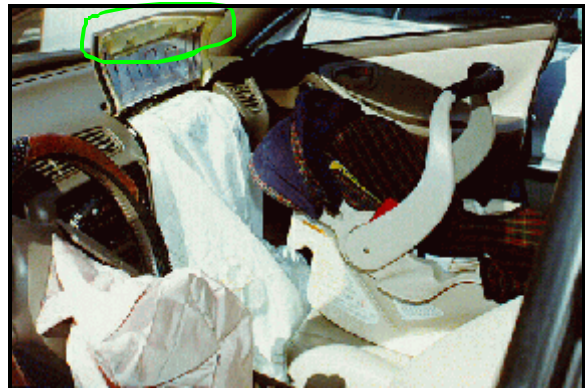
The case vehicle's driver air bag was located in the steering wheel hub, and the front right passenger air bag was located in the top of the right instrument panel. Police photographs of the driver's air bag revealed that the cover flaps opened at the designated tear points, and there was no visible evidence of damage during the deployment to the air bag or cover flaps (**Figure 7**). Because this case is a remote investigation, it is unknown if the driver's air bag was designed with tethers and/or vent ports. Police photographs of the front right air bag revealed that there was no visible evidence of damage to the air bag during the deployment, but the cover flap appeared to be bent along the front/leading edge (**Figure 8**) from contact

Figure 8: Interior view from driver's seat of case vehicle's Rear Facing Child Safety Seat and deployed front right passenger's air bag; Note: bent corner (highlighted) of module's cover flap (case photo #19)

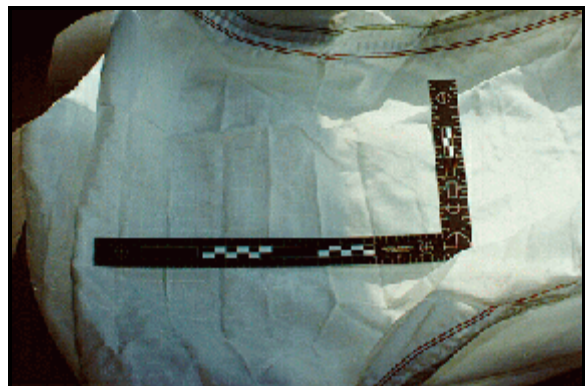
Figure 10: Case vehicle's deployed front right passenger air bag showing blue cloth transfer from Rear Facing Child Safety Seat to top portion of air bag's fabric (case photo #25)

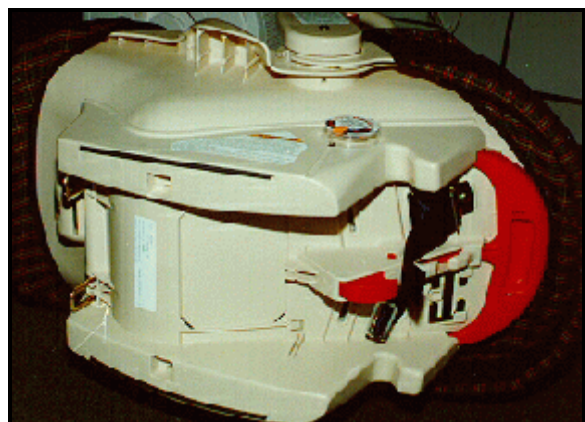
The infant child safety seat used by the case vehicle's front right infant passenger was manufactured by Graco Products on February 25, 1999 and was identified by Model number 7497SY, Serial #JJ0225995186; however, the exact model name is unknown. The seat was made of a hard plastic one piece shell and equipped with a three-point harness with two different height levels that the webbing could be adjusted too. The seat was also designed with a carry handle that either reclined or snapped upwards in order to be used as a infant carrier. Based on the police photographs, there was no visible evidence of damage to the rear facing child safety seat (Figure 11). Furthermore, it appears that the child safety seat was being used without its base.

Figure 11: Back and underneath sides of case vehicle's Rear Facing Child Safety Seat showing no visible evidence of damage (case photo #34)

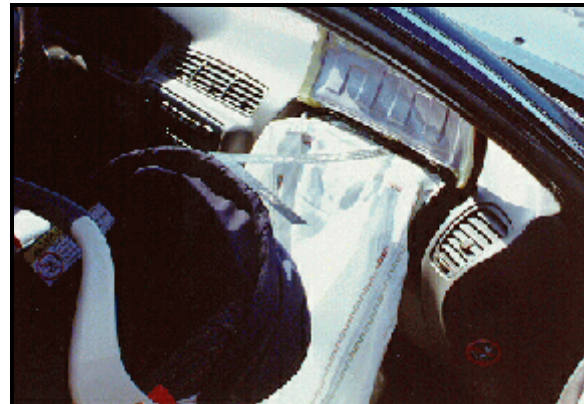
Immediately prior to the crash the case vehicle's front right infant passenger was seated in a rear facing child safety seat (RFCSS), in a reclined posture with his back against the back of the child seat, his feet on the child seat toward the seat back, and both arms on his lap. From the photographs, his seat track appears to be located between its middle and rearmost positions, and the seat back was slightly reclined. Based on the Police Crash Report, the rear facing child safety seat rested only 23 centimeters (9 inches) in front of the front right air bag module (**Figure 12**).

Figure 12: Case vehicle's front right seating area showing distance [23 cm (9 in)] from back of Rear Facing Child Safety Seat to front right passenger's air bag module (case photo #24)
