TRANSPORTATION RESEARCH CENTER

ON-SITE CHILD AIR BAG-RELATED FATALITY INVESTIGATION

CASE NUMBER - IN00-010
LOCATION - TEXAS
VEHICLE - 1996 HYUNDAI ACCENT L
CRASH DATE - December, 1999

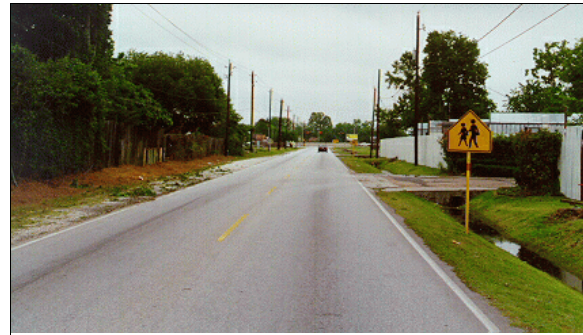
The case vehicle was traveling east in the eastbound lane of a two-lane, undivided, city roadway (**Figure 1** below) and intended to continue traveling eastward. The Mercury had been traveling west in the westbound lane of the same two-lane undivided city street and was turning left into a private drive, intending to travel northward. The case vehicle's driver braked, attempting to avoid the crash. The case vehicle deposited 23.8 meters (78 feet) of skid marks prior to impacting the Mercury. The crash occurred in the westbound lane of the roadway, within the driveway junction; see **CRASH DIAGRAM** below.

Figure 1: Case vehicle's eastbound travel path prior to impact with Mercury; Note: Mercury had been traveling westbound and was turning left at the driveway junction located on right (south) side of road (case photo #02)

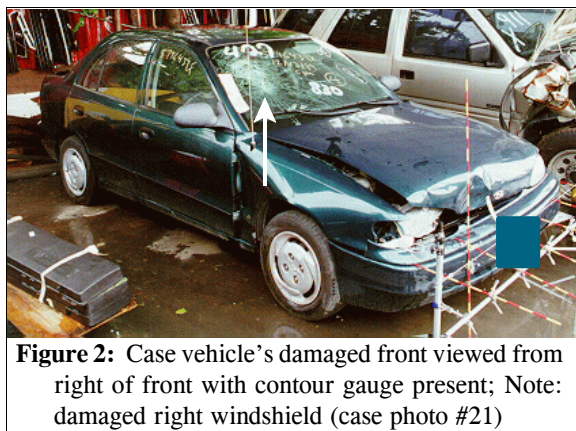
Figure 2: Case vehicle's damaged front viewed from right of front with contour gauge present; Note: damaged right windshield (case photo #21)

The front right half of the case vehicle (**Figure 2** and **Figures 3** and **4** below) was impacted by the front right of the Mercury causing the case vehicle's driver and front right passenger supplemental restraints (air bags) to deploy. Both vehicles came to rest in the eastbound lane of the driveway junction. Presumably, the case vehicle rotated slightly clockwise, no more than 10 degrees, prior to coming to rest heading east-southeast. The Mercury, which was turning, was deflected slightly counterclockwise and came to rest heading primarily southwestward; see **CRASH DIAGRAM** below.

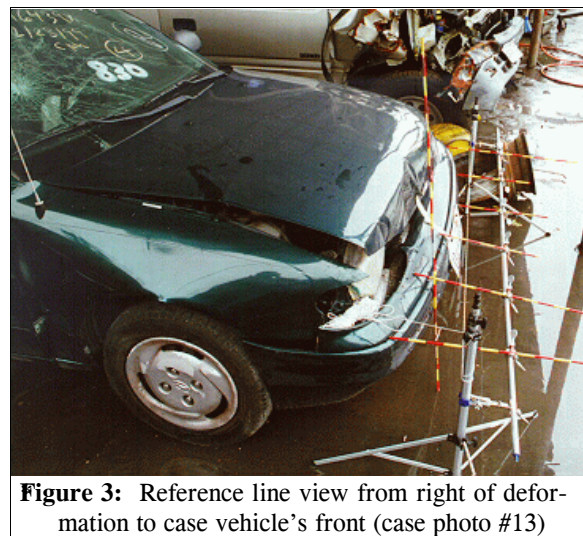
Figure 3: Reference line view from right of deformation to case vehicle's front (case photo #13)

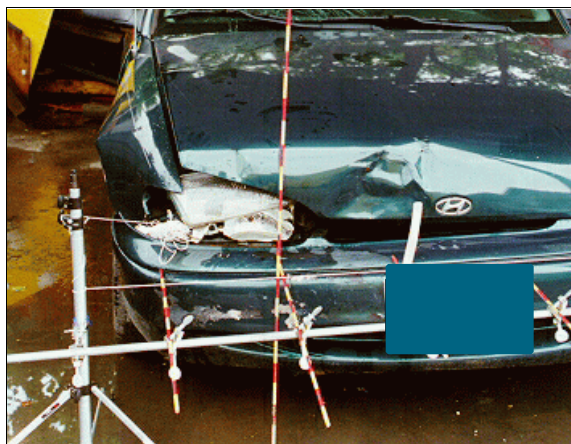
Figure 4: Close-up of direct damage area to case vehicle's front right half (case photo #11)

The case vehicle's initial contact with the Mercury involved the front right half of the vehicle (**Figure 2** above and **Figure 4**). Direct damage began 14 centimeters (5.5 inches) right of center and extended, a measured distance of 59 centimeters (23.2 inches), along the front bumper to the front right bumper corner. Induced damage was present across the entire front, and the field L was measured as 146 centimeters (57.5 inches) from bumper corner to bumper corner. Residual maximum crush was measured as 15 centimeters (5.9 inches) at C₅. The wheelbase on the case vehicle's left side was shortened at most 1 centimeter (0.4 inches) while the right side was unaltered. The case vehicle's front bumper fascia, grille, hood, right fender, and right headlight and turn signal assemblies were directly damaged and crushed rearward. The case vehicle's right front tire was physically restricted by the right fender. The left rear tire was deflated, but it is unknown if this was related to the crash. The right fender, hood, and left headlight and turn signal assemblies sustained induced damage as well as the left front bumper. No obvious induced damage or remote buckling was noted to the remainder of the case vehicle's exterior.

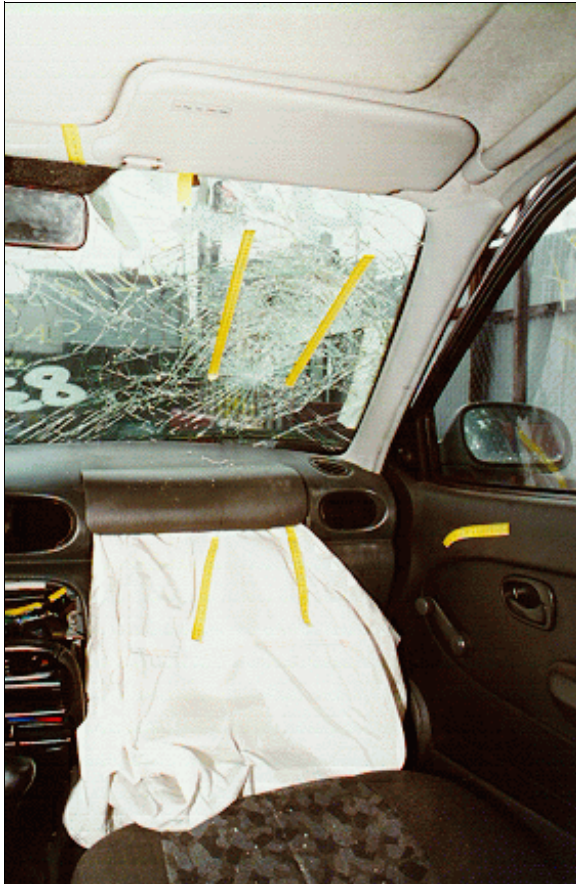
Inspection of the case vehicle's interior revealed a spider web-type impact to the right side of the windshield's glazing from contact by the "on-lap" front right passenger with embedded hair in the glazing (**Figures 5** and **6** below). Furthermore, there was contact (i.e., a strand of dark hair

Figure 5 Vertical view of case vehicle's front right passenger seating area with tape highlighting apparent occupant contacts (case photo #34)

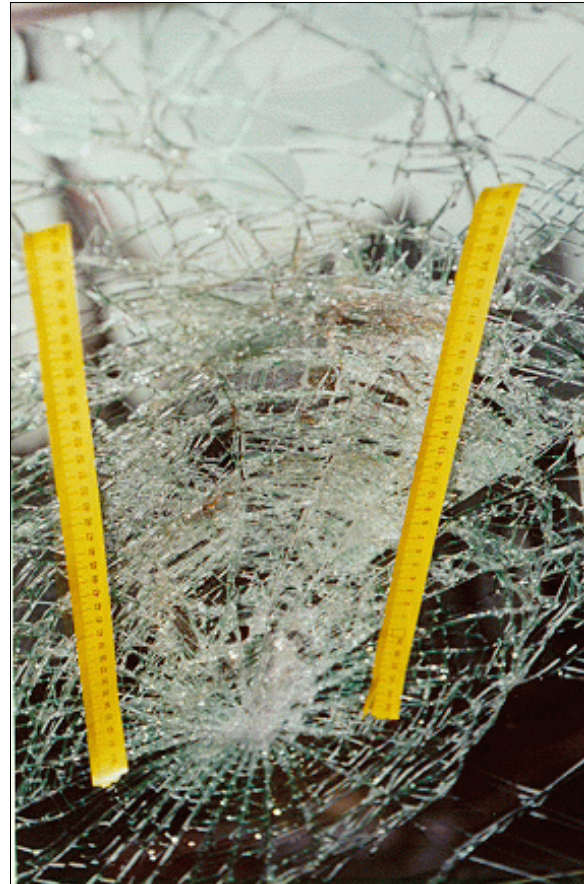
Figure 6: Close-up of large skin transfer to interior surface of case vehicle's right windshield glazing (case photo #36)

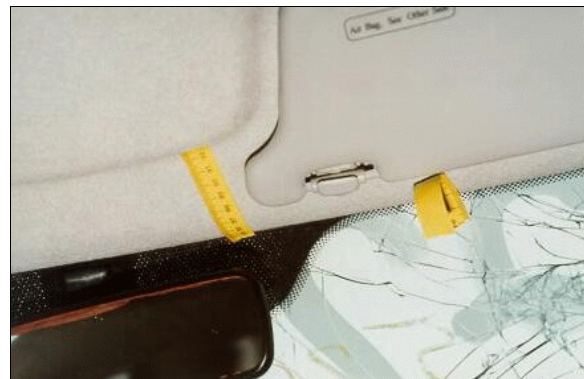
and blood) on the windshield's header toward the left side of the front right sun visor (**Figure 7**), and the rearview mirror was tilted, most likely from contact by one of the front right occupants. In addition, there was a scuff on the interior surface of the right front door (**Figure 8** below).

Figure 7: Close-up of contact scuff to case vehicle's front right header/sun visor; Note: rear view mirror tilted toward driver (case photo #38)

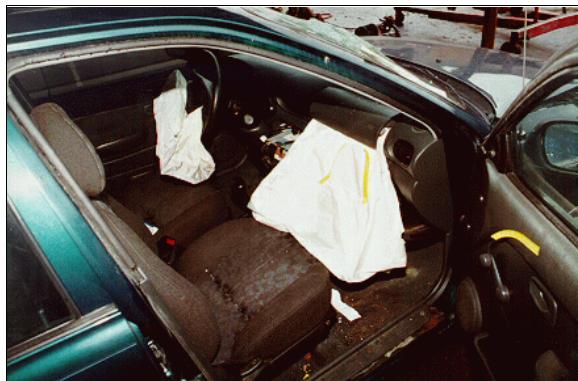
Figure 8: Case vehicle's front right seating area and interior of front right door showing seat position and evidence of occupant contact on air bag and scuff on door's interior surface (case photo #27)

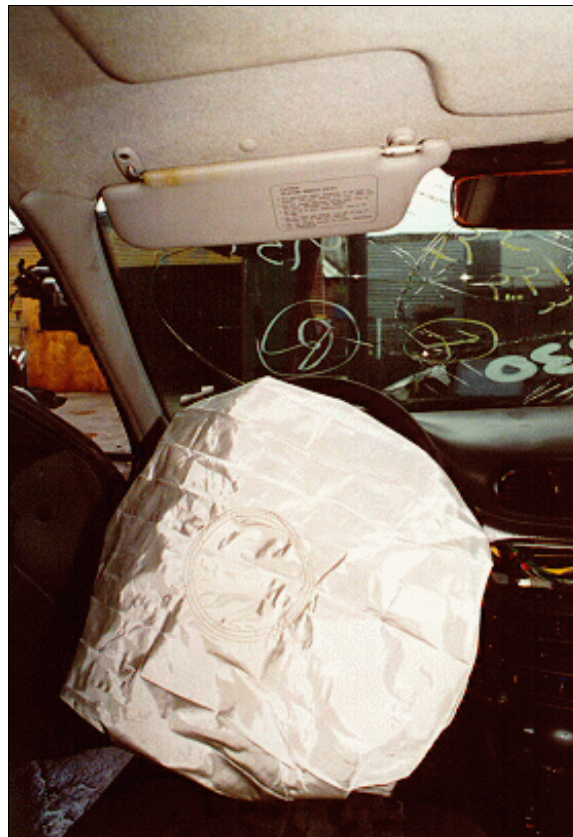
Figure 9: Case vehicle's driver seating area showing left "A"-pillar, windshield, front header/sun visor, and front surface of deployed driver air bag with no apparent evidence of occupant contact; Note: faint grease smears and black scuffs are present on air bag that occurred during deployment from contact with underside of cover flaps (case photo #31)

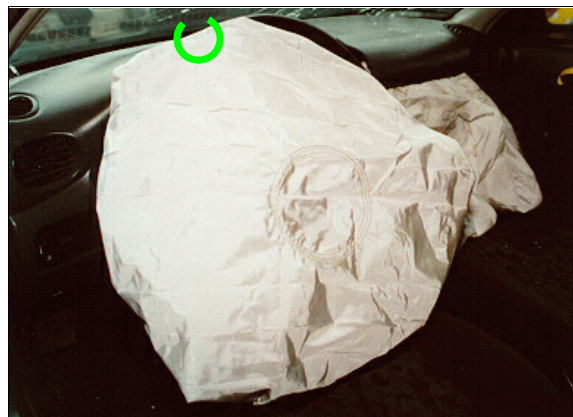
Figure 10: Case vehicle's deployed driver air bag showing no apparent skin evidence; Note: small cut (circled) found near seam (case photo #33)

designed with two tethers, each approximately 12 centimeters (4.7 inches) in width. The tethers were located at the 9 and 3 o'clock positions. The driver's air bag had two vent ports, approximately 2 centimeters (0.8 inches) in diameter, located at the 10:30 and 1:30 o'clock positions. The deployed driver's air bag was slightly elliptical with a height of approximately 60 centimeters (23.6 inches) and a width of approximately 62 centimeters (24.2 inches). An inspection of the driver's air bag fabric revealed no contact evidence (i.e., skin or make-up) readily apparent on the air bag's fabric.

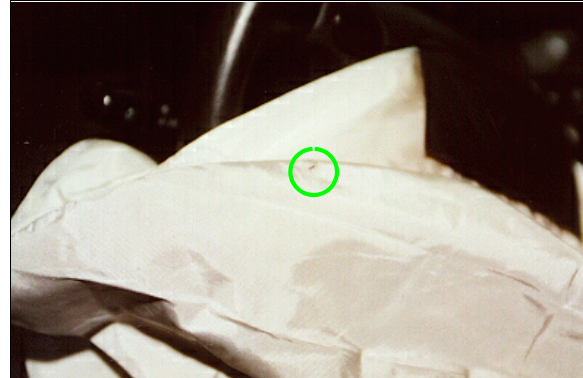
Figure 11: Close-up of cut/hole near seam in top portion of case vehicle's deployed driver air bag (case photo #33a)

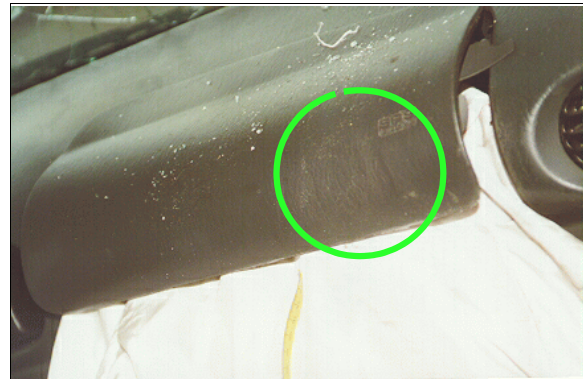
The front right passenger's air bag was located in the top of the instrument panel. There was a single, essentially rectangular shaped, curvilinear, modular cover flap. The cover flap was made of a thick vinyl over a thick cardboard type frame. The flap's dimensions were 35 centimeters (21.7 inches) at the lower horizontal seam and 15 centimeters (5.9 inches) along the curved vertical surface. The profile of the case vehicle's instrument panel was flush with the leading edge of the cover flap. An inspection of the front right air bag module's cover flap and air bag revealed that the cover flap opened at the designated tear points and there were heavy black scuffs on the front and right surfaces of the air bag's fabric from the underside of the cover flaps that occurred when the "on-lap" front right passenger loaded the air bag, temporarily blocking its deployment. In addition, there appeared to be a 10 x 9 centimeter (3.9 x 3.5 inch) area of direct contact (i.e., skin) on the right portion of the module's cover flap (**Figure 12**).

Figure 12 Close-up of oil and skin transfer on cover flap of case vehicle's front right air bag module (case photo #43)

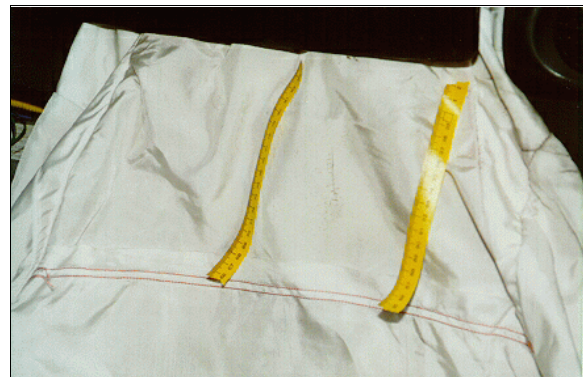
Figure 13: Close-up of skin transfer on top of case vehicle's front right passenger air bag (case photo #42)

front surfaces of the air bag. The skin transfer on the top surface of the air bag began 4 centimeters (1.6 inches) below the cover flap and was approximately 5 centimeters (2.0 inches) wide and extended toward the front right seating position 13 centimeters (5.1 inches) and ended just prior to the beginning of the front surface of the air bag (Figure 13 above). The red cloth transfer was on the front right upper quadrant of the air bag's front surface. The blood streak/smear was a 13 x 3 centimeter (5.1 x 1.2 inch) area on the upper left quadrant of the air bag's front surface (Figure 14). Finally, there was also a 13 centimeter (5.1 inch) long abraded area on the left lower quadrant of the air bag's front surface, with associated black scuffing, that occurred when the air bag contacted the upper right corner of the case vehicle's radio, which previously had been partially pulled out from the center instrument panel (Figure 15).

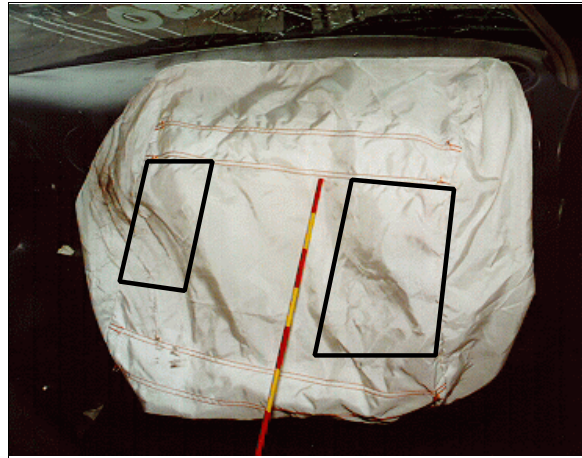
Figure 14: Front surface of case vehicle's front right passenger air bag showing evidence of occupant contact on left (i.e., blood smear) and right (i.e., red cloth transfer) upper quadrants; Note: grease smears and black scuffs are present on the air bag that resulted from contact with the underside of the cover flap during deployment (case photo #40)

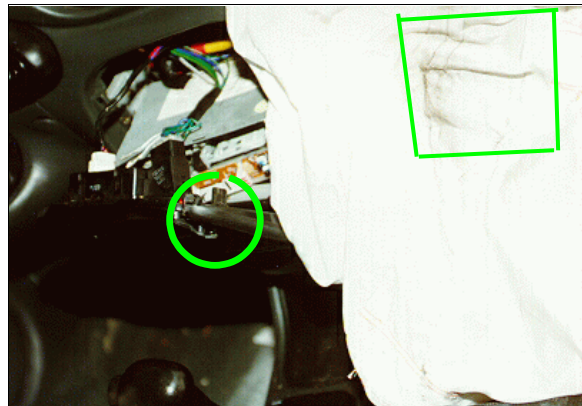
surface, with associated black scuffing, that occurred when the air bag contacted the upper right corner of the case vehicle's radio, which previously had been partially pulled out from the center instrument panel.

Figure 15: Close-up of case vehicle's deployed front right passenger air bag which contacted protruding radio (circle) during deployment causing a black scuff (square) on bag's fabric (case photo #39)
