ON-SITE DRIVER AIR BAG DEPLOYMENT/CHILD FATALITY INVESTIGATION

VERIDIAN CASE NO. CA00-011

VEHICLE: 1995 MERCURY GRAND MARQUIS

CRASH DATE - APRIL 2000

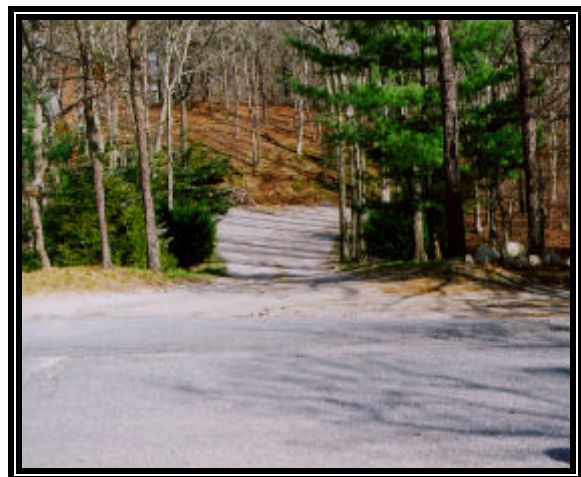
This single vehicle crash occurred in the early evening hours of April, 2000. At the time of the crash, it was daylight and the weather was not a factor. The crash occurred on private property, in the family's driveway. **Figure 1** is a trajectory view looking eastward along the driveway. The driveway consisted of packed dirt and gravel and was predominately east/west in direction. It measured approximately 43 m (141 ft) in total length. The driveway descended from the road with a negative grade of approximately 10 degrees for 25 m (81 ft) and then leveled out into a parking area measuring 18 m (60 ft) in length. The driveway terminated at the base of a hill side embankment that bordered the property. The slope of the embankment was an estimated 50 degrees. **Figure 2** is a view of

Figure 1: Trajectory view looking along the driveway.

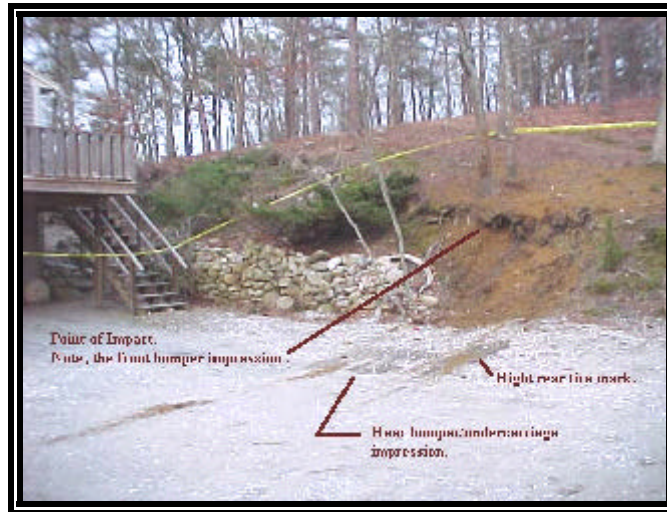
the embankment (point of impact) taken during the police investigation.

Figure 2: On-scene photograph of the point of impact.

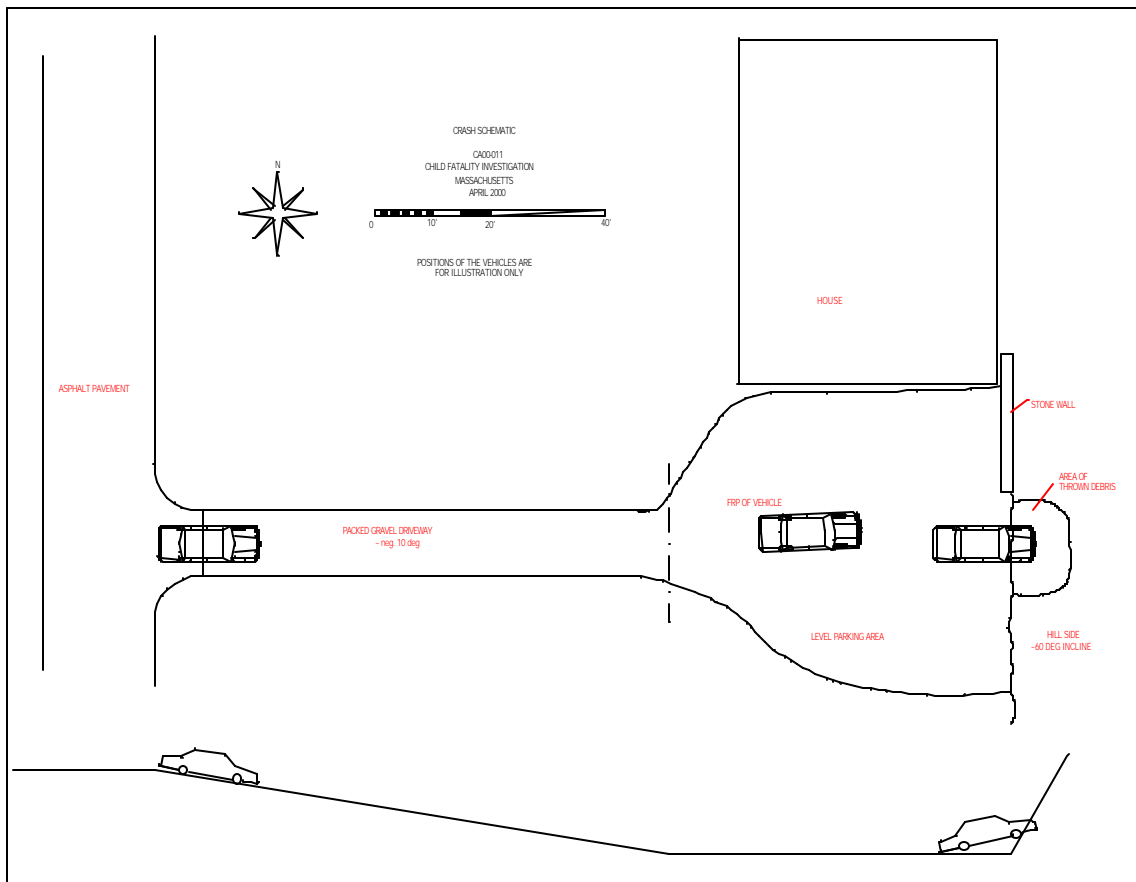
The vehicle's forward momentum caused it to climb the embankment approximately 2 m (7 ft). Analysis of the on-scene photographs determined the vehicle struck the embankment while under power. This determination was evidenced by an acceleration mark attributed to the right rear tire. The acceleration mark was caused by a loss of traction as the front of the vehicle became elevated against the embankment. The mark was generated coincident to or immediately after SRS deployment. The child would not be able to depress the accelerator at that time because of his upward/rearward kinematic pattern. It was probable that the grandmother attempted to take control of the out-of-control vehicle and also depressed the accelerator instead of the brake. An impression of the rear bumper and rear undercarriage was also observed at the point of impact. Refer to Figure 2. Dirt and debris was thrown up the embankment approximately 4 m (12 ft) by the force of the impact. The vehicle's engine then either stalled or was shut down by the grandmother and the vehicle rolled backward approximately 8 m (26 ft) to final rest. **Figure 3** is an overhead schematic of the crash scene.

Figure 3: Crash scene schematic.

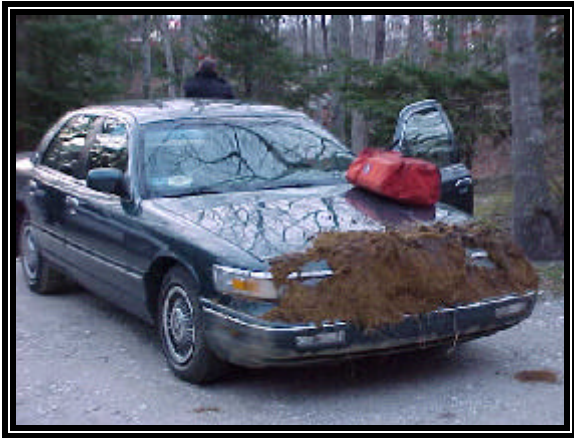
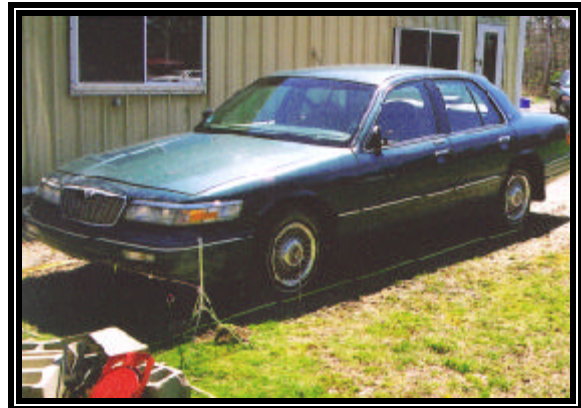
Figures 4 and 5 are views of the Mercury taken during the on-scene police investigation and SCI inspection, respectively. The Mercury Grand Marquis sustained direct contact damage across the entire 168 cm (66 in) frontal end width. The front bumper system was rotated slightly down and displaced rearward. The residual crush profile measured as follows: C1=2.5 cm (1.0 in), C2=2.5 cm (1.0 in), C3=3.0 cm (1.2 in), C4=2.5 cm (1.0 in), C5=3.0 cm (1.2 in), C6=3.8 cm (1.5 in). The front bumper system was mounted to the uni-body sub-frame by two Energy Absorbing Devices (EAD's). Inspection of the EAD's indicated both had compressed 3.8 cm (1.5 in) as a result of the impact and had returned to their original length through restitution. The force of the impact was managed by the vehicle's front bumper system and structures forward of the radiator support plane. Operation of the hood was restricted by the rearward shift of the front fascia. The center grille was broken and its hollow interior space had been packed full of dirt and debris by the embankment. Sliding contact damage was evident on the front undercarriage's lower air dam and extended 97 cm (38 in) aft of the bumper's leading edge. All doors remained closed during the crash and were operational upon inspection. The windshield was not fractured and the side glazings were intact. The bottom edge of the rear bumper and fuel tank were scratched and abraded from ground contact. This contact occurred as the vehicle climbed the embankment and momentarily came to rest (prior to rolling back to rest). The Collision Deformation Classification (CDC) of the frontal impact was 12-FDEW-01. The Barrier Model was the WINSMASH program calculated a damage based delta V of 18.7 km/h (11.6 mph). This calculated value seems high and represents an upper bound. An estimated delta V, based on SCI experience, of 13 to 16 km/h (8 to 10 mph) is more consistent with the magnitude of the vehicular damage and the dynamics of the crash.

Figure 4: Front view of the Mercury at final rest. Note the volume of dirt accumulated on the vehicle.

Figure 5: Left front view of the Mercury.

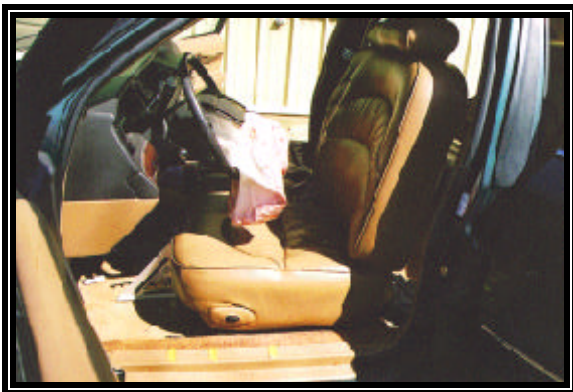
The at-crash driver's seat track position was reconstructed using the on-scene photographs and family members' statements. **Figure 6** is a left interior view of the reconstructed seat position. In this position, the track position measured 10.4 cm (4.1 in) rear of full forward.

Figure 6: View of the reconstructed seat position.

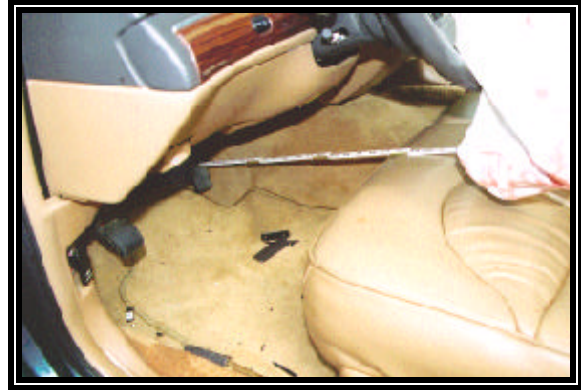
The total seat track adjustment measured 25.4 cm (10 in). The horizontal distance from the driver air bag module cover to the seat back measured 41 cm (16 in). The leading edge of the seat cushion was 3.8 cm (1.5 in) rearward of the instrument panel. The horizontal distances from the edge of the seat cushion to the brake pedal and to the accelerator measured 39.5 cm (15.5 in) and 43.2 cm (17.0 in), respectively. Refer to **Figure 7**.

Figure 7: View of the distance from the seat to the foot controls.

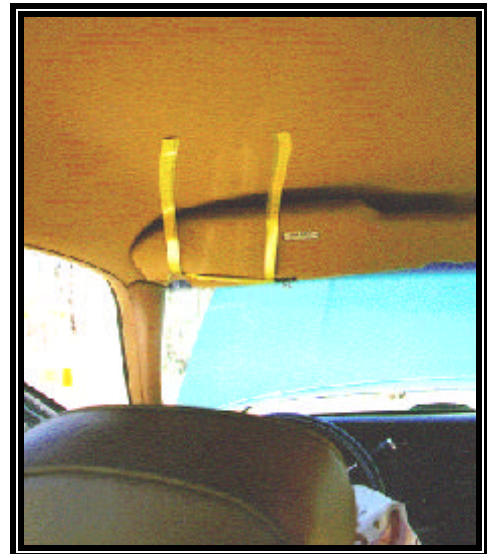
The expanding air bag lifted the child up during the deployment sequence and into contact with the sun visor. The sun visor and headliner were then abraded by the child's forehead during a rebound contact, **Figure 8**. The abrasion measured approximately 35 cm x 8 cm (14 in x 3 in), length by width, and began 6.4 cm (2.5 in) rearward of the visor's leading edge. The start and end of the contact pattern measured 16.5 cm (6.5 in) and 24.1 cm (9.5 in) inboard of the side rail. Several strands of hair were observed embedded in the abrasion pattern. An abrasion on the crown of the child's forehead was identified during the autopsy resultant to this contact.

Figure 8: View of the abraded sun visor and headliner.

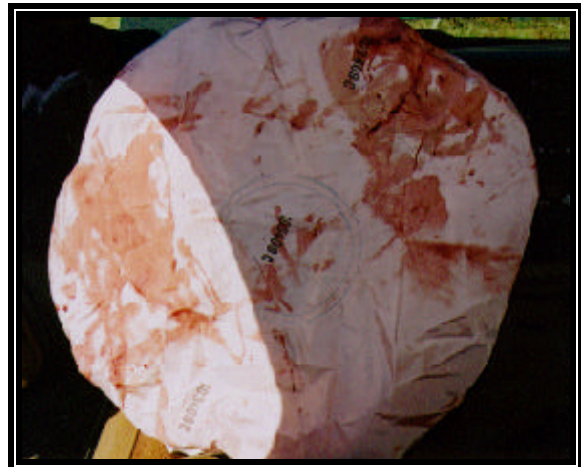
The diameter of the driver air bag measured 61 cm (24 in) in its deflated. The bag was tethered by four 6.4 cm (2.5 in) straps sewn to the face of the bag. It was vented by two 1.3 cm (0.5 in) ports located in the 10/2 o'clock sectors on the back side of the bag. **Figure 9** is a view of the face of the driver air bag. The identification number *103409C* was stamped on the face of the bag. The bag was stained with blood. The heaviest concentrations were located in the 2 and 9 o'clock sectors.

Figure 9: Driver air bag.

A total of eight black vinyl transfers were identified on the face of the bag in the 9 o'clock sector. The transfers were parallel, spaced approximately 2.0 cm (0.8 in) apart and measured 10 cm (4 in) in length. The transfers were oriented vertically. The transfers were the result of frictional contact with the interior surface of the module cover flap during the impeded air bag deployment. Vinyl transfers were also noted on the back side of the bag in its 2 and 9 o'clock sectors. These transfers resulted from frictional contact with the steering wheel rim.

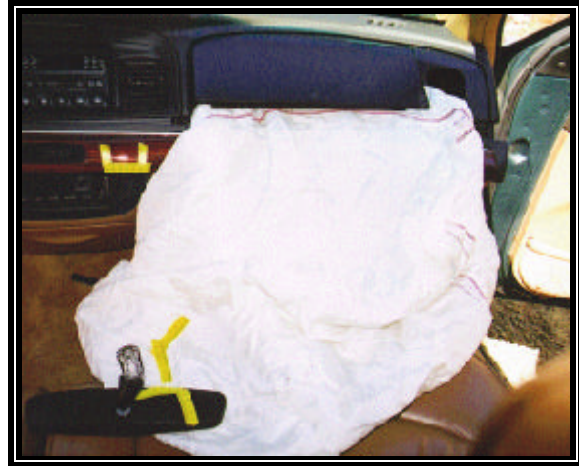
The front right passenger air bag, **Figure 10**, deployed from a mid-mount module, configured in the right aspect of the instrument panel. The module cover flap was a single vinyl flap design, measuring 39.1 cm x 16.3 cm (15.4 in x 6.3 in), width by height. The passenger bag measured 71 cm x 56 cm (28 in x 22 in), width by height, in its deflated state. It was not tethered and was vented by a single 3.8 cm (1.5 in) diameter port located on the inboard side panel. A black scuff was identified on the face of the bag. The scuff measured 8 cm (3 in) in length. It was located 13 cm (5 in) right of the inboard side panel and 10 cm (4 in) below the top of the deflated bag. The scuff mark resulted from air bag contact with the back side of the center mirror. Two areas of spattered blood were also identified of the face of the bag.

Figure 10: Front right passenger air bag.

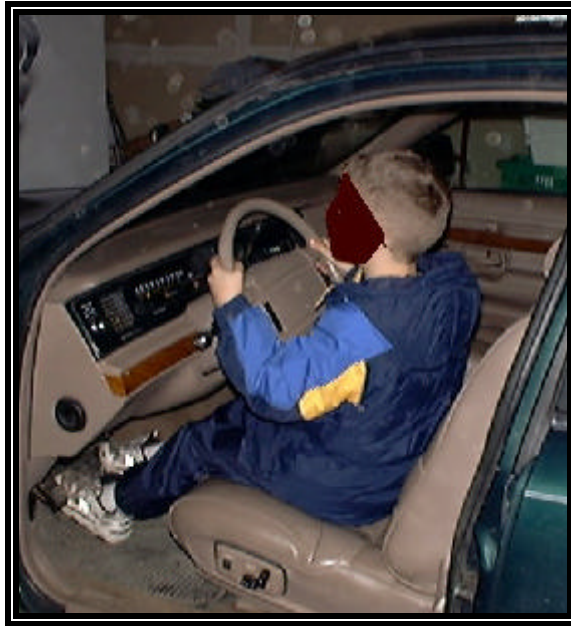
A review of anthropometry tables indicated the child was approximately fiftieth percentile (50 %) for height, given his stated age. Under this assumption, the dimensions of the 9 year old child’s lower extremities indicated he would have been able to reach the foot controls of the Mercury. However, his reach would have been at the outer limits of the controls. Additionally, he would have had to have been seated forward, near the forward edge of the seat cushion. This forward position placed the child’s head and neck in close proximity to the driver air bag module. **Figure 11** is a left interior view of an exemplar vehicle and driver, simulating the at-crash conditions. Note the position of the child forward of the seat back and the extension of his lower extremities in order to reach the foot controls. The exemplar child was 8 years of age with a reported height of 132 cm (52 in).

Figure 11: Left interior view of the exemplar driver seated in exemplar vehicle.
