REMOTE ALLEGED SAFETY-RELATED DEFECT REPORT

CASE NUMBER - IN00-012
LOCATION - MISSISSIPPI
VEHICLE - 1999 HONDA CIVIC LX
CRASH DATE - February, 2000

IN00-012

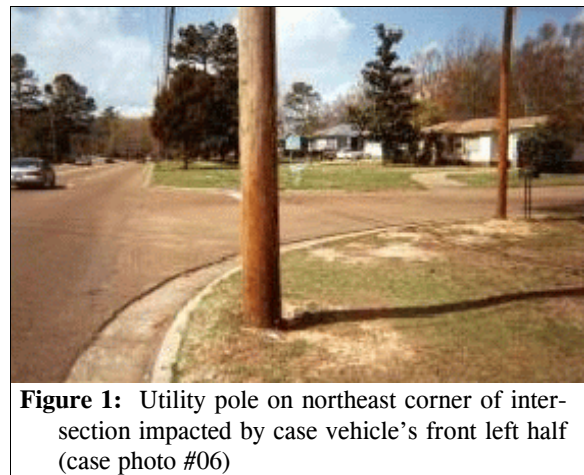
Figure 1: Utility pole on northeast corner of intersection impacted by case vehicle's front left half (case photo #06)

The case vehicle impacted a large, wooden utility pole (**Figure 1** above) with a diameter of greater than 30 centimeters (11.8 inches). No contact evidence was apparent in the one scene photograph of the utility pole, nor was there evidence that the pole had fractured and/or been replaced.

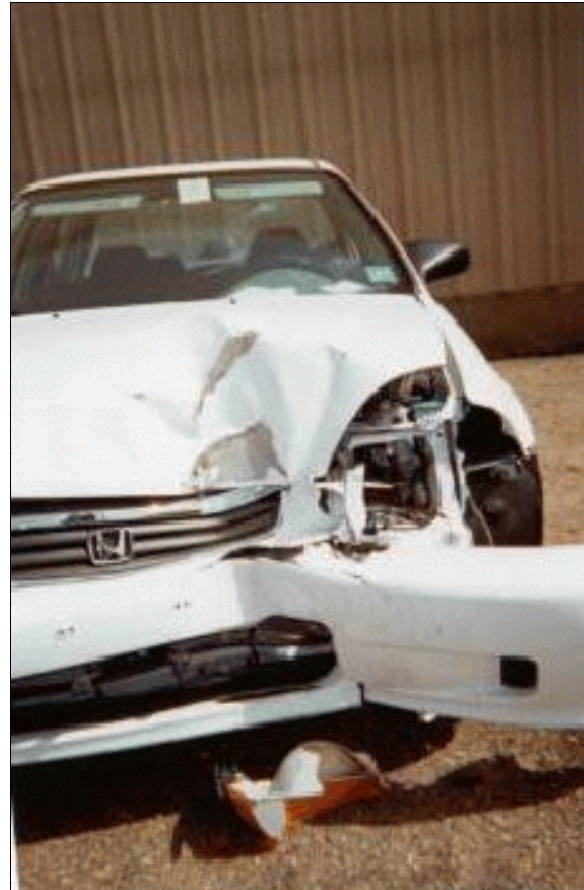
The case vehicle's contact with the utility pole involved its front left half. Direct damage began near the midpoint of the left half (**Figure 2**). The front left portion of the bumper, fascia,

Figure 2: Case vehicle's front left half damage from utility pole impact (case photo #13)

and air dam were shoved rearward, with the front left bumper corner pulled forward. The left half of the grille and hood were also displaced rearward. The left headlamp assembly was missing from its original location. Induced damage was limited to the front end of the left fender. There was a spider-web type crack to the windshield glazing above the steering wheel, approximately one-third of the way down from the front roof header (**Figure 4**). This crack was most likely caused by contact from the case vehicle's driver. Below the air vent, left of the steering column, there appears to be deformation to the lower instrument panel, possibly from contact by the driver's knee. No intrusion was detected in the available photographs.

Based on the engineer-provided photographs, the CDC for the case vehicle was estimated as: **12-FYEN-1 (10)**. The WinSMASH reconstruction program, CDC-only algorithm, provided a borderline reconstruction, but the results appear somewhat reasonable. The case vehicle's barrier equivalent Delta V was 15.4 km.p.h. (9.6 m.p.h.). With no C-measurements and no scene evidence to establish the case vehicle's approach trajectory, this contractor is uncertain as to whether the impact had sufficient Longitudinal Delta V to deploy the vehicle's air bags. The CDC-only algorithm estimated Total, Longitudinal, and Lateral Delta Vs are, respectively: 15.4 km.p.h. (9.6 m.p.h.), -15.2 km.p.h. (-9.4 m.p.h.), and -2.7 km.p.h. (-1.7 m.p.h.).

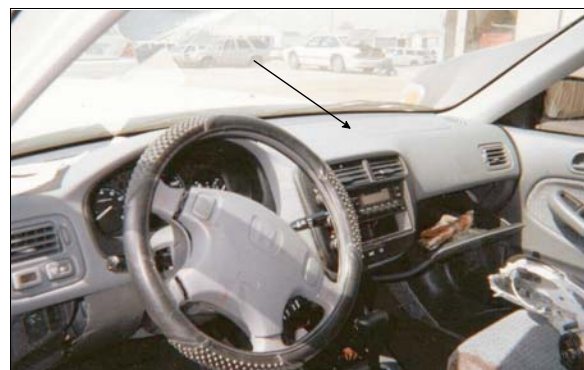
Figure 3: Case vehicle's front seating area showing non-deployed driver (steering wheel-mounted) and front right passenger (top instrument panel-mounted) air bags (case photo #02)

The case vehicle was equipped with a SRS that consisted of redesigned frontal air bags at the driver and front right passenger seat positions (**Figure 3** above). The driver's air bag was located in the hub of the steering wheel, and the front right passenger's air bag was located in the top of the right instrument panel. Case photographs verify that neither air bag deployed in this crash. There appears to be discoloration to the bottom center and top center of the driver's air bag module (**Figure 5**) and at the 12 o'clock, 1 o'clock, 7 o'clock' and 8 o'clock positions of the steering wheel rim. These inconclusive markings may be indications of possible driver contact to the steering wheel rim and driver's air bag module cover. There was no contact evidence readily apparent on the front right air bag module's cover.

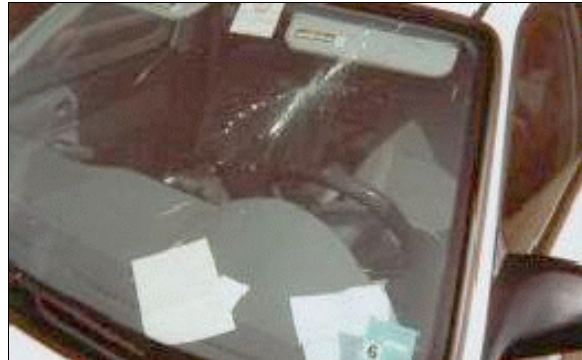
Figure 4: Close-up of crack to driver's side of case vehicle's windshield; Note: crack resulted from contact by case vehicle's driver (case photo #11)

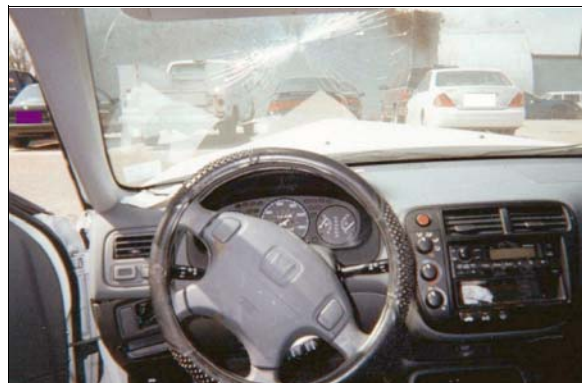
Figure 5: Case vehicle's driver seating area showing non-deployed driver air bag module and contact to windshield (case photo #14)

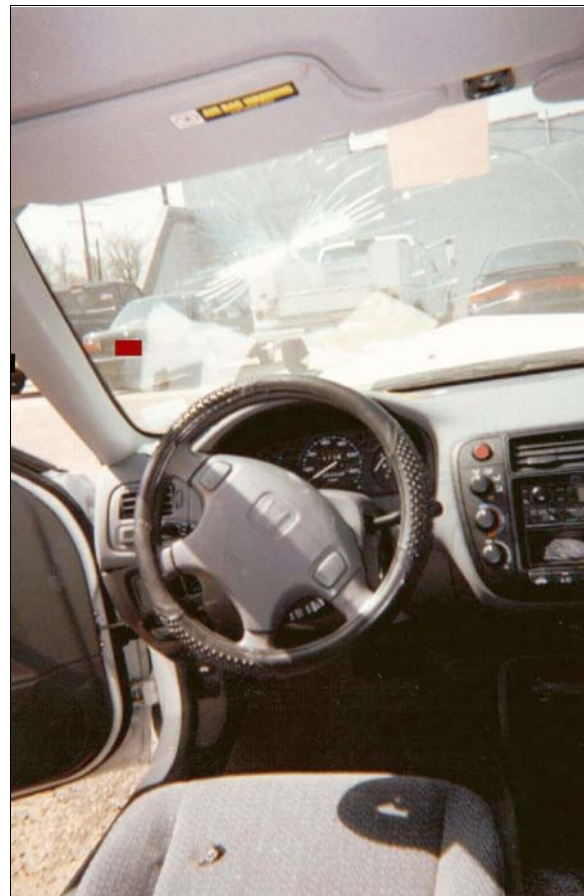
The case vehicle's driver made no known pre-crash avoidance maneuvers. As a result and independent of the improper usage of her available safety belts, her pre-impact body position did not change just prior to impact. The following discussion is based on vehicle photographs (Figure 5 above and Figure 6) and occupant kinematic principles. As the westbound case vehicle approached a four-leg intersection, it is likely that all four tires mounted the north roadside's short concrete barrier curb. Thus, the probability of damage to any of the case vehicle's four tires or wheels is relatively remote. Effects of the "low" curb override on the case vehicle's driver would have been negligible. The case vehicle's impact with the large, wooden, utility pole enabled the driver to move forward and slightly to the right toward the 10 degree Direction of Principal Force, as the case vehicle decelerated. The driver's usage of only her lap belt allowed her upper torso to "jackknife" over her lap belt and into and over the steering wheel. Because the driver's air bag did not deploy, her forward movement was inhibited only by her lap belt, the case vehicle's steering wheel, and the windshield glazing. Her head struck the windshield glazing and, according to the investigating police officer, caused a scalp laceration above her hairline.

Figure 6: Vertical view of case vehicle's driver seating area showing unidentified object on driver's seat, non-deployed driver air bag, and crack to windshield (case photo #15)

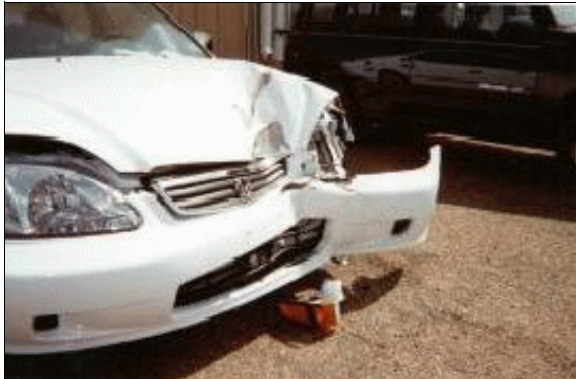
Figure 7: Case vehicle's front left half damage from utility pole impact viewed from right of front (case photo #05)

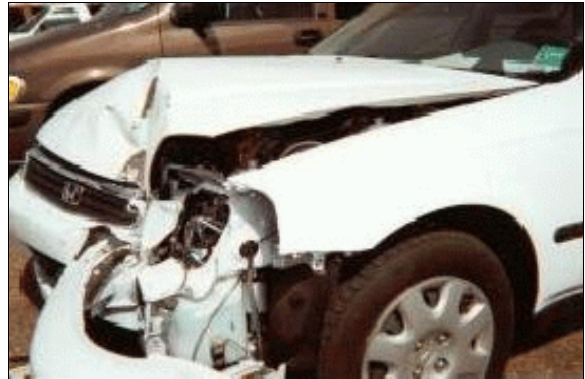
Figure 8: Case vehicle's frontal damage from utility pole impact viewed from left of front (case photo #03)

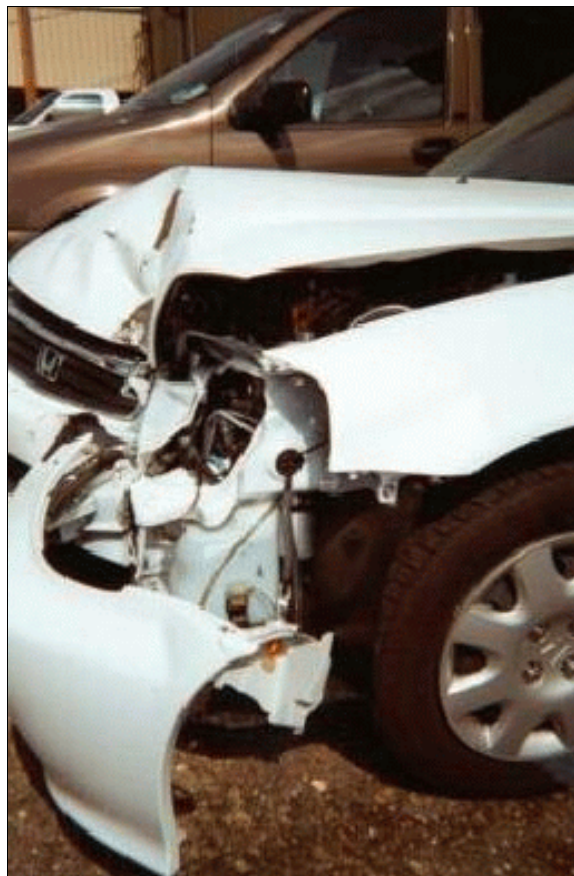
Figure 9: Closer-up vertical view of case vehicle's frontal damage from utility pole impact viewed from left of front (case photo #04)

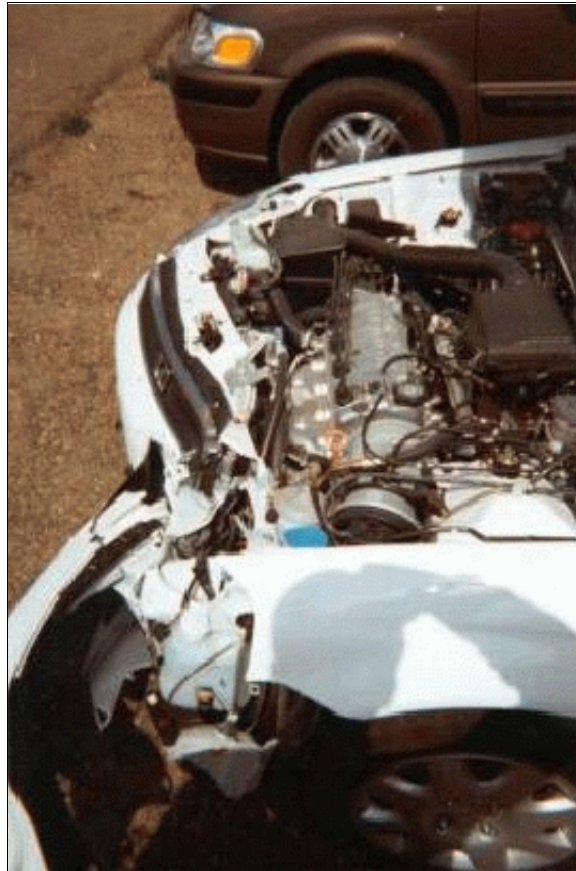
Figure 10: Vertical view of case vehicle's damaged front left half viewed from left of front with hood raised (case photo #10)

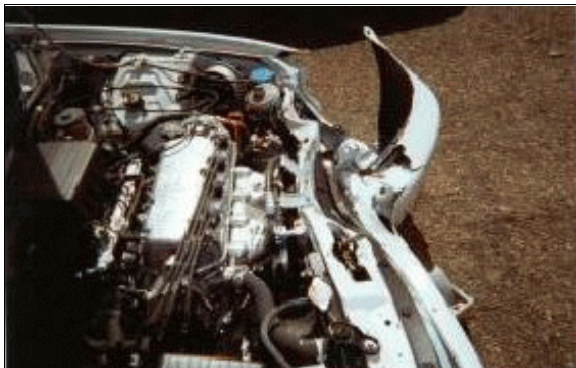
Figure 11: Case vehicle's damaged front left half viewed from right front with hood raised (case photo #09)

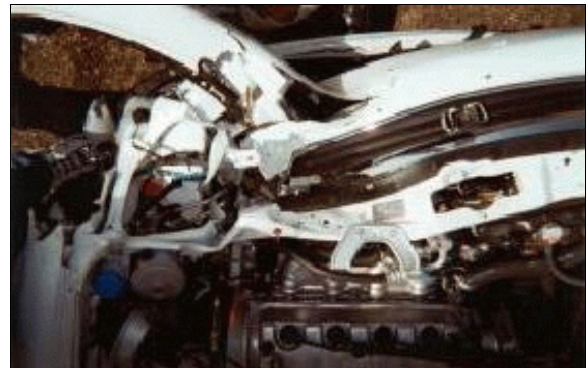
Figure 12: Overhead view of damage to case vehicle's front left half from impact with utility pole (case photo #12)
