VERIDIAN ON-SITE AIR BAG FATALITY INVESTIGATION

VERIDIAN CASE NO. CA00-012

VEHICLE - 1994 GEO PRIZM

LOCATION - STATE OF MASSACHUSETTS

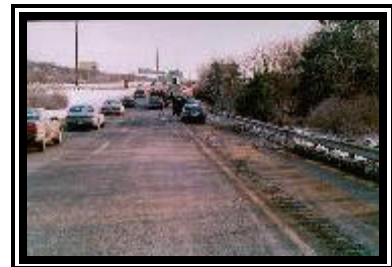
The 24 year old female driver of the 1994 Geo Prizm was en route to her residence and was operating the vehicle southbound in the outboard lane of a two lane interstate interchange area (**Figure 1**). As she observed a 2000 Ford box van encroach into her lane of

Figure 1. Southbound view of crash site.

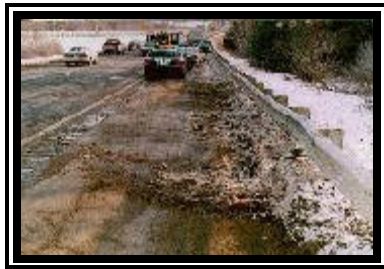
Figure 2. 1994 Geo Prizm impact to W-beam guardrail.

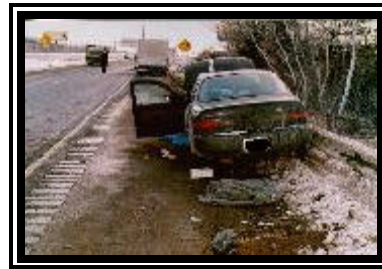
Figure 3. Police photo (south) showing the Geo at final rest against the guardrail.

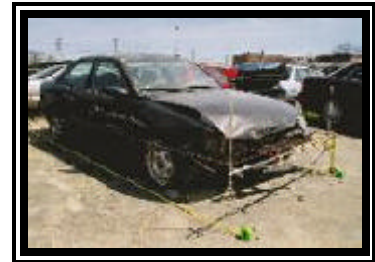
The Geo sustained moderate frontal damage as a result of the impact with the W-beam guardrail (**Figures 4 & 5**). The direct contact damage began at the front right bumper corner and extended 62.0 cm (24.4 in) inboard. The impact deformed the full frontal width resulting in a combined direct and induced damage length (Field L) of 119.0 cm (46.9 in). Six crush measurements were documented at the level of the reinforcement bar (*bumper fascia separation*): C1= 0 cm, C2= 4.0 cm (1.6 in), C3= 9.0 cm (3.5 in), C4= 13.0 cm (5.1 in), C5= 17.0 cm (6.7 in), C6= 19.0 cm (7.5 in). The Collision Deformation Classification (CDC) for this frontal impact to the Geo Prizm was 01-FZEW-1 with a principal direction of force of 30 degrees. The bumper assembly shifted 15.0 cm (5.9 in) to the left (*shifting of the entire end structure required to increment the principal direction of force*). Reduction in the right side wheelbase measured 3.0 cm (1.2 in). The hood and right fender were deformed rearward with additional contact damage documented to the right side surface attributed to the secondary guardrail impact (**Figure 6**). This damage pattern began 46.0 cm (18.1 in) aft of the front right bumper corner and extended 295.0 cm (116.2 in) rearward. The gap in the contact damage along the right fender area necessitated assignment of another event. A maximum (lateral) crush value of 4.0 cm (1.6 in) was noted at the right rear door area. The CDC for this side impact was 12-RYES-1 with a principal direction of force of (+)10 degrees. The windshield was undamaged.

Figure 4. Frontal damage to the 1994 Geo Prizm.

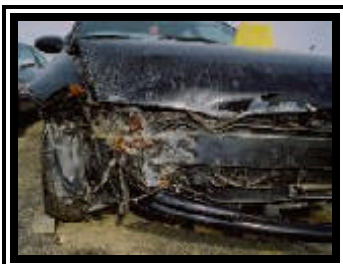
Figure 5. Guardrail damage to the front right area.

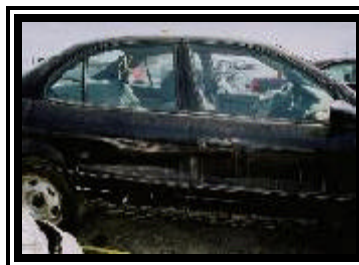
Figure 6. Guardrail damage to the right side surface.

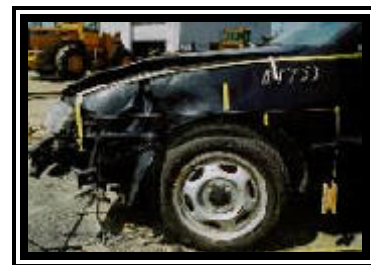
Figure 7. Opposing vehicle damage to the left front side surface.

Direct contact damage was also identified at the left fender and wheel/rim area attributed to the initial van impact (**Figure 7**). This damage pattern began 8.0 cm (3.1 in) aft of the front left bumper corner and extended 55.0 cm (21.7 in) rearward. The combined direct and induced damage length (Field L) also began 8.0 cm (3.1 in) aft of the front left bumper corner and extended 72.0 cm (28.3 in) rearward. Six crush measurements were documented at the level of the mid-door: C1= 0 cm, C2= 1.0 cm (0.4 in), C3= 5.0 cm (2.0 in), C4= 9.0 cm (3.5 in), C5= 7.0 cm (2.8 in), C6= 8.0 cm (3.1 in). The CDC for this side impact to the Geo was 08-LFEW-2 with a principal direction of force of (-)120 degrees.

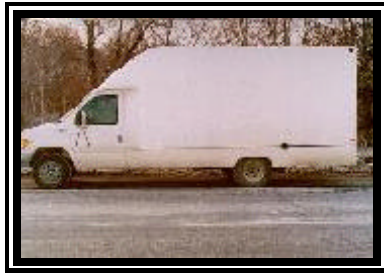
The 2000 Ford E-350 cutaway “box van” (**Figure 9**) sustained minor right rear side surface damage as a result of the impact with the Geo Prizm. Although no deformation of the side surface was identified, scuff marks began just forward of the right rear axle and extended rearward to the bumper corner (**Figure 10**). A break in the contact damage was noted aft of the right rear wheel well, which may indicate a separate (additional) event between the two vehicles; however, this could not be confirmed through the Geo inspection.

Figure 9. 2000 Ford E-350 cutaway “box van”.

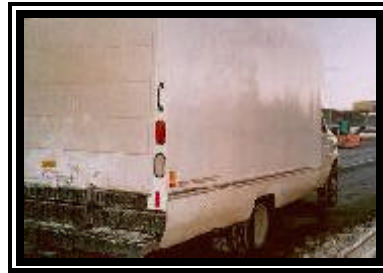
Figure 10. Right rear side surface damage.

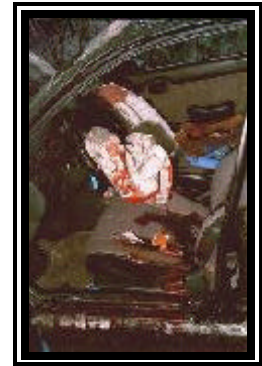
Interior damage to the Geo identified through the vehicle inspection was minimal and was attributed to occupant contact. Scratch/scuff marks were documented on the left side of the knee bolster (rigid plastic type). Blood pooling was noted to the driver’s seat cushion and aft floor area (**Figure 11**). The right portion of the steering wheel rim (fixed column) was deformed forward 1.5 cm (0.6 in) along with 1.0 cm (0.4 in) of column compression. No intrusion of interior components were found in the vehicle.

Figure 11. Police photo of Geo interior.

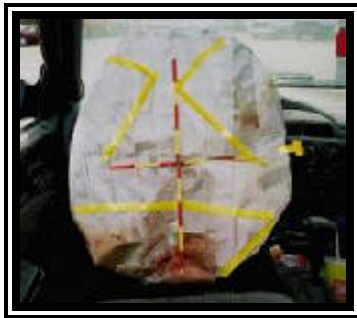
The Geo Prizm was equipped with frontal air bags for the driver and right passenger positions. The air bags deployed as a result of the frontal impact with the W-beam guardrail. The driver air bag was housed in the center of the steering wheel with a horizontally oriented flap tear seam (H-configuration). The flaps were symmetrical in shape and measured 15.0 cm (5.9 in) in width and 6.5 cm (2.6 in) in height. The diameter of the driver air bag measured 63.5 cm (25.0 in) in its deflated state (**Figure 12**). Although no contact evidence was identified on the exterior surface of the module cover flaps, green/blue fabric transfers were documented on the left section of the bag face (**Figure 13**) along with makeup transfers to the lower right quadrant. The right section of the bag face was heavily stained with blood indicative of the driver's final rest position against the air bag membrane. Black vinyl transfers were noted to the rear lower section of the air bag from expansion within the module, indicative of an impeded deployment. The bag was vented by two ports located at the 11 o'clock and 1 o'clock sectors on the rear aspect of the air bag. No internal tether straps were present.

Figure 12. 1994 Geo Prizm driver air bag.

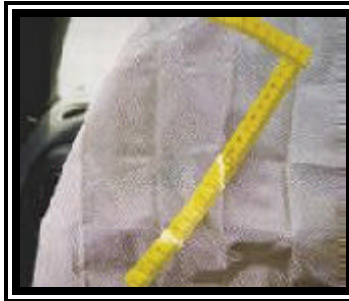
Figure 13. Green/blue fabric transfers to the driver air bag.

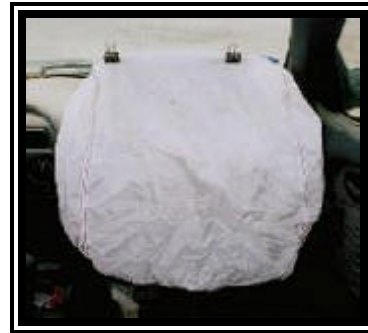
Figure 14. 1994 Geo Prizm passenger air bag.

The front right passenger air bag deployed from the right mid-instrument panel area with a single cover flap design hinged at the top aspect. The aluminum reinforced flap opened in an upward direction and produced a small scuff to the right lower windshield area. The cover flap was rectangular in shape and measured 34.0 cm (13.4 in) in width and 18.0 cm (7.1 in) in height. No contact evidence was found on the exterior surface of the module cover flap. The passenger air bag measured 52.0 cm (20.5 in) in width and 70.0 cm (27.6 in) in height in its deflated state (**Figure 14**). Blood spattering was noted to the upper left quadrant of the air bag. The bag was vented by two ports located at the 9 o'clock and 3 o'clock sectors on the side aspect of the air bag. No internal tether straps were present.

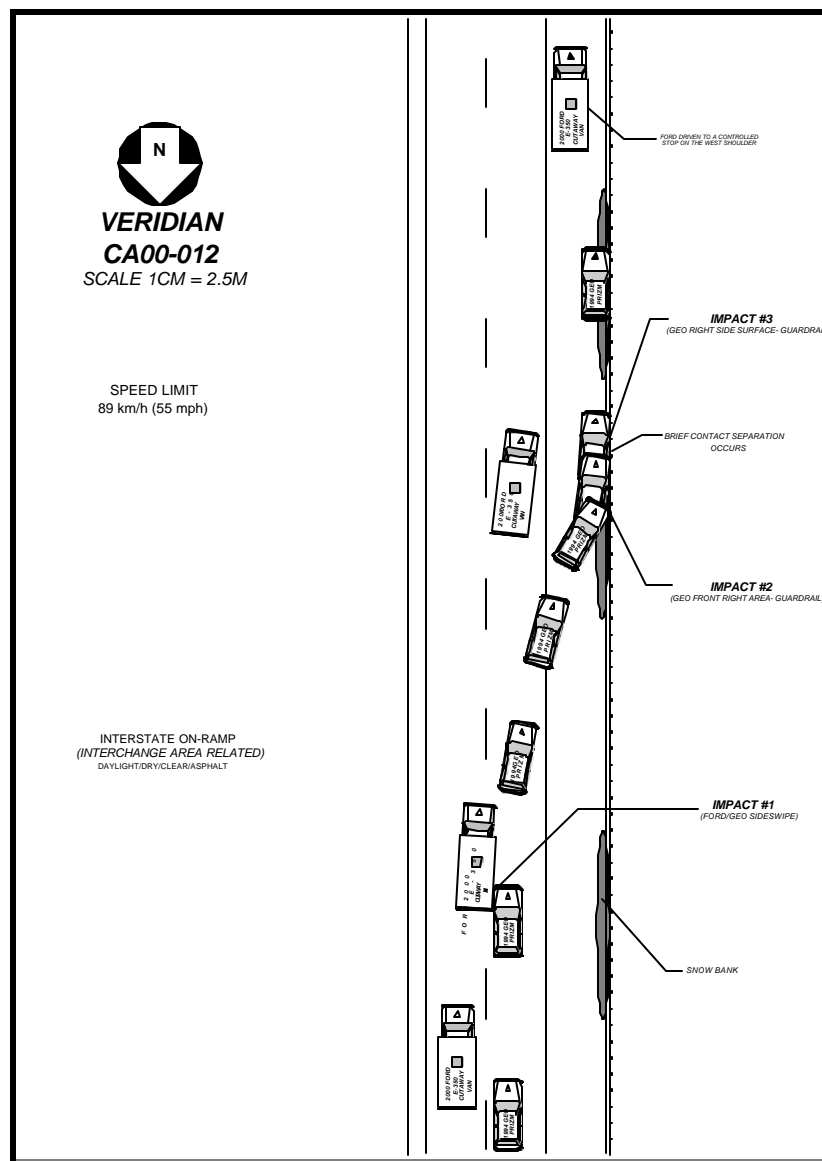
Figure 15. Scene Diagram

This two vehicle crash occurred during the afternoon hours of January, 2000. At the time of the crash, it was daylight with no adverse conditions as the roads were dry. The crash occurred in the southbound lanes of a straight two lane (one-way) interstate interchange area (see **Figure 15 - page 7**). The asphalt roadway was bordered by a narrow paved shoulder to the east and a break-down lane to the west with a tactile warning device (rumble strip) outboard of the travel lanes. A W-beam guardrail was located approximately 3.7 meters (12.0 feet) off the west fog line. I-beam strong posts approximately 1.8 meters (6.0 feet) apart supported the structure with block-outs between the post and W-beam. No traffic controls were present at the crash site which had a posted speed limit of 89 km/h (55 mph).
