On-scene Investigation / Vehicle to Vehicle  
Dynamic Science, Inc. / Case Number: DS00014  
2000 Ford Taurus  
Missouri  
May, 2000

1. Report No. DS00014		2. Government Accession No.		3. Recipient Catalog No.	
4. Title and Subtitle In-Depth Accident Investigation				5. Report Date	
				6. Performing Organization Report No.

**Dynamic Science, Inc.**  
**Accident Investigation**  
**Case Number: DS00014**

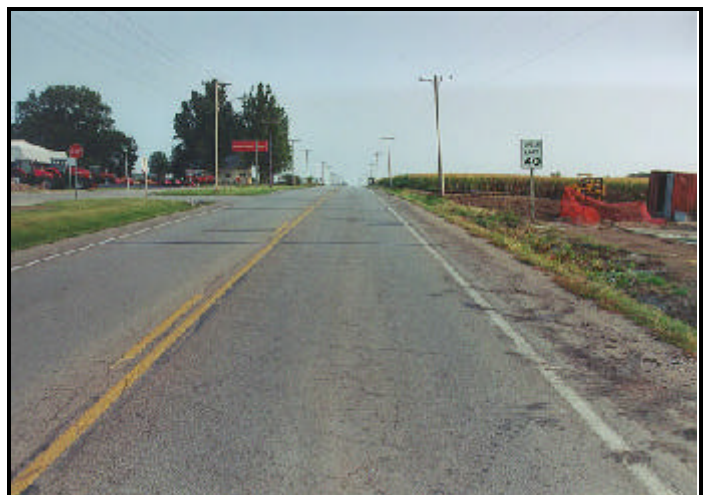
**Figure 1.** Area of impact

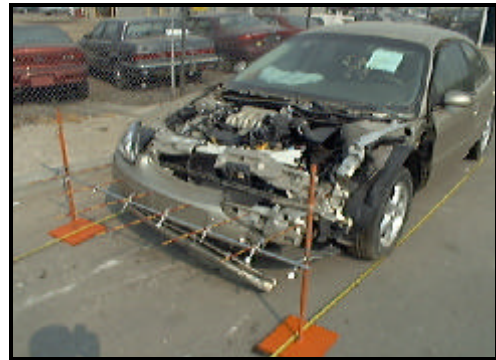
The driver of the case vehicle at the last moment braked and the vehicle deposited 11.7 m (38.4 ft) of locked wheel skidmarks on the roadway. The case vehicle was unable to stop and its front (12FYEW1) struck the back of the other vehicle. At impact, the case vehicle sustained a total delta v of 25.2 km/h (15.7 mph), a longitudinal delta v of -25.2 km/h (-15.7 mph) and a latitudinal delta v of 0 km/h (0 mph) as computed by WinSmash<sup>2</sup>. Both front air bags in the case vehicle deployed on impact with the other vehicle. The results fit the collision model and appear reasonable.

**Figure 2.** Exterior frontal damage to case vehicle.

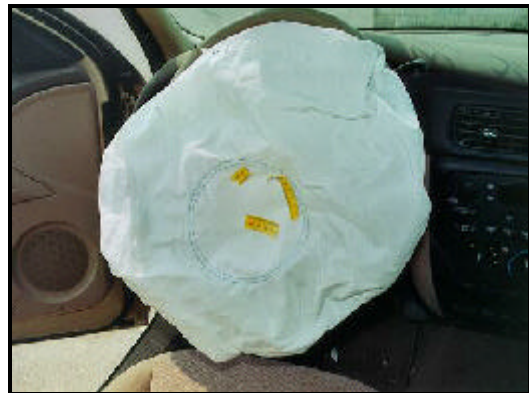
**Figure 3.** Case vehicle driver's air bag.

The case vehicle steering wheel mounted driver's air bag was equipped with two tethers and two vent

ports. The air bag is circular and measures 43 cm (16.9 in) in diameter. There was a contact evidence on the center right area of the air bag that was probably lipstick. There was no damage to the driver's air bag.

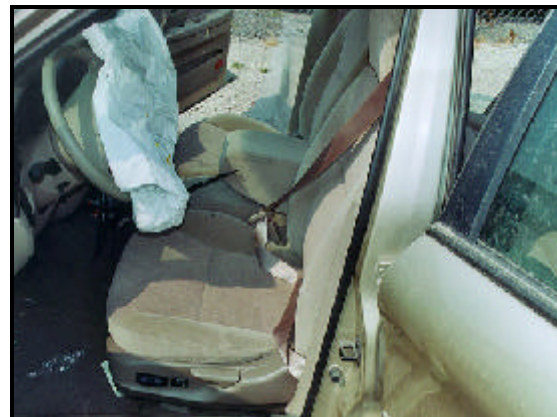
**Figure 4.** Case vehicle driver's area.

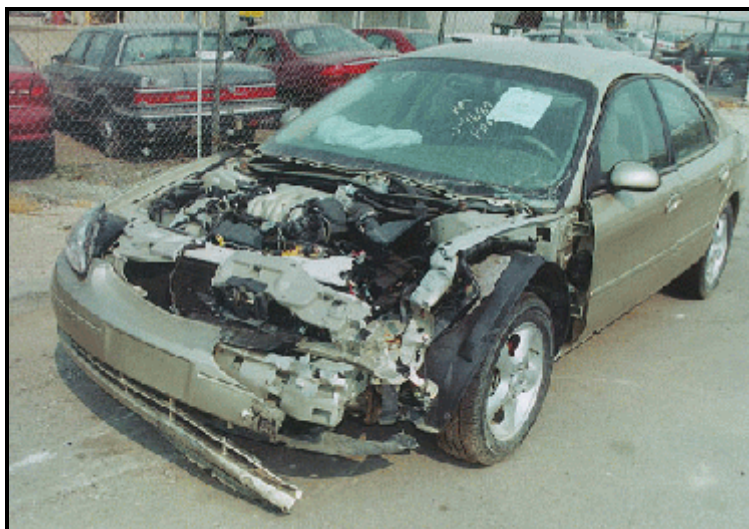
Description:	2000 Ford Taurus SE	
VIN:	1FAFP53U1YAxxxxxx	
Odometer:	19,615 km (12,189 miles)	
Engine:	6 cyl 182 ci	
Reported Defects:	None	
Cargo:	None	
Damage Description:	Moderate frontal damage. Vehicle towed from the scene. Later declared a total loss.	
CDC:	12FYEW1	
Delta V:	Total	25.2 km/h (15.7 mph)
	Longitudinal	-25.2 km/h -15.7 mph)
	Latitudinal	0 km/h (0 mph)
	Energy	25,363 joules (18,719 foot-lbs)

**Figure 6.** Front left, case vehicle

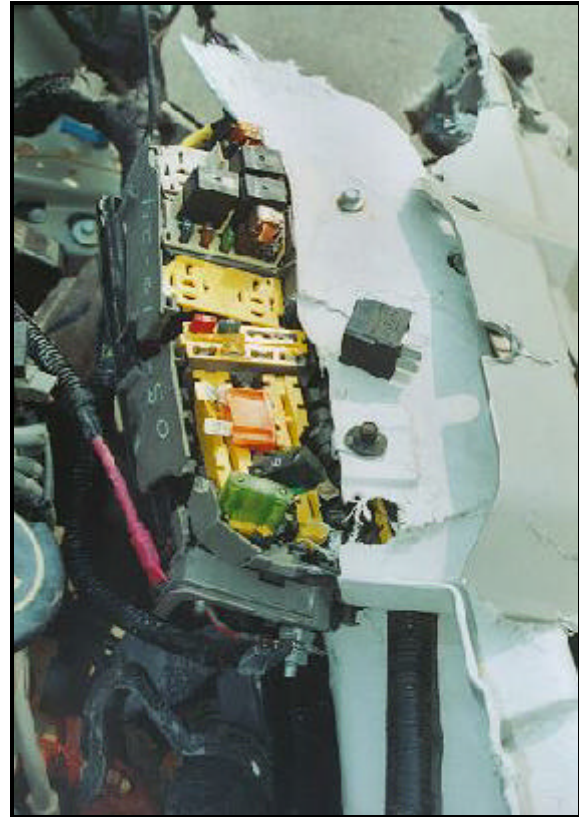
**Figure 7.** Damaged fuse block

The downloaded Electronic Data Recorder (EDR) data indicates a cumulative longitudinal  $\Delta v$  of -22.9 km/h (-14.2) at the 20 ms mark. This data is very suspect. The cumulative lateral  $\Delta v$  appears to be reasonable up until the 10 ms mark. The EDR stopped recording after 30 ms. After that point the crash pulses for both the longitudinal and lateral directions are virtually identical which is clearly impossible for this crash. The left side fuse block was damaged during the crash and may have caused the unusual data. The EDR report is included as an attachment to this report.

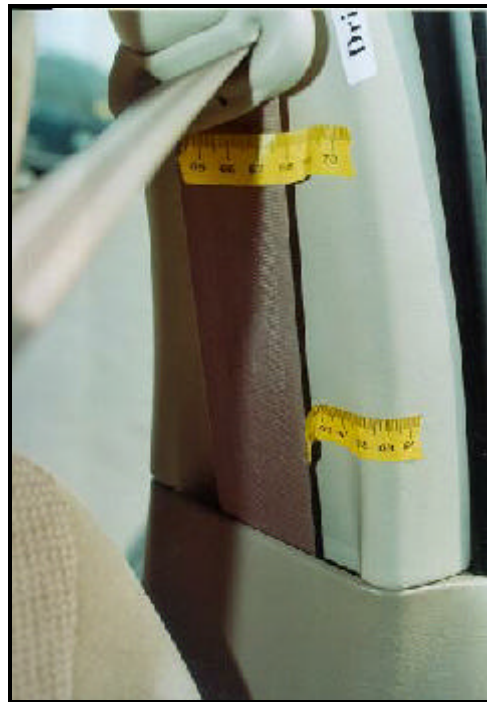
**Figure 9.** Load marks to driver's seat belt

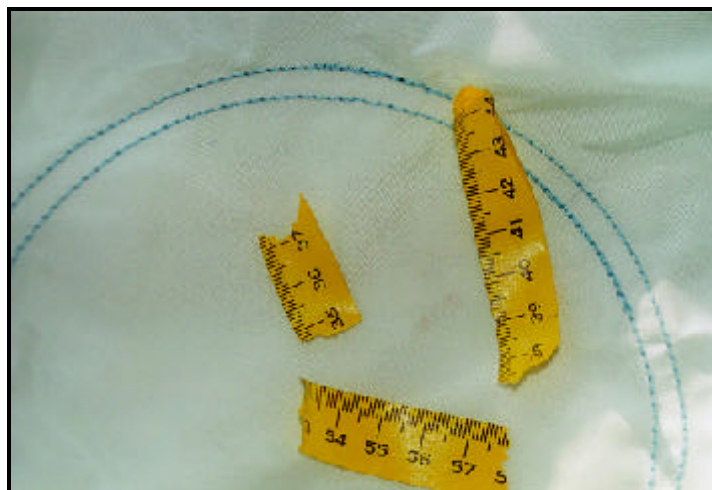
**Figure 10.** Lip stick imprint to air bag
