**VERIDIAN ON-SITE SPLIT AIR BAG DEPLOYMENT INVESTIGATION
VERIDIAN CASE NO. CA00-014
VEHICLE: 2000 HONDA ACCORD
LOCATION: VIRGINIA
CRASH DATE: MAY 2000**

Contract No.
DTNH22-94-D-07058

VERIDIAN ON-SITE SPLIT AIR BAG DEPLOYMENT INVESTIGATION
VERIDIAN CASE NO. CA00-014
VEHICLE: 2000 HONDA ACCORD EX
LOCATION: VIRGINIA
CRASH DATE: MAY 2000

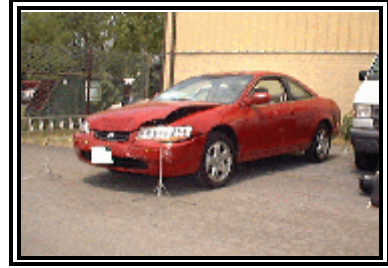
Figure 1. Frontal damage to the Honda Accord.

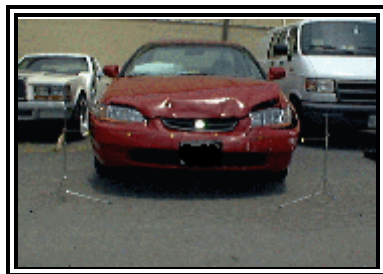
The 2000 Honda Accord sustained moderate frontal damage as a result of the intersection-type crash with the Toyota Celica. The direct contact damage (**Figure 2**) began on the bumper fascia 38.1 cm (15.0") right of center and extended 113.7 cm (44.75") to the left corner. Maximum crush was 19.7 cm (7.75") located on the bumper reinforcement bar, 12.1 cm (4.75") left of the vehicle's centerline (**Figure 3**). The frontal impact deformed the entire width of the energy absorbing frontal structure resulting in a combined induced and direct contact damage length of 153.7 cm (60.5"). The bumper fascia crushed and returned to its original form while the reinforcement bar retained the deformation pattern. Therefore, the crush profile was documented at the reinforcement bar by removing the grille and plastic filler panels. The crush profile was as follows: C1 = 3.8 cm (1.5"), C2 = 8.3 cm (3.25"), C3 = 17.1 cm (6.75"), C4 = 5.1 cm (13.0"), C5 = 3.8 cm (1.5"), C6 = 0 cm. The Collision Deformation Classification (CDC) for this frontal impact sequence was 01-FDEW-1.

Figure 2. Frontal damage to the Honda Accord.

Damaged components included the front bumper fascia, styro-foam backer material, bumper reinforcement bar, grille, hood, radiator support panel, air conditioning condenser, and the radiator.

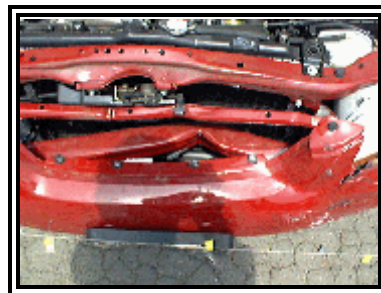
Figure 3. Maximum crush to the bumper reinforcement bar.

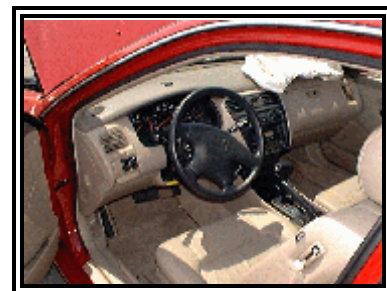
component was of sufficient magnitude to trigger the deployment of the frontal air bag system, however, only the front right air bag deployed. The front left (driver) air bag did not deploy.

The Honda Accord was equipped with a Supplemental Restraint System (SRS) that consisted of redesigned frontal air bags for the driver and right passenger positions. In addition, this vehicle was equipped with side impact air bags for the front seated positions. The Honda was involved in a frontal crash sequence which exceeded the threshold for deployment. The front right air bag deployed, however, the front left (driver) air bag failed to deploy (**Figure 4**). The crash did not warrant deployment of the side impact air bags.

Figure 4. Split deployment of the frontal air bag system.

The technician further explored the control module for stored fault codes in the history mode. There were no stored DTCs in the unit. Therefore, it was not possible to detect system malfunctions for this split deployment using this PGM tester. NHTSA's Office of Defects Investigation (ODI) will explore the possibility of further diagnostic testing of the air bag control module through Honda.

A local body shop was scheduled to repair the structural and sheet metal damage to the Honda Accord. Following this repair process, the Accord will be transported to a local Honda dealership for repair and replacement of the frontal air bag system. The insurance carrier will cover the required replacement of the deployed front right air bag module and the air bag control module. Honda will replace the non-deployed front left air bag module and the clock spring assembly under warranty. The air bag control module will be available to ODI following the repair process.

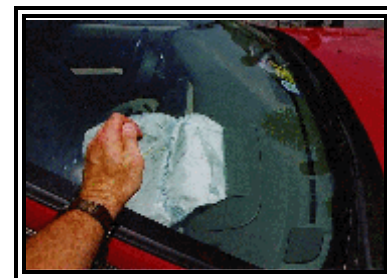
The front right air bag was a top mount module in the upper right instrument panel (**Figure 5**). The module assembly was retained in the instrument panel by a series of friction fit (push) clips. Symmetrical H-configuration cover flaps concealed the air bag membrane within the module assembly. The cover flaps were 5.1 x 25.4 cm (2.0 x 10.0") and hinged at the fore and aft segment segments.

Figure 5. Top mount and flap configuration of the front right air bag.

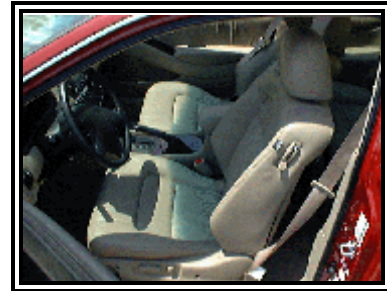
The driver of the 2000 Honda Accord was seated in a mid track position with the seat back support reclined to approximately 25 degrees and the adjustable head restraint set to the lowest position. In this position, the seat track was adjusted 10.4 cm (4.1") rearward of the full forward position and 13.7 cm (5.4") forward of the full rear position (**Figure 6**). The horizontal distance between the mid point of the front left air bag module cover and the seat back support was 55.9 cm (22.0"), thus providing the driver with a safe distance between herself and the steering assembly and the front left air bag module. The driver stated she was wearing the manual belt system although there was no loading evidence on the belt system.

Figure 6. Adjusted seat track position for the female driver.
