**VERIDIAN ON-SITE ADVANCED OCCUPANT PROTECTION
SYSTEM INVESTIGATION
VERIDIAN CASE NO. CA00-020
VEHICLE: 2000 FORD TAURUS SE
LOCATION: ALABAMA
CRASH DATE: APRIL 2000**

Contract No.
DTNH22-94-D-07058

U.S. Department of Transportation
National Highway Traffic Safety Administration
Washington, D.C. 20590

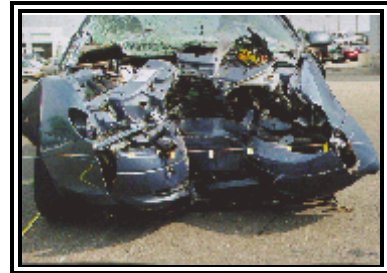
Figure 1. Frontal view of the impact damage to the 2000 Ford Taurus.

The 2000 Ford Taurus sustained severe center frontal damage that resulted from its impact sequence with the blunt end of the concrete bridge rail. Maximum crush was 94.2 cm (37.1") located on the centerline of the bumper reinforcement beam. The direct contact damage width was 32.4 cm (12.75") and was centered on the frontal plane. The severe impact deformed the full frontal width of the Taurus resulting in a combined induced and direct damage length of 77.7 cm (30.6") that extended from bumper corner-to-bumper corner. The crush profile at the level of the bumper beam was as follows: C1 = 46.0 cm (18.1"), C2 = 68.6 cm (27.0"), C3 = 93.7 cm (36.9"), C4 = 94.2 cm (37.1"), C5 = 75.4 cm (29.7"), C6 = 41.9 cm (16.5"). The wheelbases was reduced in length by 20.5 cm (8.1") on the right and 23.1 cm (9.1") on the right side. The Collision Deformation Classification (CDC) for the bridge rail impact was 12-FCEN-4.

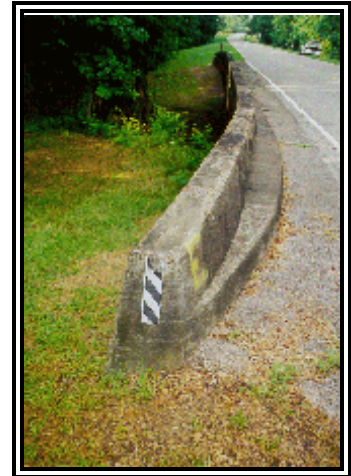
At the crash site, a concrete bridge railing system paralleled both edges of the parkway. The struck bridge rail (**Figure 2**) was formed with an integral 20.3 cm (8.0") barrier curb that was located 1.0 m (3.3') outboard of the edge line. The curb transitioned to a horizontal surface of 35.6 cm (14.0") in width. The vertical aspect of the railing was 66 cm (26") in height, 30.5 cm (12.0") in width at the top surface and 50.8 cm (20.0") wide at the base. The struck face of the rail flared outboard of the travel lanes and was located 2.1 m (6.9') east of the edge line. There were no barriers protecting the flared end of the bridge rail from southbound traffic.

Figure 2. Struck concrete bridge railing.

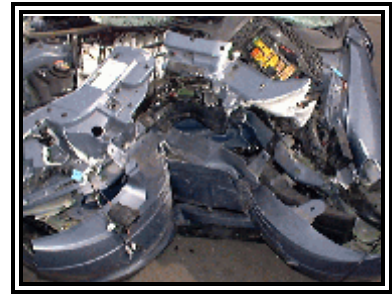
The center frontal area of the Ford Taurus impacted the blunt end of the concrete bridge rail at a WinSMASH computed speed of 65.6 km/h (40.8 mph). The front bumper crushed to a maximum residual depth of 94.2 cm (37.1") (**Figure 3**). No damage occurred to the concrete bridge rail. The Taurus rebounded from the barrier impact and rotated approximately 45 degrees in a CW direction prior to coming to rest on the grassy area east of the bridge. The damage algorithm of the WinSMASH program computed velocity change of 68.9 km/h (42.8 mph) with a longitudinal component of -68.9 (-42.8 mph). As a result of the impact, the front seat belt buckle pretensioners fired, however, the frontal air bags did not deploy.

Figure 3. Rearward crush to the front bumper.

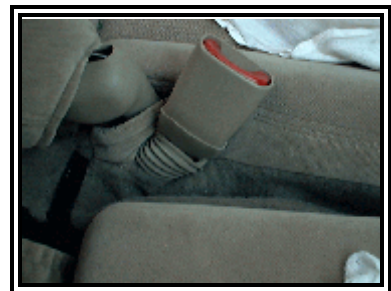
Figure 4. Driver side fired pretensioner.

The driver's side pretensioner fired at impact (**Figure 4**). Based on a post-crash measurement, the pretensioner piston traveled 60.0 mm (2.375"), resulting in 47.6 mm (1.875") of clearance between the end of the piston and the end of the barrel. The driver loaded the belt webbing which produced an abrasion to the plastic surface of the D-ring. Rescue personnel cut the shoulder belt webbing which retracted into the B-pillar. Approximately 162.6 cm (64.0") of belt length remained which extended from the lower anchorage to the cut point. The majority of the belt webbing was blood stained. The area of the belt webbing that extended over the driver's chest contained fragments of tissue and fabric transfers. This evidence pattern was located 86-102 cm (34-40") above the lower anchor point. An additional area of transfer was located 112-120.0 cm (44-47.25") on the outboard aspect of the webbing, the side away from the driver's chest.

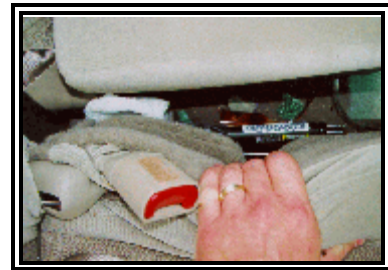
The front right passenger was properly restrained by the manual belt system. At impact, the pretensioner fired (**Figure 5**). The post-crash measurement of the pretensioner was 44.5 mm (1.75") which equated to 63.5 mm (2.5") of travel of the piston within the barrel. Her loading against the belt webbing resulted in witness marks (abrasions) to the seat trim, D-ring, and the belt webbing.

Figure 5. Passenger side fired pretensioner.

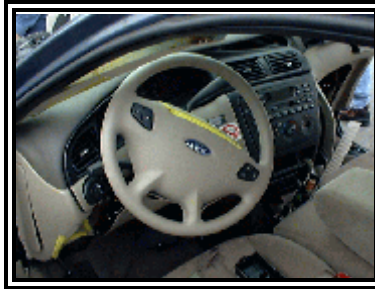
The 2000 Ford Taurus was equipped with an Advanced Occupant Protection System (AOPS) for the driver and front right passenger positions. The system consisted of dual stage frontal air bags, a driver's seat track positioning sensor, seat belt buckle pretensioners, seat belt retractor load limiters, and a Restraints Control Module (RCM) with event data recording capabilities (**Figure 6**). The RCM measures the severity of the crash and deploys the appropriate safety system (pretensioner and/or air bag) and level of air bag deployment. In addition to the RCM, the Taurus was equipped with a center front crash sensor that was mounted to the top aspect of the upper radiator support panel. Although this crash was an above threshold crash for air bag deployment, the frontal air bags did not deploy (**Figures 7 and 8**).

Figure 7. Non-deployment of driver air bag.

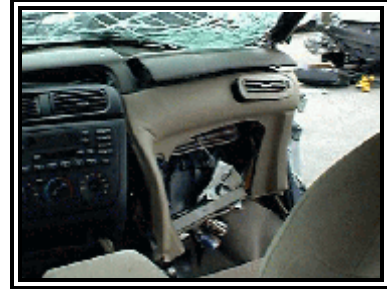
Figure 8. Non-deployment of front right air bag.

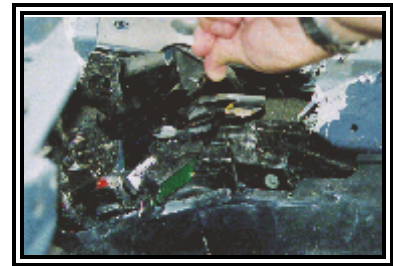
The center front crash sensor was mounted within the crush zone of the vehicle and was destroyed by the severe frontal damage (**Figure 9**). The RCM was mounted on the top aspect of the center tunnel, directly under the mid instrument panel. Although the floor was damaged surrounding the RCM location, the RCM was not damaged. The RCM was identified by Serial No. 212025280019 and was manufactured on 01/15/2000. The Model No. of the RCM was YF1A014B321-AC. During the on-site investigation, the RCM was removed from the vehicle by a Ford engineer. The three mounting bolts were properly installed with measured torque values of 108 in/lbs.

Figure 9. Damaged center front crash sensor.

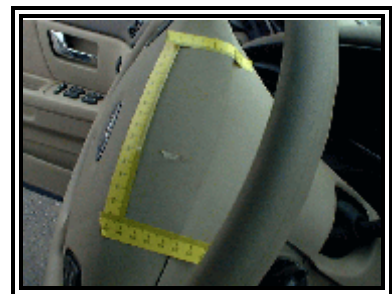
Although the manual belt system restrained the driver's torso and prevented contact with the steering assembly, his head continued forward in flexion mode, jack-knifing over the belt system. His facial and forehead area impacted the top aspect of the steering wheel hub/air bag module cover (**Figure 10**). This contact was evidenced by tissue transfers. As a result of this facial impact, the driver sustained unspecified blunt force trauma of the head and face. In addition to the tissue transfers, his head impact fractured the alloy shear capsule brackets as the load was transmitted vertically to the steering assembly. There was no deformation of the steering wheel rim.

Figure 10. Driver contact evidence on steering wheel hub/air bag module cover.
