**VERIDIAN REMOTE REDESIGNED AIR BAG RELATED CHILD PASSENGER  
FATALITY INVESTIGATION  
SCI TECHNICAL SUMMARY REPORT**

**VERIDIAN CASE NO. CA00-026**

**VEHICLE - 1999 CHEVROLET METRO**

**CRASH DATE - SEPTEMBER 1999**

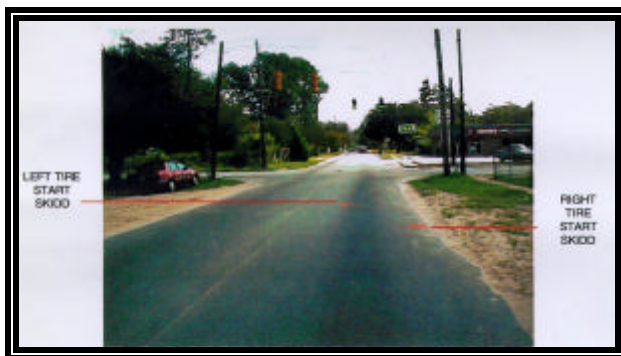
**Figure 2. Eastbound approach for the Chevrolet Metro with police documented pre-impact skid marks**

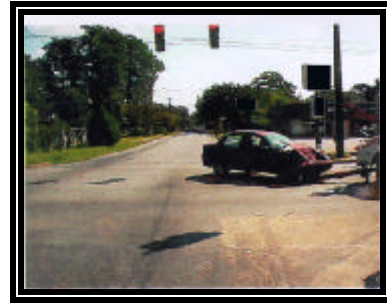
**Figure 4. Eastbound view showing final rest of the Chevrolet Metro**

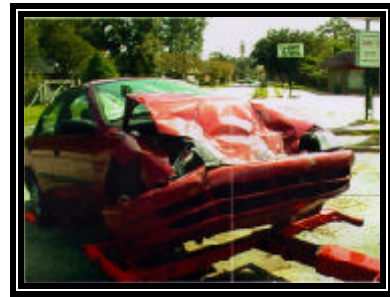
The 1999 Chevrolet Metro sustained moderate damage as a result of the impact with the Jeep Cherokee. The direct contact damage began approximately 35 cm (12") to the left of the centerline and extended laterally to the right bumper corner (**Figure 5**). The combined direct and induced damage involved the entire frontal plane of the vehicle. The bumper fascia was fractured and crushed rearward on the right corner from direct contact, and was separated from the vehicle on the right side. The maximum crush at the bumper level was located at the right bumper corner at C6 and was estimated to be 30 cm (12"). The right front fender was displaced rearward against the right front wheel (**Figure 6**). The right head lamp assembly was fractured and displaced rearward. The leading edge of the hood was crushed rearward and sustained abrasions from the direct contact with the Cherokee. The hood was also buckled rearward at the designated fold points. The Collision Deformation Classification (CDC) for the impact with the Cherokee was 11-FDEW-2. Six crush measurements were estimated at the level of the bumper and were as follows: C1 = 5 cm (2"), C2 = 10 cm (4"), C3 = 15 cm (6"), C4 = 20 cm (8"), C5 = 25 cm (10"), C6 = 30 cm (12").

**Figure 5. Frontal damage to the Chevrolet Metro**

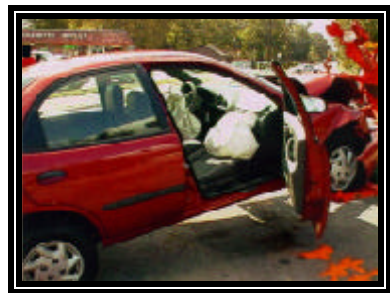
**Figure 6. Right side view of the frontal damage**

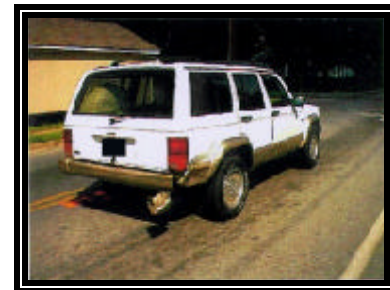
The 1993 Jeep Cherokee sustained minor damage as a result of the impact with the Chevrolet Metro. The direct contact damage was concentrated on the bottom aspect of the right rear quarter panel (**Figure 7**). The direct damage began on the lower edge of the quarter panel, aft of the right rear wheel and extended rearward approximately 76 cm (30") to the rear right bumper corner. The combined direct and induced damage began above the rear aspect of the right rear wheel and extended approximately 80 cm (31") rearward to the rear bumper. The maximum crush was approximately 21 cm (8"), and located at C3, approximately 30 cm (12") forward of the rear bumper. The rear right bumper corner fascia was displaced downward and laterally. The CDC for this impact to the Cherokee was 02-RBEW-2. Six crush measurements were estimated from the police photographs and were as follows: C1 = 5 cm (2"), C2 = 10 cm (4"), C3 = 21 cm (8") C4 = 18 cm (7"), C5 = 8 cm (3"), C6 = 0 cm.

**Figure 7. Right rear damage to the Jeep Cherokee**

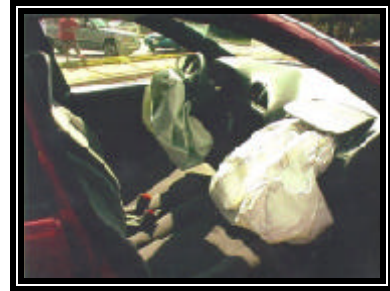
The 1999 Chevrolet Metro was equipped with redesigned air bags for the driver and front right passenger positions (**Figure 8**) that deployed as a result of the impact with the Jeep Cherokee. The impact sensor was centered on the frontal plane and located near the hood latch above the grille. The redesigned driver's air bag was housed in the center of the steering wheel with symmetrical H-configuration module cover flaps.

**Figure 8. Deployed redesigned frontal air bags in the Chevrolet Metro**

The redesigned front right passenger's air bag deployed from top-mounted module with a single cover flap design hinged at the forward aspect. The cover flap was rectangular in shape. There did not appear to be any damage to the air bag or module cover flap in the police photographs.
