**ADVANCED OCCUPANT PROTECTION SYSTEM STUDY (AOPSS)**

**VERIDIAN CASE NO. CA00-035**

**VEHICLE - 2000 FORD TAURUS LX**

**LOCATION - STATE OF NEW JERSEY**

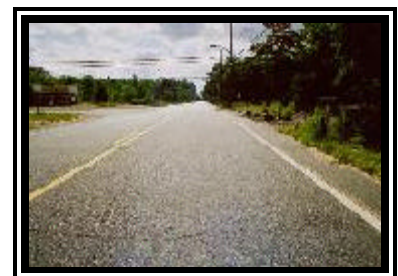
**Figure 1. Westbound approach to the crash site.**

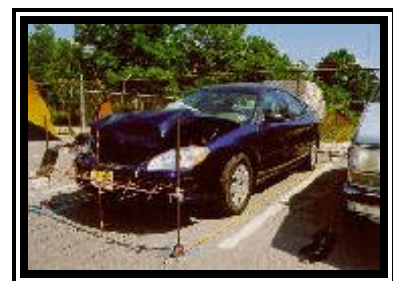
The Ford Taurus sustained moderate frontal damage as a result of the impact with the Chevrolet pickup truck (**Figure 2**). The direct contact damage began 2.0 cm (0.8 in) to the left of the front right bumper corner and extended 108.0 cm (42.5 in) inboard. The impact deformed the full frontal width resulting in a combined direct and induced damage length (Field L) of 142.0 cm (55.9 in). Six crush measurements were documented at the level of the bumper:

**Figure 2. Frontal damage to the 2000 Ford Taurus LX.**

C1= 0 cm, C2= 0 cm, C3= 5.0 cm (2.0 in), C4= 7.0 cm (2.8 in), C5= 15.0 cm (5.9 in), C6= 2.0 cm (0.8 in). A secondary profile was obtained 14.0 cm (5.5 in) above the level of the bumper to capture the underride damage resulting in an *averaged profile* of: C1= 0 cm, C2= 0 cm, C3= 12.0 cm (4.7 in), C4= 14.0 cm (5.5 in), C5= 15.0 cm (5.9 in), C6= 2.0 cm (0.8 in). The Collision Deformation Classification (CDC) for this impact to the Ford was 12-FDEW-1 with a principal direction of force of 0 degrees. The grille separated intact while the right headlight fractured during the collision sequence. The hood was deformed up and rearward from the underride. Reduction in the left side wheelbase measured 2.0 cm (0.8 in). The windshield sustained no damage from exterior impact forces.

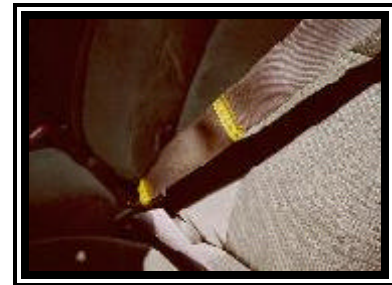
The interior of the Ford Taurus consisted of a six passenger seating configuration with front bucket and rear bench seats. The front left 3-point manual restraint consisted of a continuous loop belt webbing with a sliding latchplate and dual mode retractors (inertial lock/belt sensitive). Loading marks were identified on the shoulder portion of the webbing which supports usage (**Figure 3**). The front right 3-point manual lap and shoulder belt system consisted of a continuous loop belt webbing with a sliding latchplate and a retractor equipped with an inertial and switchable lock mechanism. The center front seat (“flip and fold” console) was equipped with a 2-point manual lap belt. The rear seating positions were equipped with 3-point manual lap and shoulder belt systems which consisted of continuous loop belt webbings with sliding latchplates that retracted into inertial sensitive and switchable locking retractors.

**Figure 3. Loading marks to the front left shoulder belt webbing.**

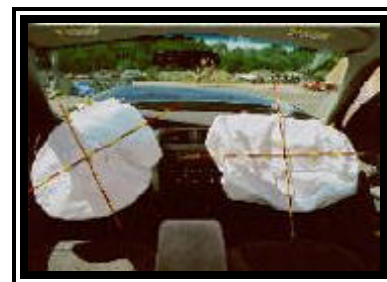
The Ford Taurus was equipped with dual stage frontal air bags for the driver and front right passenger positions. The air bags had deployed as a result of the crash (**Figure 4**). The driver air bag was identified by the following part number: TXM000331713 with a bar coded lot number of: P5206000-00D. The air bag was housed in the center of the steering wheel with a horizontally oriented flap tear seam (H-configuration). The flaps were nearly symmetrical in shape as the upper flap measured 17.5 cm (6.9 in) in width and 6.5 cm (2.6 in) in height while the lower flap measured 17.5 cm (6.9 in) in width and 5.0 cm (2.0 in) in height. No contact evidence was identified on the air bag or exterior surface of the module cover flaps. The diameter of the driver air bag measured 58.5 cm (23.0 in) in its deflated state (**Figure 5**). The bag was tethered by two internal straps and vented by two ports located at the 11 o'clock and 1 o'clock sectors on the rear aspect of the air bag.

**Figure 4. 2000 Ford Taurus LX deployed frontal air bags.**

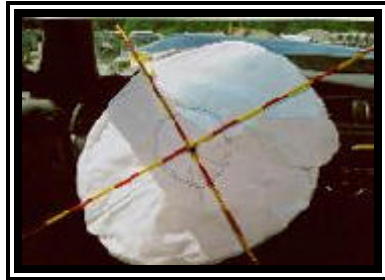
**Figure 5. 2000 Ford Taurus LX deployed redesigned driver air bag.**

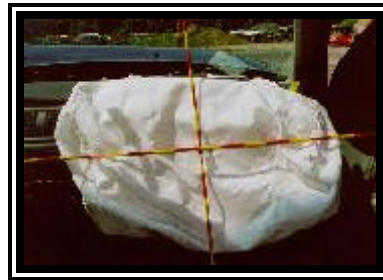
The front right passenger air bag deployed from the right top instrument panel area with a single cover flap design hinged at the forward aspect. The cover flap was somewhat rectangular in shape and measured 28.0 cm (11.0 in) in width and 9.0 cm (3.5 in) in height along the left edge of the flap and 13.0 cm (5.1 in) in height along the right edge. Multiple black vinyl transfers were noted to the right upper quadrant of the air bag face from expansion within the module. In addition, passenger air bag contact to the right windshield produced the noted scuff mark to the mid-windshield area. The passenger air bag measured 52.0 cm (20.5 in) in width and 53.0 cm (20.9 in) in height in its deflated state (**Figure 6**). The bag was vented by two ports located at the 10 o'clock and 2 o'clock sectors on the side aspect of the air bag. No internal tether straps were present.

**Figure 6. 2000 Ford Taurus LX deployed redesigned passenger air bag.**

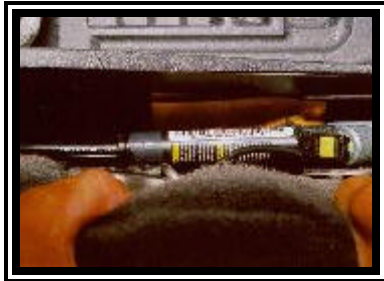
**Figure 7. Front left restraint activated belt pretensioner.**

The driver's restraint system also included a buckle pretensioner mounted longitudinally alongside the seat cushion (**Figure 7**). The deployment of this pretensioner resulted in 7.0 cm (2.8 in) of piston movement. The piston pulls a cable which lowers the height of the buckle assembly, reducing slack in both the lap and shoulder belt webbing.

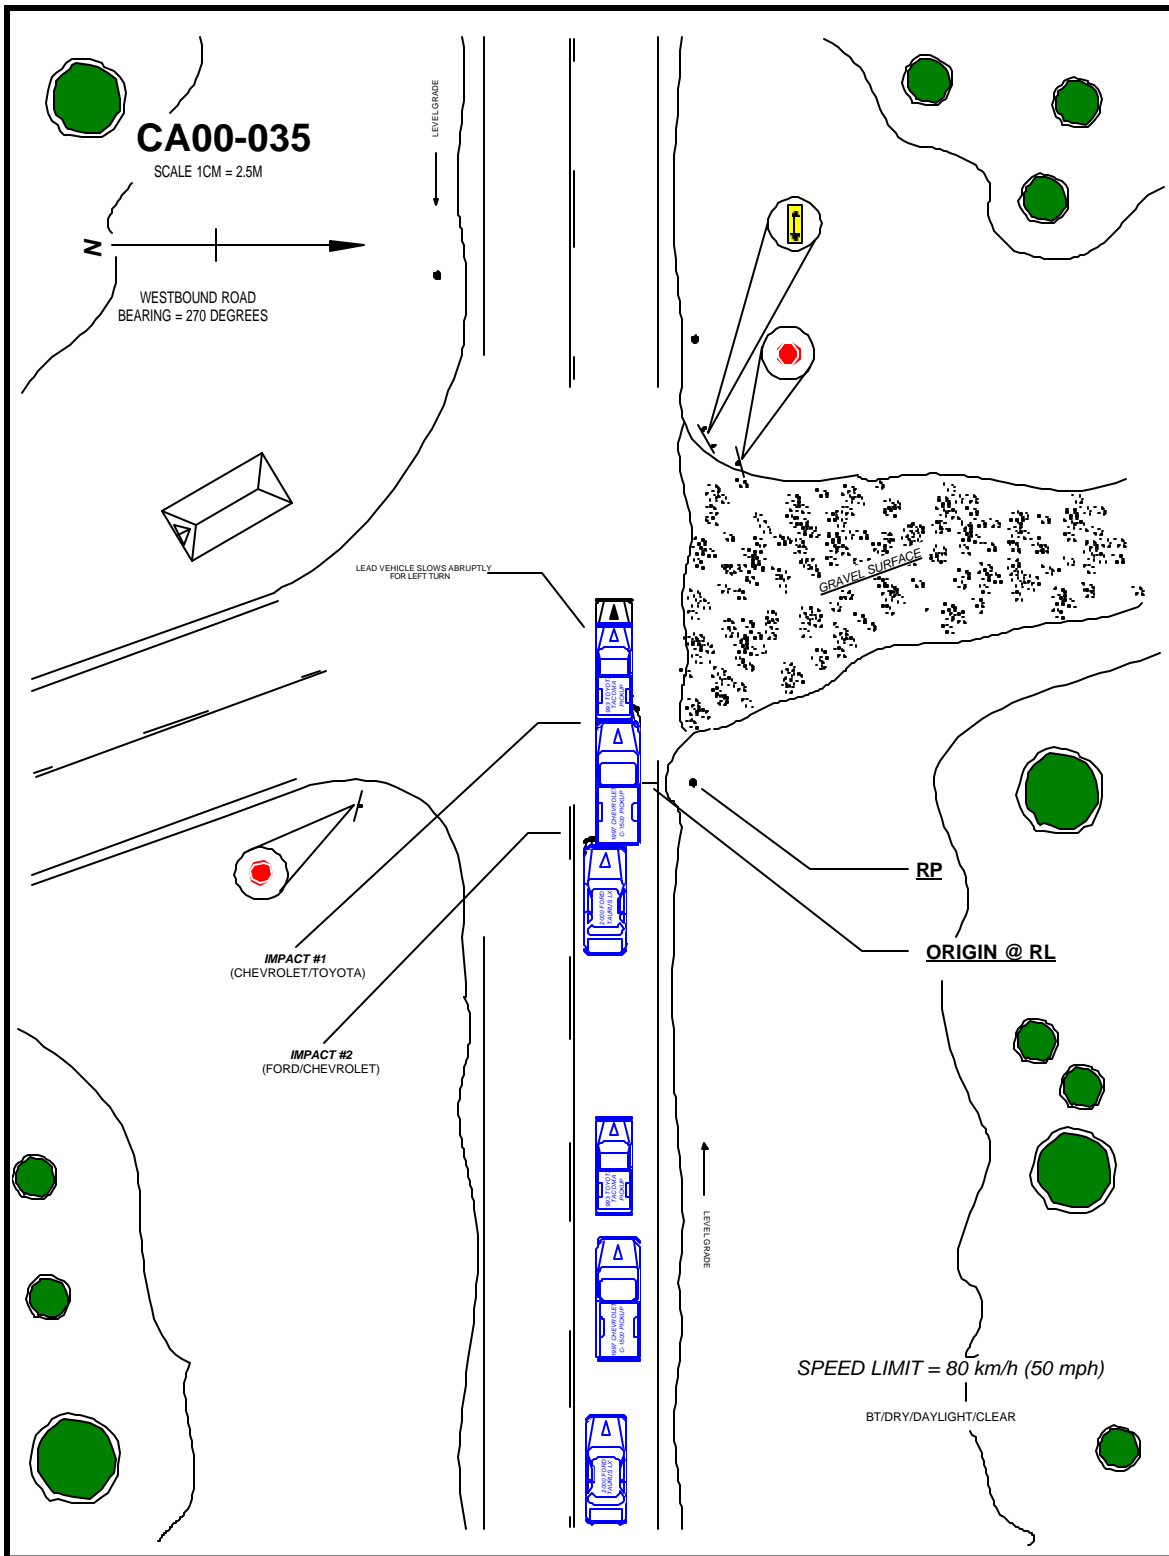
Figure 8. Scene Diagram.

This three vehicle crash occurred during the afternoon hours of August, 2000. At the time of the crash, it was daylight with no adverse conditions as the roads were dry. The crash occurred in the westbound lane of a straight/level 4-leg rural intersection (see **Figure 8 - page 6**). The east/westbound lanes consisted of two asphalt travel lanes which were bordered by narrow paved shoulders. Traffic control through the intersection was controlled by stop signs for north/southbound traffic. The posted speed limit at the crash site was 80 km/h (50 mph).

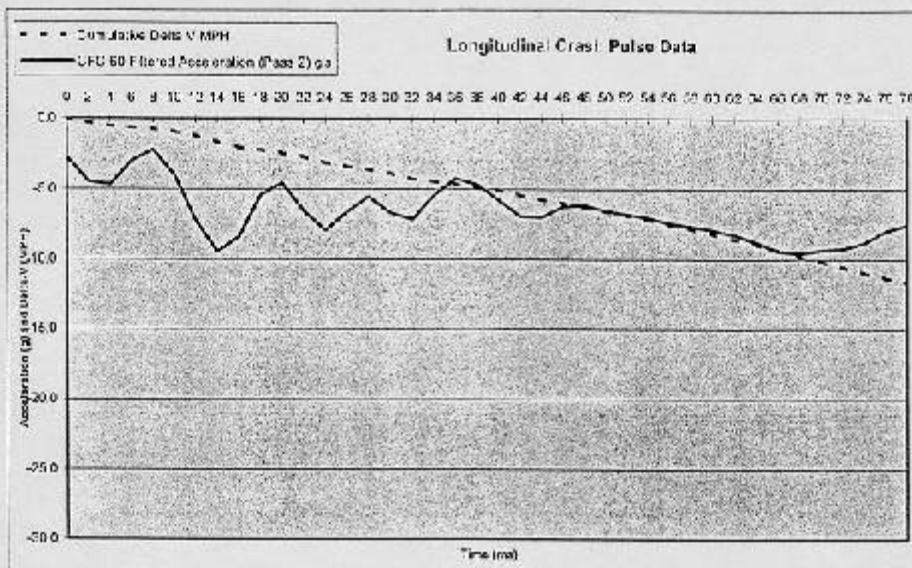
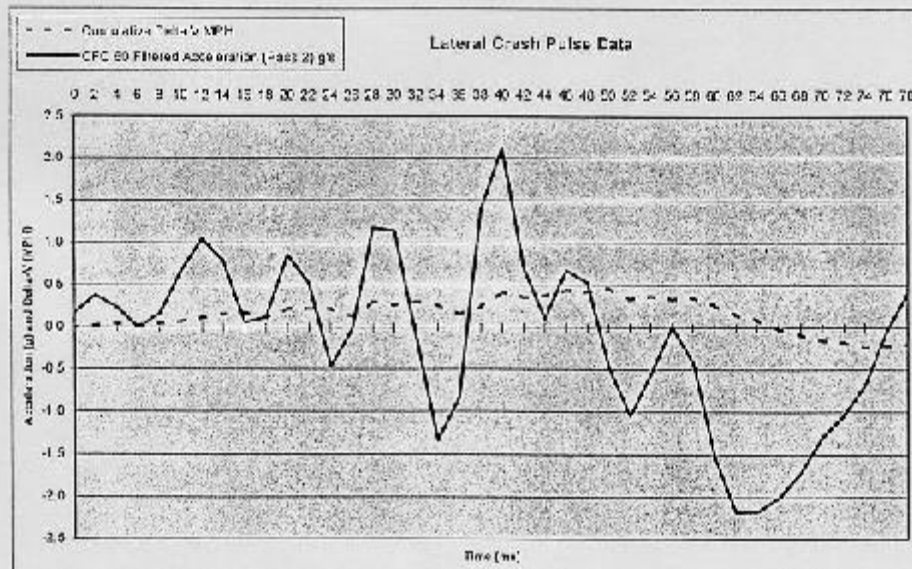
Figure 10. 2000 Ford Taurus LX EDR Report.

Time (ms)	0	10	20	30	40	50	60	70	78
Delta-V (MPH)	-9.2	-9.9	-1.5	-1.8	-5.1	-6.6	-11.2	-16.1	-11.6

Time (ms)	0	10	20	30	40	50	60	70	78
Delta-V (MPH)	0.0	0.3	1.2	1.3	0.4	1.5	0.3	-0.2	-0.2
