**VERIDIAN ON-SITE AIR BAG RELATED
CHILD PASSENGER FATALITY INVESTIGATION**

VERIDIAN CASE NO. CA00-036

VEHICLE - 1995 PLYMOUTH VOYAGER

CRASH DATE - MAY, 2000

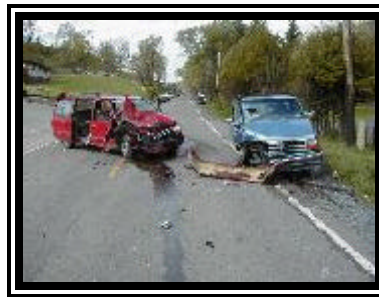
As the vehicles crushed to maximum engagement, the Plymouth rotated 156 degrees clockwise and came to rest over the centerline 2.6 meters (8.5 feet) south of the point of impact facing southeast. The Ford rotated 22 degrees clockwise and traveled 10.0 meters (32.8 feet) in a southeasterly direction coming to rest on the east shoulder facing south (**Figure 4**).

Figure 4. Police photo north of the crash site.

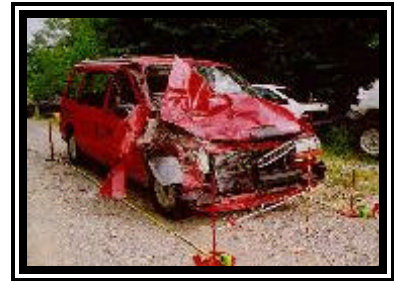
The 1995 Plymouth Voyager sustained moderate frontal damage as a result of the impact with the Ford Ranger pickup truck (**Figure 5**). The direct contact damage began at the front right bumper corner and extended 70.0 cm (27.6 in) inboard. The impact deformed the full frontal width resulting in a combined direct and induced damage length (Field L) of 145.0 cm (57.1 in). Six crush measurements were documented at the level of the reinforcement bar (*bumper fascia separation*): C1= 0 cm, C2= 8.0 cm (3.1 in), C3= 15.0 cm (5.9 in), C4= 33.0 cm (13.0 in), C5= 36.0 cm (14.2 in), C6= 32.0 cm (12.6 in). The Collision Deformation Classification (CDC) for this impact to the Plymouth was 01-FZEW-2 with a principal direction of force of (+) 30 degrees. The hood was displaced up and rearward from the impact force. The grille and right headlight assembly fractured and separated from the vehicle during the crash sequence. The right fender was deformed rearward which restricted the right front wheel/tire (not deflated). This damage pattern also induced buckling along the right A-pillar, roof, door (restricted) and disintegrated the right front window glazing. In addition, hair strands were documented to the right front (lower) window frame approximately 6.4 cm (2.5 in) aft of the side mirror. Along this area of the exterior door panel, a blood trail began which extended to the lower sill (*with blood pooling noted to the pavement in the police photographs*). Pry marks were also noted to the right front door assembly sustained during post-impact activities. Reduction in the right side wheelbase measured 9.0 cm (3.5 in). The entire windshield was fractured from exterior impact forces and out-of-place along the right portion from (interior) occupant contact and the passenger air bag. The symmetry of the fracture pattern along the upper right portion of the windshield suggests an inferior application of the bonding agent during repairs subsequent to the vehicle's purchase. Hair strands were also documented along the *exterior portion* of the right upper windshield area (with outward bowing) indicative of an occupant ejection.

Figure 5. Frontal damage to the 1995 Plymouth Voyager.

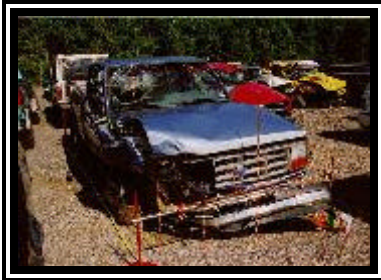
Figure 6. Frontal damage to the 1991 Ford Ranger XLT 4x4 pickup truck.

The 1991 Ford Ranger XLT 4x4 pickup truck sustained moderate frontal damage as a result of the impact with the Plymouth Voyager (**Figure 6**). The direct contact damage began at the front right bumper corner and extended 55.0 cm (21.7 in) inboard. The impact deformed the full frontal width resulting in a combined direct and induced damage length (Field L) of 139.0 cm (54.7 in). Six crush measurements were documented at the level of the bumper: C1= 0 cm, C2= 0 cm, C3= 0 cm, C4= 5.0 cm (2.0 in), C5= 11.0 cm (4.3 in), C6= 36.0 cm (14.2 in). The Collision Deformation Classification (CDC) for this impact to the Ford was 01-FZEW-2 with a principal direction of force of (+)20 degrees. The leading edge of the right

hood was displaced up and rearward from the impact force. The right fender was deformed rearward which restricted/deflated the right front wheel/tire. Reduction in the right side wheelbase measured 32.5 cm (12.8 in). Elongation of the left side wheelbase measured 11.5 cm (4.5 in). The windshield was fractured along the right lower A-pillar area by exterior impact forces and holed at the right (centered) area by driver contact. The left front brake line was found hanging below the undercarriage and possibly disconnected from the brake caliper, however, uniform pre-impact brake marks documented at the scene suggests it was impact induced separation and not pre-existing.

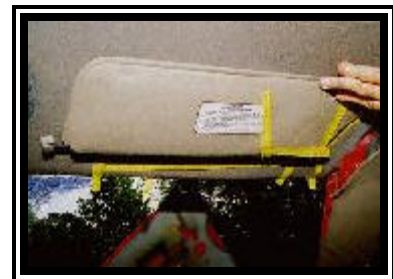
Figure 7. Contact evidence to the sunvisor and windshield header.

An indentation was documented to the right sunvisor (**Figure 7**) with the aft mirror undamaged. An associated indentation was found to the adjacent roof area. The windshield was fractured from passenger air bag interaction, indicative of an impeded/re-directed deployment pattern. The windshield was also out-of-place along the upper/lower A-pillar area, however, given the symmetry of the fracture pattern in police photos it appeared to be a substandard bonding application, contributing a partial ejection of the front right child passenger. Blood trails/pooling were noted on the front right seat back, door panel, lower window frame (*exterior and interior*) and B-pillar. The concentration of blood in these areas were indicative of the child passenger's head position post-crash. Hair strands, fluid and blood spattering were also documented along the right roof side rail. The front right passenger seat was

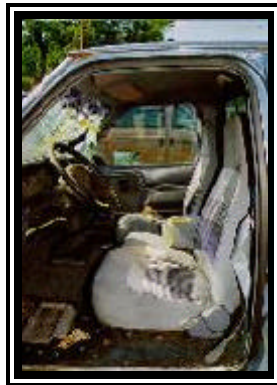
Interior damage to the Ford Ranger identified through the vehicle inspection was moderate and was attributed to occupant contact and minimal component intrusion (**Figure 8**). The vehicle's principal direction of force and associated (+)18 degree sideslip (beta) angle contributed to a resultant occupant kinematic pattern towards the front right passenger space. Deformation to the lower portion of the steering wheel rim measured 2.0 cm (0.8 in). The left portion of the steering column cover panel was fractured. The center armrest was displaced to the right. The gearshift knob separated from the floor-mounted transmission gearshift shaft which was also minimally deformed to the right. The rear view mirror was fractured and displaced to the right with an associated fracture site identified to the mid-upper windshield area. The right mid-windshield area was holed by driver contact with hair strands surrounding the fracture site (**Figure 9**). Scuff marks were documented on the right mid-instrument panel area. Longitudinal intrusions into the front right passenger space involved 17.0 cm (12.2 in) of toe pan and 3.0 cm (1.2 in) of instrument panel intrusion. Vertical intrusions into the passenger space involved 5.0 cm (2.0 in) of floor and 8.0 cm (2.2 in) of seat cushion intrusion.

Figure 8. Interior view of the driver space.

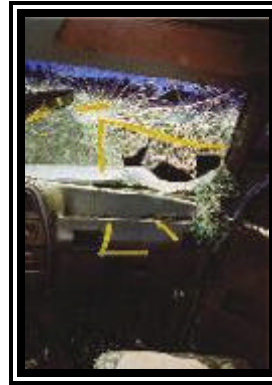
Figure 9. Contact evidence to the front right passenger space.

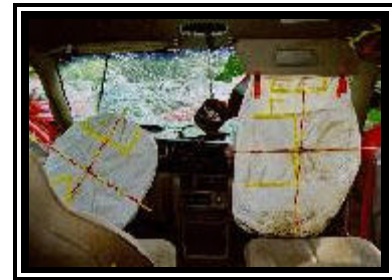
The 1995 Plymouth Voyager was equipped with frontal air bags for the driver and front right passenger positions. The air bags had deployed as a result of the crash (**Figure 10**). The driver air bag was identified by the part number: PUT11446-02E with a serial number of: TAC319H24236 and housed in the center of the steering wheel with a horizontally oriented flap tear seam (H-configuration). The flaps were nearly symmetrical in shape as the upper flap measured 17.3 cm (6.8 in) in width and 6.2 cm (2.4 in) in height while the lower flap measured 17.3 cm (6.8 in) in width and 6.9 cm (2.7 in) in height. A small scuff mark was documented along the right lower portion (exterior surface) of the upper module cover flap. The diameter of the driver air bag measured 60.2 cm (23.7 in) in its deflated state (**Figure 11**). Makeup transfers were identified across the upper portion of the air bag face along with multiple black vinyl transfers to the rear lower section of the air bag from expansion within the module. Blood spattering was also noted across the lower portion of the air bag face. The bag was vented by two ports located at the 11 o'clock and 1 o'clock sectors on the rear aspect of the air bag. No internal tether straps were present.

Figure 10. 1995 Plymouth Voyager deployed frontal air bags.

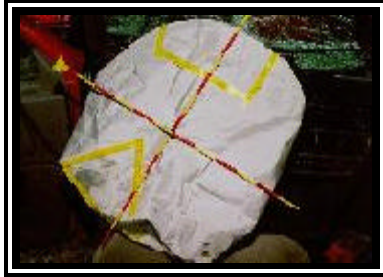
Figure 11. 1995 Plymouth Voyager deployed driver air bag.

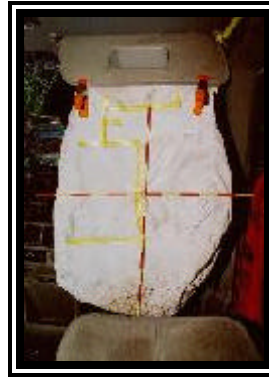
The front right passenger air bag deployed from the right top instrument panel area with a single cover flap design hinged at the forward aspect. The cover flap was rectangular in shape and measured 32.2 cm (12.7 in) in width and 14.5 cm (5.7 in) in height. No contact evidence was identified on the exterior surface of the cover flap or surrounding instrument panel area. The passenger air bag measured 49.0 cm (19.3 in) in width and 77.5 cm (30.5 in) in height in its deflated state (**Figure 12**). The bag was tethered by two internal straps. No vent ports were present. Although heavily stained by dirt and mold from exposure to the environment post-crash, scuff marks and skin oil were documented along the upper left quadrant of the air bag face along with light colored horizontal fabric transfers to the left mid-portion. Heavy concentrations of blood were noted to the right lower portion of the air bag (front/back) indicative of the child's final rest position post-crash. The top portion of the air bag was abraded from engagement against the windshield.

Figure 12. 1995 Plymouth Voyager deployed passenger air bag.

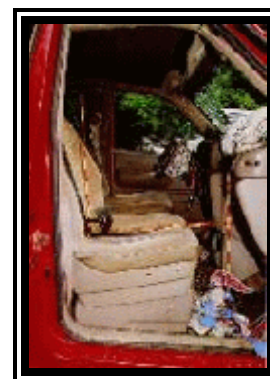
Figure 13. Interior view of the front right passenger space.

The air bag membrane continued to expand which vertically displaced the unrestrained child into the sunvisor and windshield header (**Figure 13**) with subsequent partial ejection of the head through the right upper windshield area. Contact to the windshield header resulted in a contusion behind the left ear which was evidenced by the location of the injury relative to the scuffs and hair strands documented on this component. Partial ejection of the head was evidenced by the hair strands identified on the exterior surface of the windshield header and symmetrical fracture pattern of the surrounding windshield area, attributed to a weak bonding application. In addition, the interaction with the expanding air bag re-directed the proper deployment path of the membrane and produced the noted abrasions to the top section of the passenger air bag.

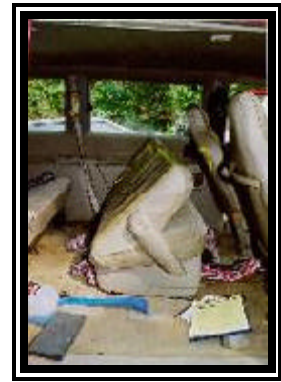
determined by the trajectory of the child relative to the extensive loading evidence to the second row seat back and lack of significant associated injury to be expected from being “sandwiched” while secured in the restraint harness (**Figure 14**). At impact, the child initiated a forward and slightly lateral trajectory in response to the 1 o’clock impact force and loaded the driver seat back which resulted in contusions to the posterior forearms and lateral aspect of the left lower leg. This trajectory was evidenced by the indentations and scuff marks documented to this component. The child occupant exited the vehicle under her own power through the right rear door and was subsequently transported two hours later by private vehicle to a local hospital for treatment and released.

Figure 14. Contact evidence to the middle and front seat backs.
