**VERIDIAN ON-SITE AIR BAG NON-DEPLOYMENT  
FATALITY INVESTIGATION  
VERIDIAN CASE NO. CA00-037  
VEHICLE: 2001 CADILLAC DeVILLE  
LOCATION: LOUISIANA  
CRASH DATE: SEPTEMBER 2000**

14. <i>Sponsoring Agency Code</i>	
15. <i>Supplementary Notes</i> On-site investigation of an off-set, head-on crash that killed both drivers. The frontal air bag system in a 2001 Cadillac DeVille failed to deploy.

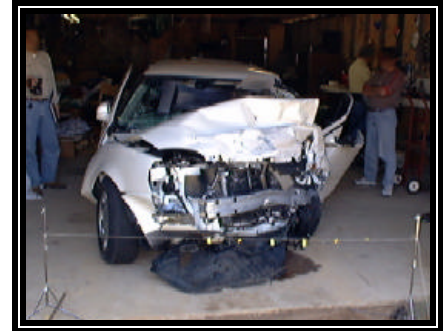
**Figure 1. Frontal damage to the 2001 Cadillac.**

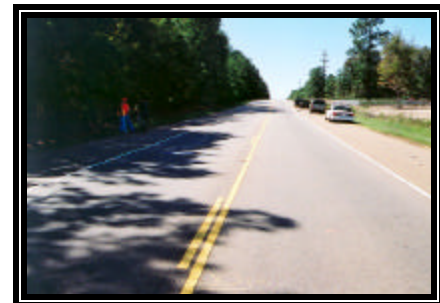
The crash occurred on a state route during daylight hours. In the vicinity of the crash site (**Figure 2**), the roadway was 7.1 m (23.3') in width and delineated into two travel lanes by a solid and broken centerline that prohibited passing in the southbound direction. The asphalt travel lanes were straight with a 1.5 percent grade, positive to the south. The weather conditions were clear and dry, with dry environmental surfaces. The travel lanes were bordered by 3.2 m (10.5') wide asphalt shoulders. The east shoulder was bordered by a 3.7 m (12.1') wide grassy area that had a gradual negative slope that transitioned into a shallow, irregular 1.1 m (3.6') wide drainage ditch that was approximately 20.3 cm (8.0") in depth. A wooded area of mature trees bordered the ditch. The posted speed limit was 89 km/h (55 mph).

**Figure 2. View of the crash site.**

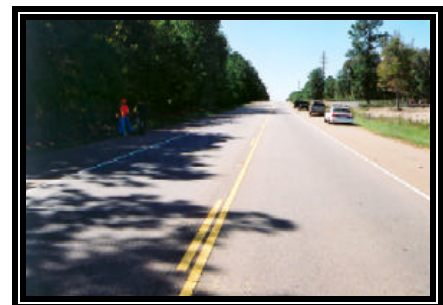
**Figure 3. Trajectory of the Cadillac DeVille.**

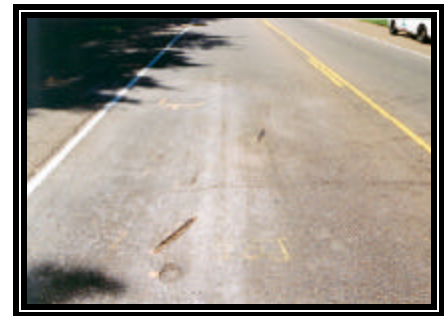
The Cadillac impacted the Nissan pickup truck in the northbound travel lane (**Figure 4**) in a head-on, off-set configuration. Initial contact involved the front left and center areas with resultant directions of force within the 12 o'clock sector for both vehicles. The impact initially crushed the frontal structure of the Nissan and rotated the vehicle in a clockwise direction. The full frontal area of the Cadillac subsequently engaged the left front fender area of the Nissan as the vehicles crushed to maximum engagement. The Cadillac sustained 127 cm (50") of maximum crush located at the left corner of the bumper beam while the Nissan sustained 128.5 cm (50.6") of bumper crush. The damage algorithm of the WinSMASH program computed total velocity changes of 55.8 km/h (34.6 mph) for the Cadillac and 80.1 km/h (49.8 mph) for the Nissan. The specific longitudinal and lateral components were -55.0 km/h (-34.2 mph) and -9.7 km/h (-6.0 mph) for the Cadillac and -78.9 km/h (-49.0 mph) and 13.9 km/h (8.6 mph) for the Nissan pickup truck. Although the Cadillac was equipped with a redesigned frontal air bag system, the frontal air bags failed to deploy in this above threshold crash. It should be noted that the Cadillac's seat belt buckle pretensioners fired. The Nissan was not equipped with an air bag system.

**Figure 4. Point of impact.**

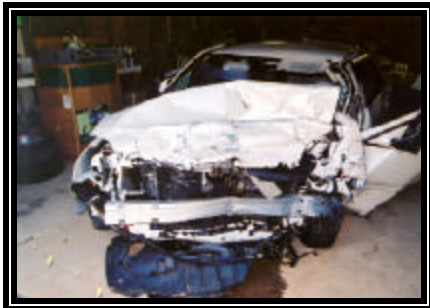
The 2001 Cadillac sustained severe frontal damage as a result of the impact with the Nissan pickup truck. The Cadillac sustained 127.0 cm (50.0") of frontal crush located at the left corner of the bumper reinforcement bar. The impact separated the bumper fascia from the vehicle, however, measurements from the fascia indicated the direct contact damage began at the right corner, 85.1 cm (33.5") right of center and extended 170.2 cm (67.0") to the left corner. The damage on the hood face began 53.8 cm (21.2") right of center and extended 108.5 cm (42.7") to the left corner. Although the direct contact damage was distributed across the entire frontal structure (**Figure 5**), the resultant damage was located primarily on the left aspect of the vehicle, supporting an initial off-set impact configuration with engagement against the left front fender of the Nissan. The damage profile was documented along the bumper fascia (**Figure 6**) that resulted in a Field L measurement of 91.4 cm (36.0"). The crush profile at the level of the reinforcement bar was as follows: C1 = 127.0 cm (50.0"), C2 = 117.2 cm (46.1"), C3 = 94.3 cm (37.1"), C4 = 66.0 cm (26.0"), C5 = 36.2 cm (14.25"), C6 = 8.4 cm (3.3"). The Collision Deformation Classification (CDC) for this impact was 12-FDEW-5.

**Figure 5. Frontal damage to the Cadillac DeVille.**

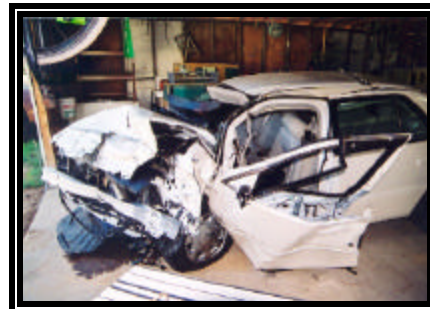
**Figure 6. Lateral view documenting the extent of frontal crush.**

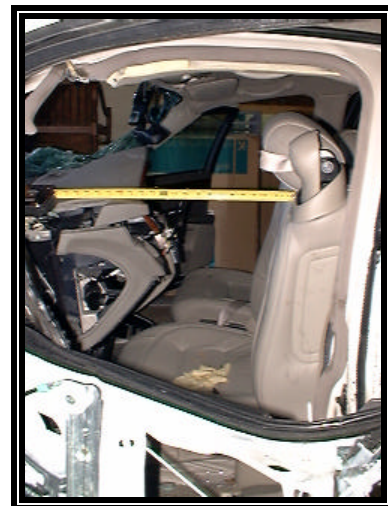
The driver loaded the manual integrated (seat mounted) 3-point lap and shoulder belt system. His loading of the belt system was evidenced by stretching of the lap belt webbing. Additionally, the seat back was deflected forward (**Figure 7**) to a post-crash measured value of (-) 1 degree forward of vertical. This seat back deflection allowed the driver to move further forward into the intruding steering assembly. His loading force was transmitted into the energy absorbing steering column as evidenced by approximately 6.0 cm (2.375") of left shear capsule displacement and 5.1 cm (2.0") of right shear bracket separation. The left side of the alloy bracket was fractured. Deformation to the steering wheel was minimal, however, rescue personnel used a chain and the hydraulic boom of the tow truck in an attempt to pull the steering column upward, away from the deceased driver. The tension of this pull fractured the mounting flange of the alloy composition steering wheel, thus separating the wheel from the column. The 12 o'clock sector of the steering wheel rim was deformed vertically upward.

**Figure 7. Forward deflection of seat back and rearward intrusion of the steering column and instrument panel.**

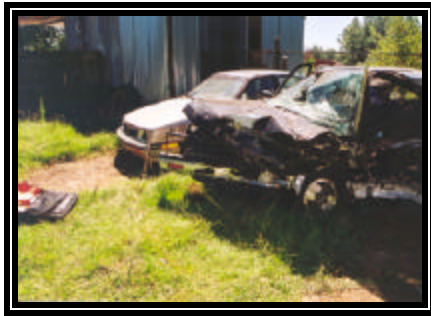
Cadillac. The direct contact damage on the front bumper began 7.6 cm (3.0") right of center and extended 76.2 cm (30.0") to the front left bumper corner. The direct damage on the hood face began 50.8 cm (20.0") inboard of the right corner and extended 87.0 cm (34.25") to the left corner. The frontal impact crushed the left bumper corner rearward to a maximum depth of 128.5 cm (50.2") and shifted the right structure laterally to the left. As a result, the entire frontal structure was deformed that produced a direct and induced damage length (Field L) of 68.6 cm (27.0"), measured parallel to the reference line. The crush profile (**Figure 8**) was documented as follows: C1 = 128.5 cm (50.2"), C2 = 99.1 cm (39.0"), C3 = 83.2 cm (32.75"), C4 = 54.6 cm (21.5"), C5 = 8.0 cm (20.3"), C6 = 0 cm. The Collision Deformation Classification (CDC) for this impact was 12-FYEW-6.

**Figure 8. Extent of frontal crush to the Nissan KingCab.**

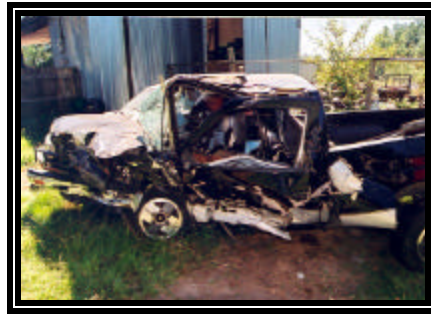
**Figure 9. Continuous engagement onto the left side of the Nissan.**

As the vehicles crushed, the frontal area of the Cadillac contacted the left front fender and door areas of the Nissan in a continuous engagement pattern (**Figure 9**) resulting in direct contact damage that extended to the left A-pillar area of the pickup truck. As a result of the frontal crush, the left A-pillar was displaced rearward which jammed the left front door in the closed position. Although distorted by deformation, the right front door remained operational.

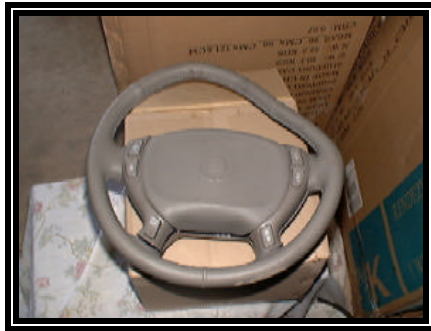
The 2001 Cadillac DeVille was equipped with redesigned frontal air bags and seat back mounted side impact air bags for the driver and front right passenger positions. The air bags did not deploy (**Figures 10 and 11**) as a result of the severe frontal crash sequence with the Nissan pickup truck.

**Figure 10. Separated steering wheel with non-deployed air bag module.**

The frontal air bag system consisted of a conventionally mounted driver air bag module that was housed within the four-spoke steering wheel rim. The spokes were configured at the 3/9 and 5/7 o'clock positions. The lower right aspect of the cover flap was identified with AIR BAG molded into the vinyl flap. It should be noted that although the driver's air bag did not deploy, emergency personnel at the scene of the crash pulled the steering wheel with a chain during extrication of the driver. The upper aspect of the wheel rim was deformed (**Figure 10**) and the alloy steering wheel flange fractured which resulted in complete separation of the steering wheel and non-deployed air bag module from the steering column.

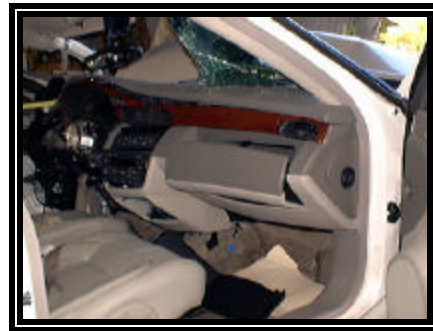
**Figure 11. Non-deployed front right air bag.**

The front right passenger air bag was mounted in a top mount configuration under the right upper instrument panel. This application did not utilize a conventional flap design module. At deployment, the upper

instrument panel would separate from the mid panel allowing the bag membrane to deploy. There was minimal separation of these components, however, this separation was related to the interior deformation.

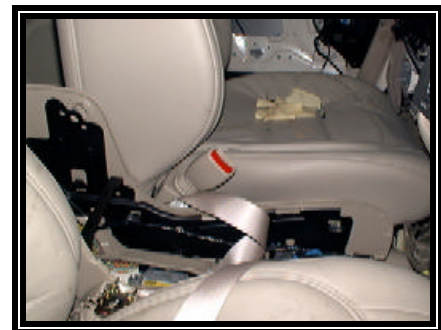
**Figure 12. Fired seat belt buckle pretensioners.**

buckle pretensioners. The buckle was attached to the pretensioner and concealed within a vinyl sleeve with a convoluted jacket located between the buckle and the vinyl sleeve. Both front pretensioners fired during the crash. The left buckle pretensioner reduced the height of the buckle by 4.9 cm (1 15/16") while the right buckle was reduced in height by 5.1 cm (2.0"). The housing for the right buckle assembly, although not engaged with the latchplate for this unoccupied seat position, fractured as a result of the firing of the pretensioner. **Figure 12** shows the fired buckle pretensioners.

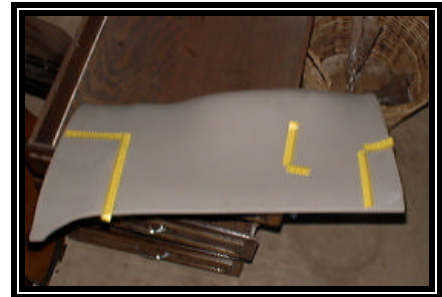
The driver's knees contacted the intruding knee bolster as evidenced by dark blue fabric transfers to the bolster cover (**Figure 13**). The left knee contact was located 50.2-60.7 cm (19.75-23.9") left of the right edge of the bolster panel and was located 10.4-28.2 cm (4.1-11.1") below the top edge of the bolster. The right knee scuff was located 0-5.1 cm (0-2.0") inboard of the right edge and 16.5-26.7 cm (6.5-10.5") below the top of the bolster. The driver sustained a laceration of the right lower leg. The specific location of the laceration was unknown, therefore it was unknown if the laceration was related to the bolster contact.

**Figure 13. Knee contacts to the knee bolster.**

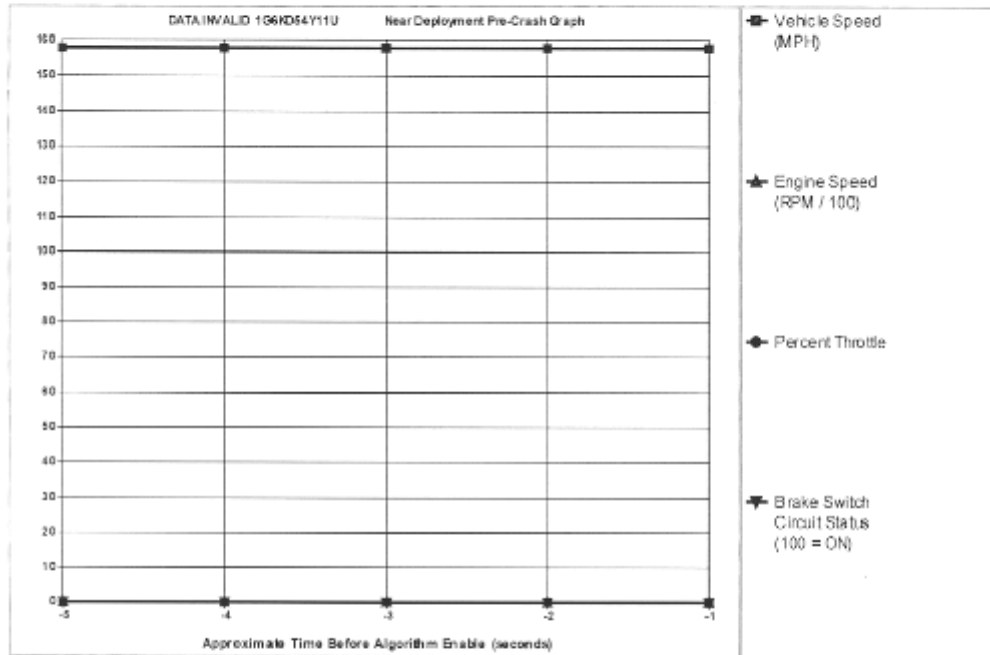
The Pre-Crash data fields were listed as INVALID. The Non-Deployment Pre-Crash Graph was identified as DATA INVALID. The Pre-Crash Vehicle Speed was defaulted to a value of 158 MPH with default values of 0 for the Engine Speed and Percent Throttle. The Brake Circuit Status was defaulted to OFF. He EDR Output is attached as **Figure 15**, Page 13 of this report.

Seconds Before AE	Vehicle Speed (MPH)	Engine Speed (RPM)	Percent Throttle	Brake Switch Circuit Status
-5	158	0	0	OFF
-4	158	0	0	OFF
-3	158	0	0	OFF
-2	158	0	0	OFF
-1	158	0	0	OFF
