**ADVANCED OCCUPANT PROTECTION SYSTEM STUDY  
2000 FORD TAURUS SE INVESTIGATION**

**VERIDIAN CASE NO. CA00-044**

**LOCATION - MICHIGAN**

**CRASH DATE - SEPTEMBER 2000**

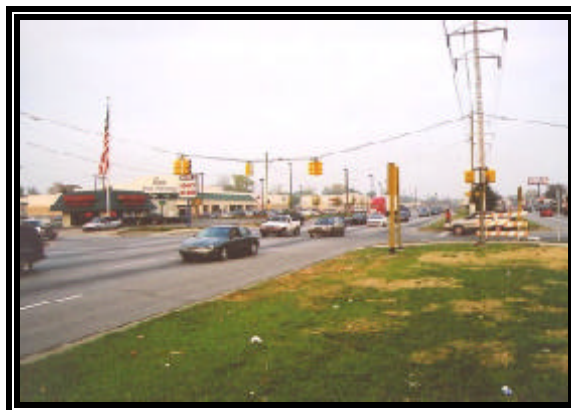
This two-vehicle crash occurred during the morning hours of September 2000. It was dawn at the time of the crash and the weather was not a factor. The road surface was dry. The crash occurred at the intersection of a five-lane westbound divided road and a two-lane north/south road. The three center lanes were for westbound through traffic. The inboard and outboard lanes of the westbound road were only for left and right turns, respectively. A standard (red/amber/green) traffic signal controlled the traffic flow through the intersection. The signal was functioning properly at the time of the crash. The speed limit in the area of the crash was 64 km/h (40 mph). **Figure 1** is a lookback view into the intersection.

**Figure 1:** Northeastward view into the intersection.

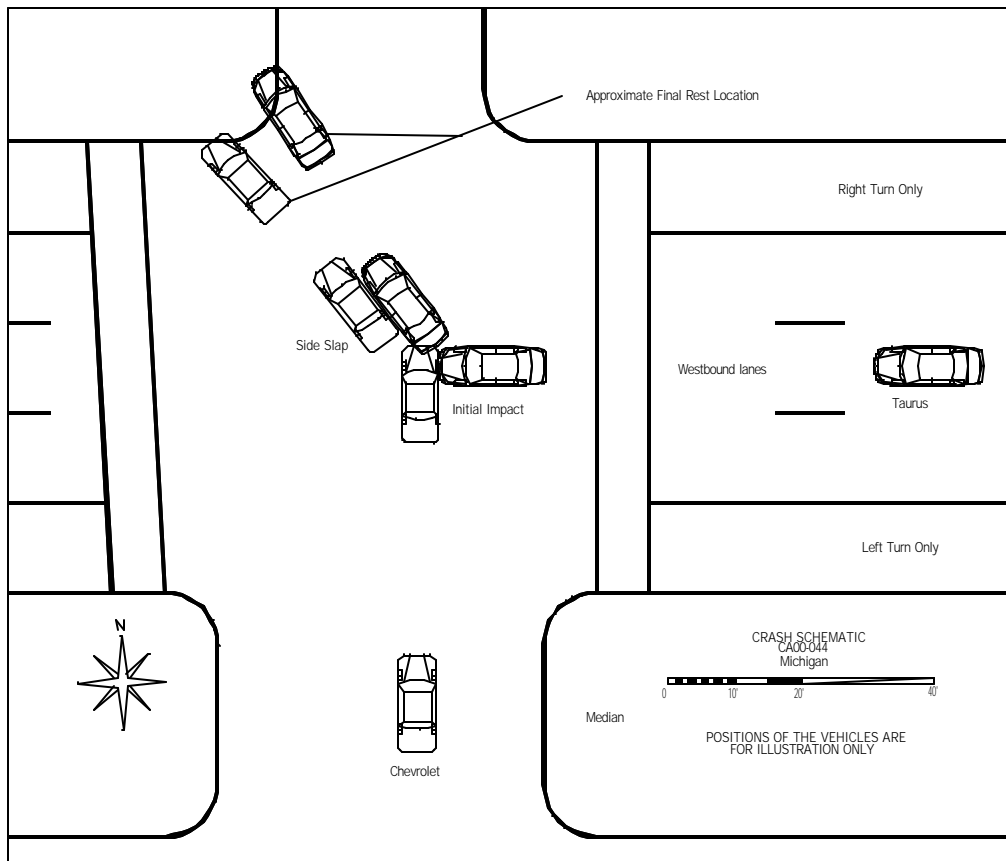
The crash occurred with the frontal left area of the Ford striking the forward right side area of the Chevrolet in an L-configuration impact. The Direction of Force was in the 11 o'clock sector for the Ford and 2 o'clock sector for the Chevrolet. Refer to the crash schematic on page 3, **Figure 2**. The total velocity change of the Ford determined by the WINSMASH model was 18.4 km/h (11.4 mph). The longitudinal and lateral delta V components were -15.9 km/h (-9.9 mph) and 9.2 km/h (5.7 mph), respectively. The velocity change of the Chevrolet was 20.9 km/h (13.0 mph). The force of the crash caused the frontal air bags in the Ford to deploy. The Chevrolet was not equipped with an air bag system.

The lateral impact of the Ford, forward of the Chevrolet's center of gravity, caused the Chevrolet to rotate counterclockwise. The northward momentum of the Chevrolet caused the Ford to rotate clockwise. The vehicles contacted again in a secondary side slap with the right side of the Chevrolet striking the left side of the Ford. The resultant direction of forces were 3 and 9 o'clock for the Chevrolet and Ford, respectively. Both vehicles then slid to rest in the northwest quadrant of the intersection. Their exact final rest positions were not documented by the police.

**Figure 2:** Crash schematic.

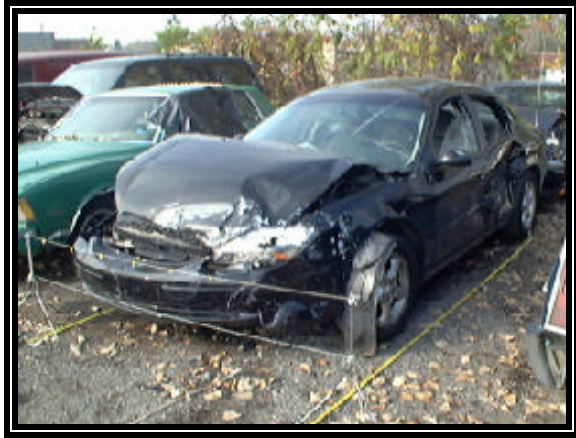
**Figure 3** is a left front view of the damaged Taurus SE. The vehicle’s front plane and left side plane sustained direct contact damage as a result of the intersection impact. The frontal direct damage began 21.6 cm (8.5 in) right of center and extended 95.3 cm (37.5 in) to the left corner. The direct damage pattern wrapped around the bumper corner and extended 52.1 cm (20.5 in) along the left side of the vehicle. The crush profile measured along the bumper beam (bumper reinforcement) was as follows: C1=18 cm (7.1 in), C2=16 cm (6.3 in), C3=15 cm (5.9 in), C4=12 cm (4.7 in), C5=8 cm (3.1 in), C6=8

Figure 3: Left front view of the Ford.

cm (3.1 in). The hood was buckled and jammed shut. The windshield was not fractured. The wheelbase measurements were unchanged. The front of the vehicle was shifted approximately 32 cm (12.5 in) to the right. The Collision Deformation Classification was 71-FYEW-1. (The direction of force was incremented by 60 to accommodate the lateral end-shift.) The total velocity change of the Ford determined by the Damage Algorithm of the WINSMASH model was 18.4 km/h (11.4 mph). The longitudinal and lateral delta V components were -15.9 km/h (-9.9 mph) and 9.2 km/h (5.7 mph), respectively.

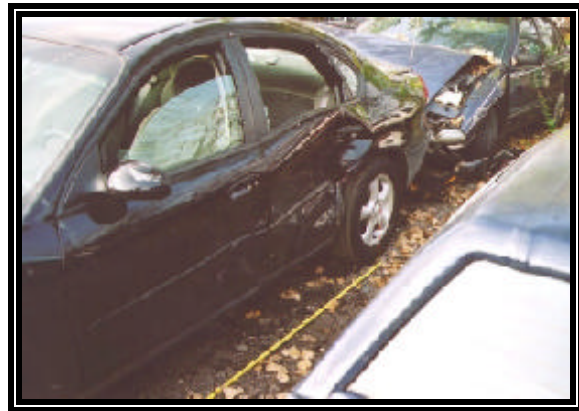
The left side of the Taurus SE sustained 157 cm (62 in) of direct and induced damage as a result of the secondary side slap, **Figure 4**. The left side damage began 178 cm (70 in) forward of the left rear axle on the left front door and ended 20 cm (8 in) forward of the left rear axle, near the C-pillar location. The maximum lateral deformation measured 8.9 cm (3.5 in). It was located 41 cm (16 in) forward of the left rear axle and was caused by contact with the rear bumper of the Chevrolet's. The side slap impact jammed both left side doors shut and disintegrated the left rear window glazing. The CDC of this impact was 09-LPEW-3.

Figure 4: View of the side slap damage to the Taurus SE.

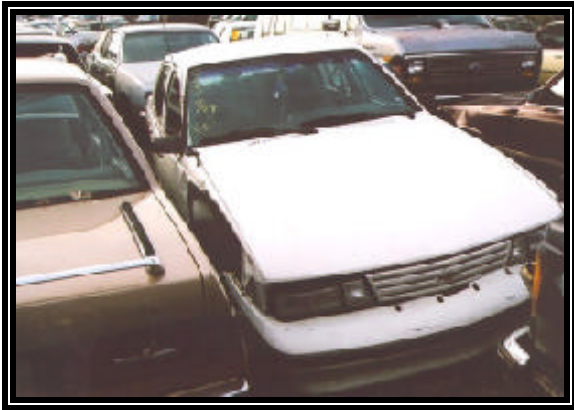
The right side of the Chevrolet sustained two distinct regions of direct contact damage attributed to the crash. The width of the damage resultant to the initial impact measured 165 cm (65 in) and was centered

approximately on the right front axle, **Figure 5**. The damage began at the right corner of the front bumper, extended longitudinally rearward across the right front fender, and terminated at the right A-pillar location. The crush profile at the trim elevation measured as follows: C1=1.2 cm (0.5 in), C2=11 cm (4.3 in), C3=18 cm (7.1 in), C4=18 cm (7.1 in), C5=8 cm (3.1 in), C6=2 cm (1.0 in). The total velocity change of the Chevrolet calculated of the WINSMASH model was 20.9 km/h (13.0 mph). The longitudinal and lateral components of the delta V were -10.4 km/h (-6.5 mph) and -18.1 km/h (-11.2 mph), respectively. The CDC of this damage region was 02-RFEW-3.

**Figure 5:** Front view of the Chevrolet.

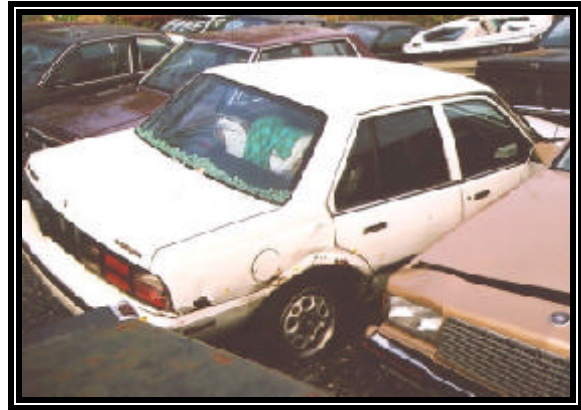
The damage resultant to the side slap was located on the right rear quarter of the vehicle, **Figure 6**. The width of the damage measured 109 cm (43 in). It began 23 cm (9 in) forward of the right rear axle and extended to the right rear corner. The maximum lateral deformation measured 5 cm (2 in) and was located at the right rear corner. The CDC of the impact was 03-RBEW-2.

**Figure 6:** Right rear side slap damage.

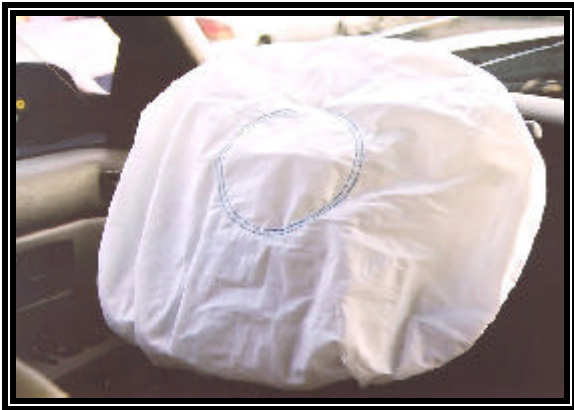
The driver air bag module was located in the center of the steering wheel. The driver air bag (**Figure 7**) had deployed from the H-configuration module cover flaps. The cover flaps opened along the designated tear seams. The height of the upper and lower flaps measured 6.4 cm (2.5 in) and 4.6 cm (1.8 in), respectively. The width of the flaps measured 17.2 cm (6.8 in). The deployed driver air bag measured 53 cm (21 in) in diameter. It was tethered by four straps sewn to the face of the bag. The bag was vented by two 2.9 cm (1.1 in) ports located in the 10/2 o'clock position of the back side of the bag. There was no evidence of occupant contact to the air bag. The following nomenclature identified the air bag:

**Figure 7:** View of the deployed driver air bag.

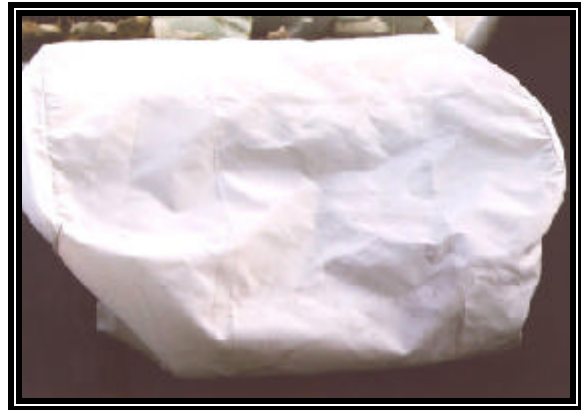
The right front seat was adjusted to a rear track position and measured 2.5 cm (1.0 in) forward of full rear. No contact evidence was identified on the right bolster. The front right passenger air bag module was a top mount design located in the right aspect of the instrument panel. The air bag (**Figure 8**) had deployed as designed from the module. The face of the deployed passenger bag measured 58.4 cm x 39.4 cm (23.0 in x 15.5 in), width by height, and extended 46 cm (18 in) from the aft edge of the module. A series of vertical vinyl transfers was located on the lower central aspect of the face of the bag. These transfer marks resulted from contact between the air bag and the edge of the module during the deployment sequence. This transfer pattern had been identified on several other Ford Taurus SE AOPS investigations and was typical of this system's deployment. Further inspection of the passenger air bag was unremarkable. No evidence of occupant contact was identified.

**Figure 8:** View of the deployed front passenger air bag.

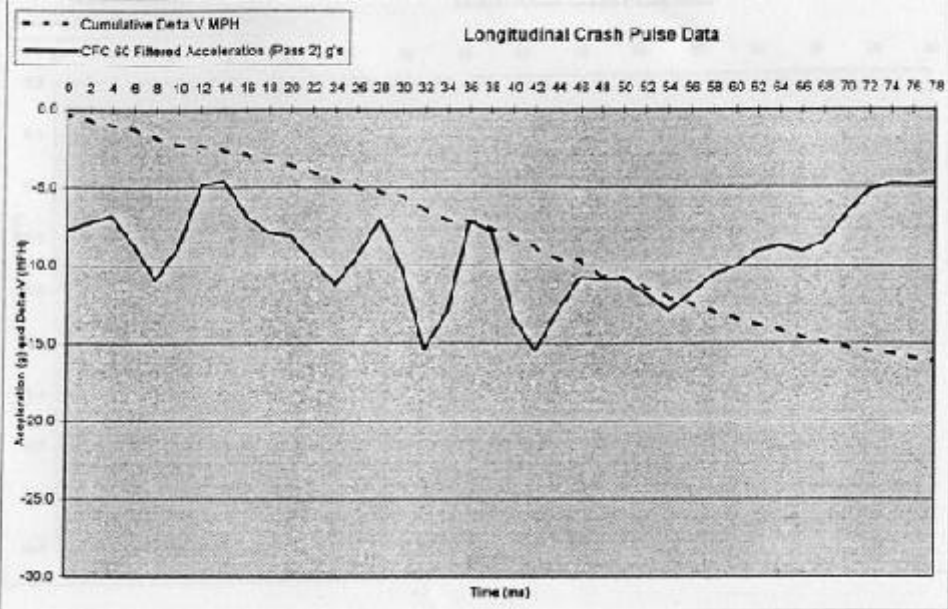
### Longitudinal Cumulative Delta-V

The RCM data indicated the front belt systems were not buckled at the time of the crash and the buckle pre-tensioners did not fire. The driver seat was not adjusted to a forward position and Stage 1 frontal air bag deployments were commanded to fire 19 milliseconds into the crash. (The second stage of the dual stage system was disposed of approximately 100 milliseconds after the stage 1 deployment.) The RCM sensed and recorded the crash acceleration pulse for a duration of 78 milliseconds. The 78 millisecond longitudinal delta V recorded by the RCM was approximately -25.9 km/h (-16.1 mph). The 78 millisecond lateral delta V was approximately 18.5 km/h (11.5 mph).

Time (ms)	0	10	20	30	40	50	60	70	78
Delta-V (MPH)	-0.3	-2.3	-3.6	-5.6	-6.2	-10.7	-13.4	-15.2	-15.1

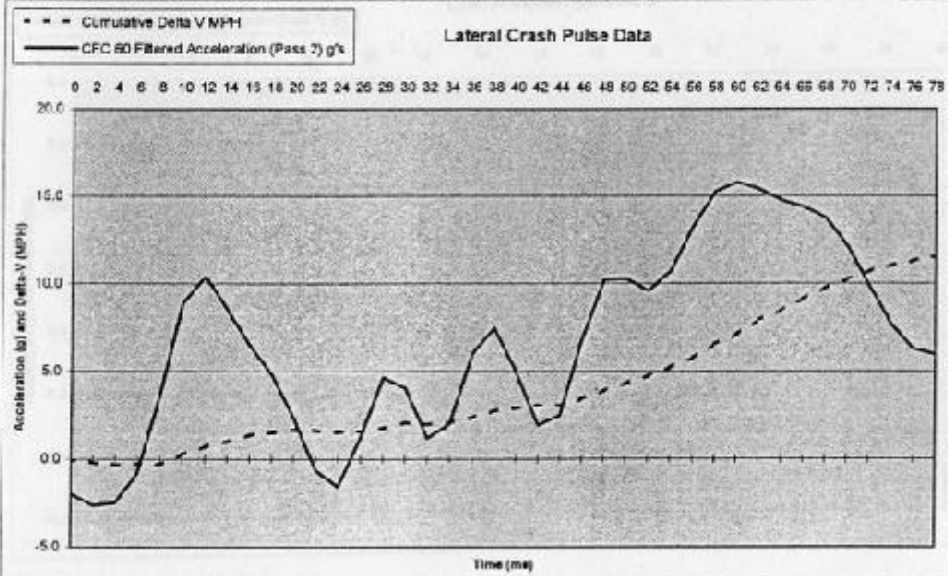
### Lateral Cumulative Delta-V

Time (ms)	0	10	20	30	40	50	60	70	78
Delta-V (MPH)	-0.1	0.3	1.7	2.1	2.9	4.3	7.1	10.2	11.5
