**REMOTE AIR BAG RELATED CHILD PASSENGER FATALITY INVESTIGATION
SCI TECHNICAL SUMMARY REPORT**

VERIDIAN CASE NO. CA00-049

SUBJECT VEHICLE - 1997 MITSUBISHI GALANT

CRASH DATE - MAY 1999

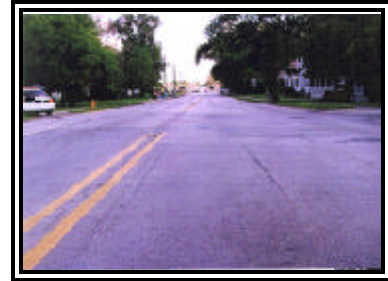
Figure 6. Point of impact showing pre-impact skid marks from the Galant

As the Mitsubishi Galant entered the intersection, the front area impacted the left front side area of the Ford Taurus (**Figure 6**). The center area of the front bumper of the Galant impacted the left front wheel of the Taurus. The grille area of the Galant engaged the front left fender of the Taurus above the left front wheel. The resultant directions of force the Galant and the Taurus were in the 12 o'clock and 9 o'clock sectors, respectively. Impact resulted in moderate damage to both vehicles. The impact induced deceleration was sufficient to deploy the frontal air bag systems in both vehicles. The damage algorithm of the WinSMASH program computed a total velocity change of 18.1 km/h (11.3 mph) for the Galant based on an estimated

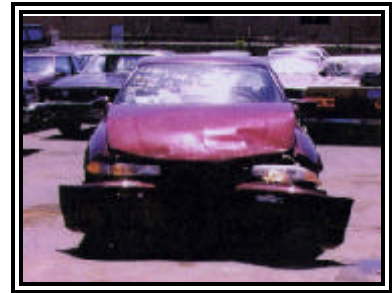
Figure 9. Frontal damage to Mitsubishi Galant

The 1997 Mitsubishi Galant sustained moderate frontal damage as a result of the impact with the Ford Taurus (**Figure 9**). The direct contact damage involved the entire frontal plane of the vehicle. The outboard corners of the bumper fascia were bowed outward on both sides from the bumper engagement with the wheel of the Taurus. The outboard side portions of the fascia were separated from both fenders. The left headlamp assembly was displaced. Paint transfers from the Taurus were noted along the entire width of the leading edge of the hood and the hood was buckled rearward at the designated fold points. The bumper fascia was cracked approximately 3 cm (1") to the left of center from engagement against the left front wheel of the Taurus that was turned counterclockwise (CCW) (**Figure 10**). The estimated maximum crush of 25 cm (10") was located in that area. The Collision Deformation Classification (CDC) for the impact with the Taurus was 12-FDEW-1. Six crush measurements were estimated along the bumper and were as follows: C1 = 0 cm, C2 = 12 cm (5"), C3 = 25 cm (10"), C4 = 20 cm (8"), C5 = 12 cm (5"), C6 = 0 cm.

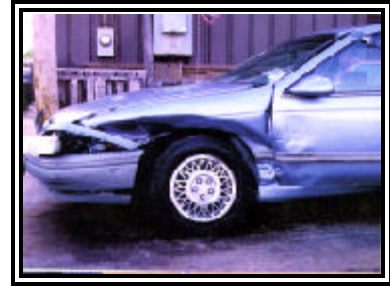
Figure 11. Side damage to the Ford Taurus

The 1992 Ford Taurus sustained moderate damage as a result of the impact with the Mitsubishi Galant (**Figure 11**). The direct damage was concentrated above the side body line. Direct contact damage began at the leading edge of the left front door and extended forward to the left front bumper corner. Pocketing was noted in the sheet metal forward and above the left front wheel. The top of the left front wheel was displaced inward toward the right side of the Taurus, and scuff marks were noted on the left front tire. The left headlamp assembly and grille fascia were displaced. The Collision Deformation Classification (CDC) for the impact with the Galant was 09-LFEW-2. Six crush measurements were estimated above the side body line and were as follows: C1 = 10 cm (4"), C2 = 20 cm (8"), C3 = 25 cm (10"), C4 = 13 cm (5"), C5 = 5 cm (2"), C6 = 0 cm. The crush profile does not represent the damage pattern for this configuration due to the involvement of the left front tire and suspension components.

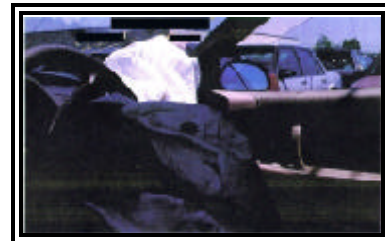
Figure 12. Deployed frontal air bag system in the Galant

The 1997 Mitsubishi Galant was equipped with air bags for the driver and front right passenger positions that deployed as a result of the impact with the 1992 Ford Taurus (**Figure 12**). The driver's air bag was housed in the center of the steering wheel with asymmetrical H-configuration module cover flaps. Two vent ports were visible in the police photographs on the top aspect of the driver's air bag.

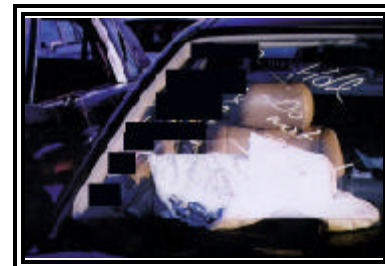
Figure 13. Deployed front right passenger's air bag in the Galant

The front right passenger's air bag deployed from the right mid-instrument panel area with a single cover flap design hinged at the top aspect (**Figure 13**). The cover flap was rectangular in shape. A vent port was visible in the police photographs on the right aspect of the front right passenger's air bag.

The 7-year-old male front right passenger was not restrained by the available 3-point lap and shoulder belt system. Belt non-usage was reported by the police and supported by the injuries sustained. The front right passenger initiated a forward trajectory due to pre-impact braking which placed him out-of-position forward in the deployment zone of the front right passenger's air bag. At impact with the Ford Taurus, the 7-year-old front right passenger most likely had his arms extended in an effort to brace. As the front right passenger's air bag deployed, the cover flap appears to have struck his left arm resulting in a transverse fracture at the mid level of the arm with deformity. The air bag expanded against his neck and chest and redirected him rearward. He sustained a large separation between C1 and the occipital bone, a laceration of the spleen, a large abrasion on the anterior aspect of the neck which extended to the inferior part of the chin, and an abrasion on the anterior aspect of the right chin. He was transported by ambulance to a local trauma center and transferred to a regional children's hospital where he expired two days following the crash.
