ON-SITE AIR BAG RELATED CHILD FATALITY INVESTIGATION

VEHICLE: 1996 JAGUAR XJS CONVERTIBLE

VERIDIAN CASE NO. CA00-053

CRASH DATE: OCTOBER 1999

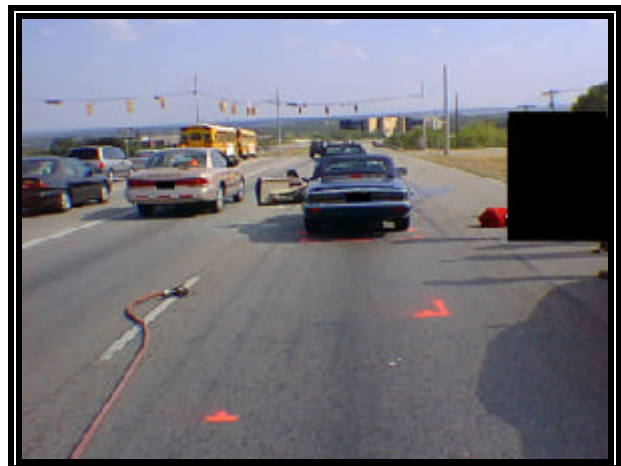
Figure 1: Southbound view of the subject vehicle at final rest.

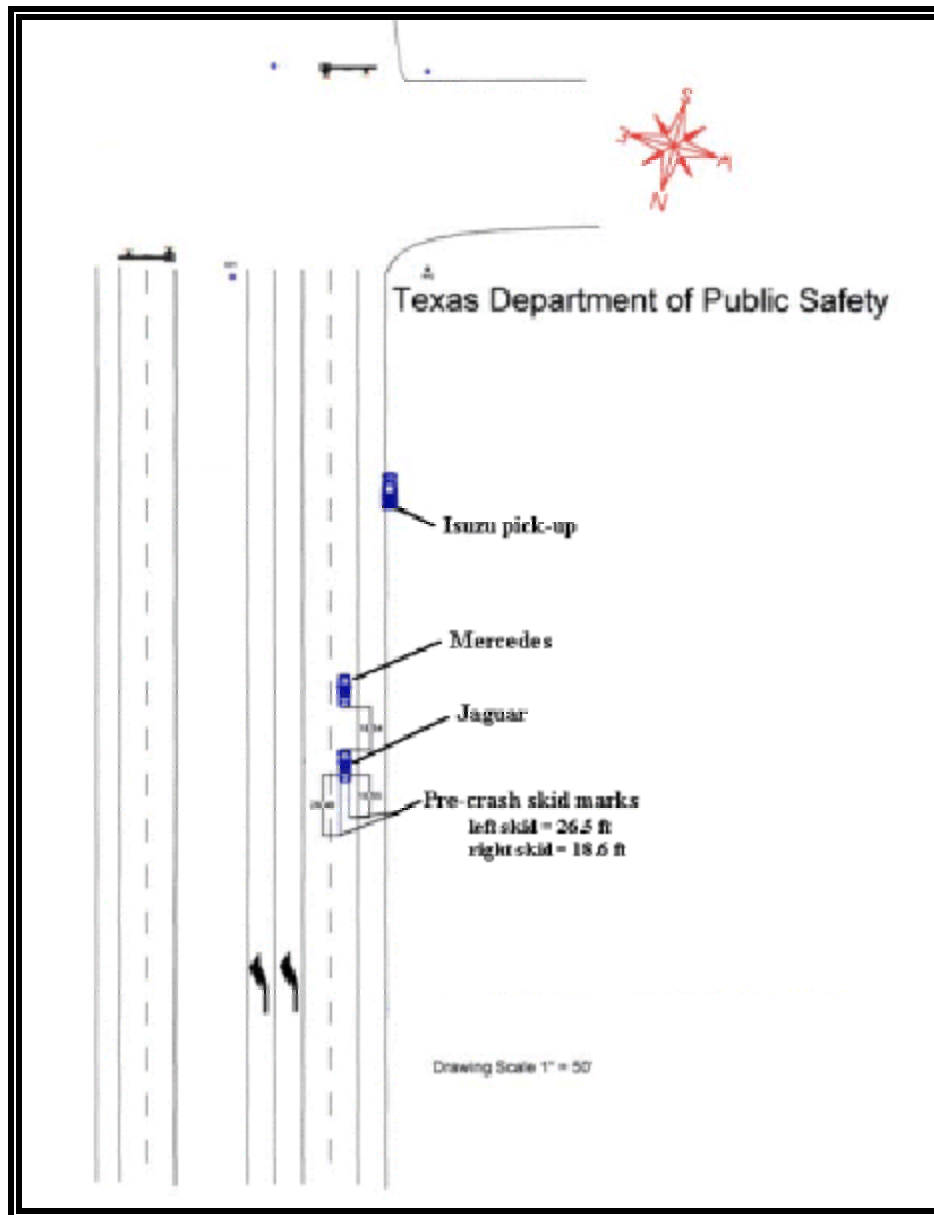
The crash occurred with the front of the Jaguar impacting the rear of the Mercedes in a 12/6 o'clock impact configuration. **Figure 2** is the investigating officer's schematic of the crash scene. The force of the impact collapsed the trunk of the Mercedes and resulted in approximately 15 cm (6 in) of longitudinal deformation to the Jaguar. The Jaguar's delta V calculated by the Damage Algorithm of the WINSMASH model was 24.3 km/h (15.1 mph). The force of the impact was above the threshold to cause the deployment of the Jaguar's Supplemental Restraint System. The vehicle's driver and front passenger air bag deployed. A review of the on-scene police photographs indicated the Jaguar came to rest approximately 2 to 3 m (7 to 10 ft) south of the point of impact.

Figure 2: Police schematic of the crash.

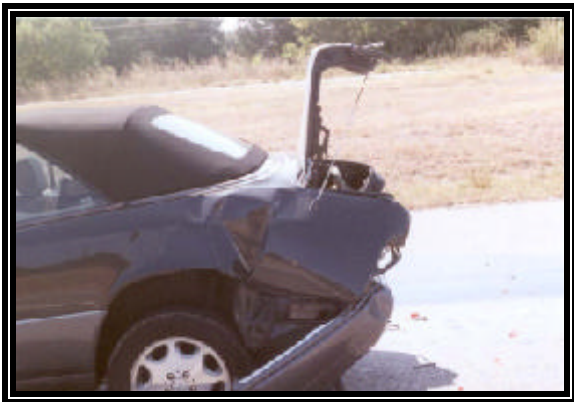
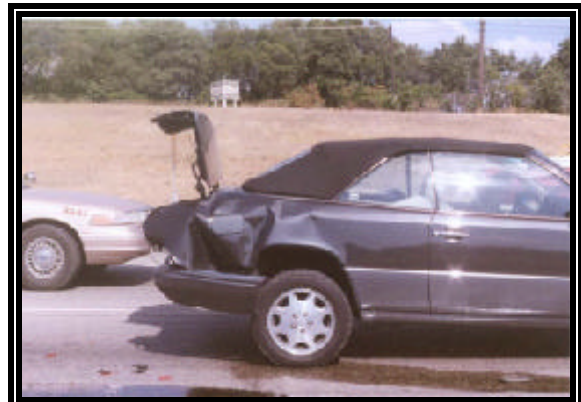
Figures 3 and 4 are left side and right side views of the vehicle taken at the time of the on-scene investigation. Due to the delay in crash notification, the Mercedes Benz was not available for inspection. Analysis of the photographs indicated the vehicle sustained direct contact damage across the entire end width of the vehicle. The impact collapsed the vehicle's rear bumper and trunk space. During the impact sequence, the trunk lid opened and was not damaged. The estimated crush at the left rear (C1) and right rear (C6) bumper corners were 30 cm (12 in) and 25 cm (10 in), respectively. The WINSMASH model calculated a damaged based delta V of 27.3 km/h (17.0 mph) for the Mercedes. The estimated Collision Deformation Classification was 06-BDEW-3. The secondary collision with the rear of the Isuzu pick-up truck resulted in no residual deformation.

Figure 3: Left side view of the damaged Mercedes.

Figure 4: View of the right side damage.

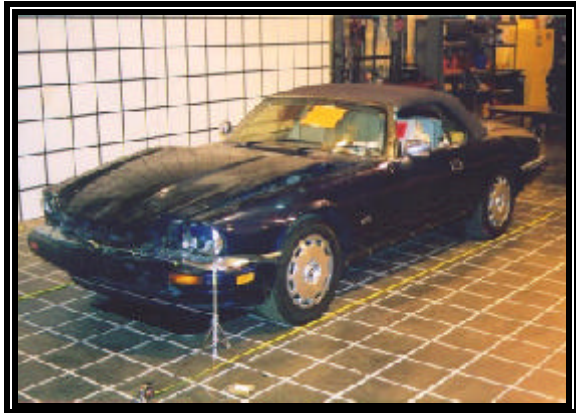
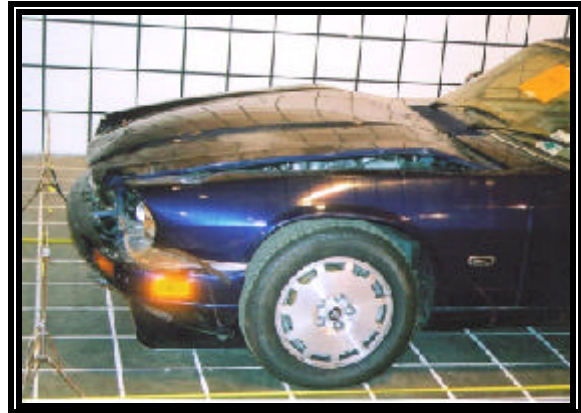
Figures 5 and 6 are the left front and left lateral views of the Jaguar. The vehicle sustained 161.3 cm (63.5 in) of direct contact damage that extended across its full frontal width. The energy of the impact was

managed primarily by the front bumper system and vehicle structures forward of the radiator support plane. The damaged components included the front bumper, grille, headlamp assemblies and hood. The front bumper was a hollow, rectangular cross section constructed out of aluminum and covered with a hard plastic. The bumper system was mounted to the vehicle's frame by Energy Absorbing Devices (EAD's) that fully stroked as a result of the impact. The EAD's returned to their original length through full restitution. The stroke of the EAD's measured 3.8 cm (1.5 in). The residual crush profile measured at the elevation of the front bumper (including the EAD stroke) was as follows: C1=15.2 cm (6.0 in), C2=12.7 cm (5.0 in), C3=12.4 cm (4.9 in), C4=11.4 cm (4.5 in), C5=11.4 cm (4.5 in), C6=11.9 cm (4.7 in). At maximum engagement, the extent of the longitudinal direct contact between the vehicle's measured 53.3 cm (21.0 in) and 47.0 cm (8.5 in) at the left and right front fenders, respectively. This engagement is depicted in **Figure 7**. The (forward opening) hood buckled at impact. There was no measurable change in the wheelbase dimensions. The vehicle's doors remained operational and were not restricted. The Collision Deformation Classification of the Jaguar was 12-FDEW-1. The delta V calculated by the Damage Only algorithm of the WINSMASH model was 24.3 km/h (15.1 mph).

Figure 5: Left front view of the Jaguar.

Figure 6: Left lateral view across the front plane.

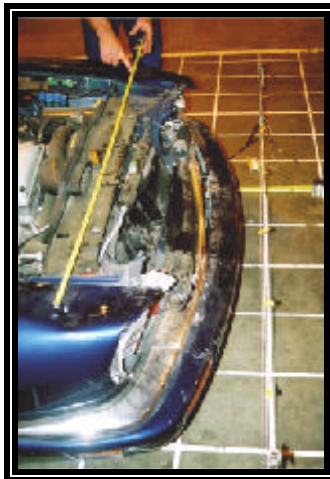
Figure 7: Longitudinal extent of the direct contact.

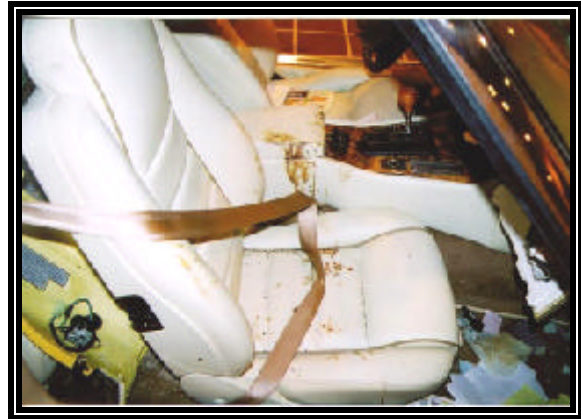
The interior damage to the vehicle was limited to the deployment of the vehicle's Supplemental Restraint System and the associated occupant contacts to the interior components. There was no intrusion into the occupant space as a result of the exterior crash forces. The left front glazing shattered upon impact. The right front glazing was intact. The right aspect of the windshield was fractured. The fracture site was located 25.4 cm (10.0 in) inboard of the right A-pillar and 20.8 cm (8.2 in) below the windshield header. The fracture resulted from contact with the posterior aspect of the front right passenger's head during the air bag deployment sequence. **Figure 8** is a right interior view into the Jaguar.

Figure 8: Right interior view of the Jaguar.

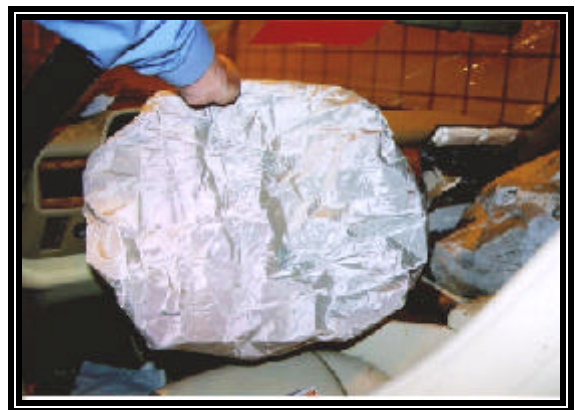
The driver air bag, **Figure 9**, was located in the typical manner in the center hub of the steering wheel rim.

The air bag deployed from the symmetrical H-configuration cover flaps. The cover flaps were not contacted or damaged during the deployment sequence. The diameter of the driver bag measured 71 cm (28 in), in its deflated state. It was tethered by 6 straps sewn to the face of the bag. The diameter of the tether circle measured 18 cm (7 in). It was vented by a single 3.0 cm (1.2 in) diameter port located in the 12 o'clock sector of the back side of the bag. The perimeter of the bag was blood stained across its 10/4 o'clock sectors from post-crash incidental contact by the driver. There was no evidence of direct occupant contact to the face of the air bag.

Figure 9: Driver air bag.

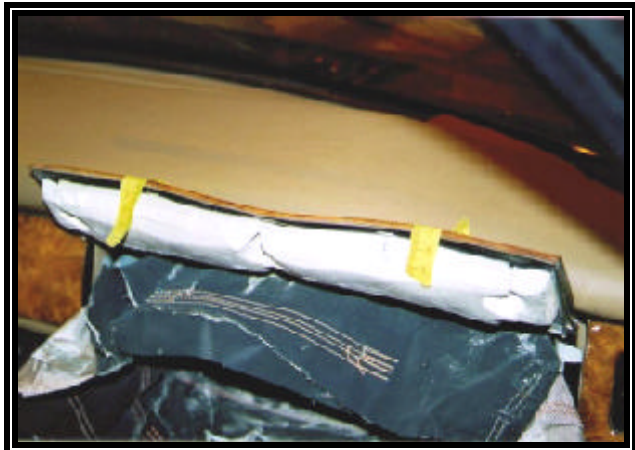
The H-configuration cover flaps were symmetrical and measured 8.9 cm x 35.6 cm (3.5 in x 14.0 in). The rigid cover flaps were constructed of vinyl trimmed with an exterior wood finish. The interior surface of the flap was backed by styro-foam. The upper cover flap deformed as a result of contact to the child's head at the time of the deployment, **Figure 10**. The exterior wood trim panel was cracked. The width of the deformed section approximately 20 cm (8 in). The maximum deflection along the centerline of the flap measured approximately 6.4 mm (0.25 in). A single strand of blonde hair was embedded in the flap. The hair strand was located 11.4 cm (4.5 in) inboard of the right edge of the flap. Examination of the lower cover flap revealed it was not damaged.

Figure 10: View of the deformed upper cover flap.

Upon impact, the two independent ball-in-tube sensors in the respective air bag modules recognized the force of the crash was above the design threshold and commanded deployment. The cover flaps of the front right module rotated open. The rotating upper cover flap impacted the child passenger's face, across the bridge of his nose, causing the extensive facial fractures (AIS 2) and skull fractures (AIS 4), identified above. This region was extensively abraded, contused and lacerated. The impact of the cover flap also caused the associated basilar subarachnoid hemorrhage. The initial expansion of the passenger air bag abraded the child's face. As the air bag continued to expand, the child was lifted slightly and the posterior aspect of his head contacted and fractured the windshield. The windshield contact did not result in an injury. As the child's torso was lifted, the pelvic skin contusion occurred as a result of contact with the lap belt. The child then rebounded back into the seat and came to rest over the center sole evidenced by the blood stains in this region and on the inboard seat buckle anchor.

In this crash, the devastating injuries sustained by the child passenger resulted from the direct contact to the deploying upper cover flap of the front right passenger air bag module. However, the child's contact with the cover flap resulted from the consequences of improper use of the 3-point lap and shoulder belt system. This crash was probably survivable had the child been restrained with the shoulder belt positioned over his shoulder. Alternatively, he could have been seated in the rear of the vehicle where his outcome probably would have similar to the uninjured right rear passenger.

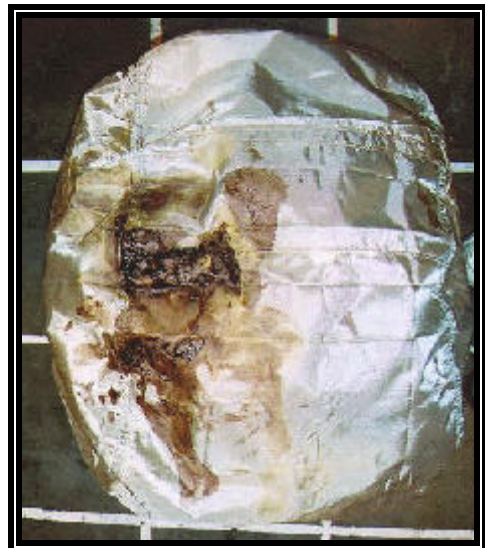
The passenger air bag was cut from the module during the police investigation for unknown reasons. **Figure 11** is a view of the face of the bag. The face of the bag measured 43 cm x 66 cm (17 in x 26 in), width by height. The side panels of the bag were egg-shaped. The rearward extension of the bag measured approximately 46 cm (18 in). The bag was tethered by a single strap sewn across the bag's full width. The primary tether stitching was a 2.5 cm (1.0) band located 16.5 cm (6.5 in) below the top of the bag. Located 31.8 cm (12.5 in) below the top surface of the bag was a secondary tether. The attachment of the tether in this manner and the fold pattern of the bag caused the deploying air bag to expand rearward and down. The air bag vented internally back through the module.

Figure 11: View of the face of the passenger air bag.
