**VERIDIAN ON-SITE AIR BAG RELATED CHILD
SERIOUS INJURY INVESTIGATION**

VERIDIAN CASE NO. CA00-056

VEHICLE - 1999 FORD CONTOUR SPORT SE

LOCATION - STATE OF GEORGIA

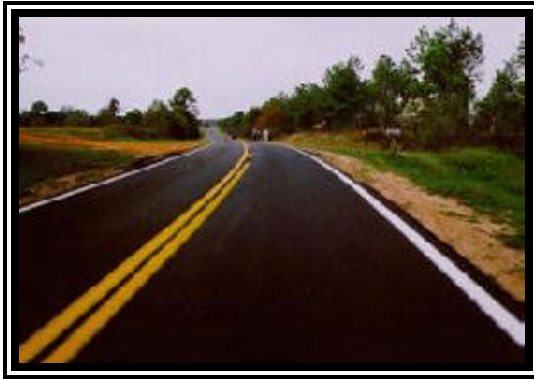
The 15 year old female driver of the 1999 Ford Contour was operating the vehicle northbound (**Figure 1**) when she approached the apex of the road curvature (at the hillcrest) and allowed the vehicle to depart the right (east) pavement edge. The vehicle traveled 71.0 meters (233.0 feet) alongside the apron before the vehicle re-entered the roadway in a slight counterclockwise yaw, evidenced by the police reported re-entry tire marks approximated during the SCI scene inspection. Subsequent right steering maneuvers re-directed the vehicle back towards the east pavement edge. The Ford again exited the east pavement edge (**Figure 2**) and continued 22.0 meters (72.2 feet) into a wooded area. This trajectory was evidenced by 11.9 meters (39.0 feet) of pre-impact soil furrows documented at the scene. The driver reported to police that she struck a pothole in the road which contributed to pre-crash circumstances, however, evidence suggested this was more of an issue related to excessive speed and driver inexperience.

Figure 1. Northbound approach for the 1999 Ford Contour Sport SE.

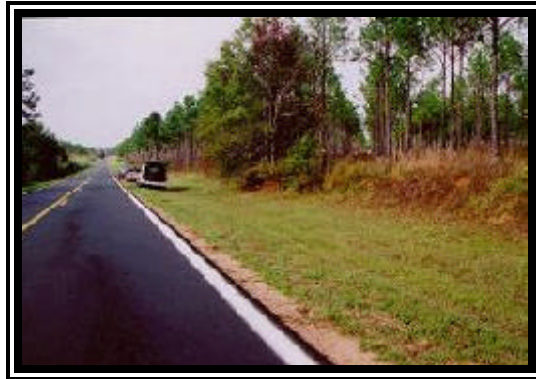
Figure 2. Northbound approach for the 1999 Ford Contour Sport SE.

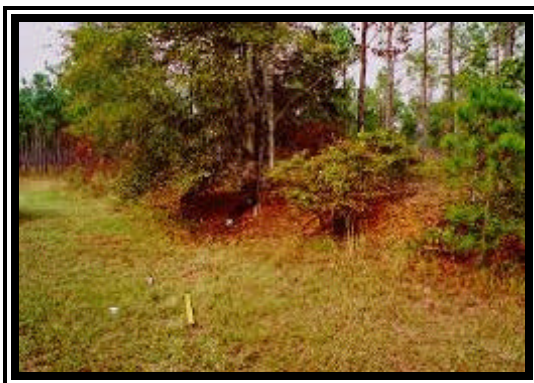
As the Ford approached the wooded terrain, the frontal area was deflected slightly upward by the embankment (no impact) as the front right area impacted a tree cluster (**Figures 3 & 4**) resulting in severe damage. The WinSMASH damage and trajectory algorithm computed an impact speed of 67.8 km/h (42.1 mph) with an overall velocity change of 51.4 km/h (31.9 mph) and a matching negative longitudinal component. The speed change exceeded the threshold for deployment, therefore, the Ford's redesigned frontal air bag system deployed. At this point, the Ford rotated clockwise approximately 130 degrees and came to rest 6.5 meters (21.3 feet) from the point of impact facing southeast.

Figure 3. Struck tree cluster.

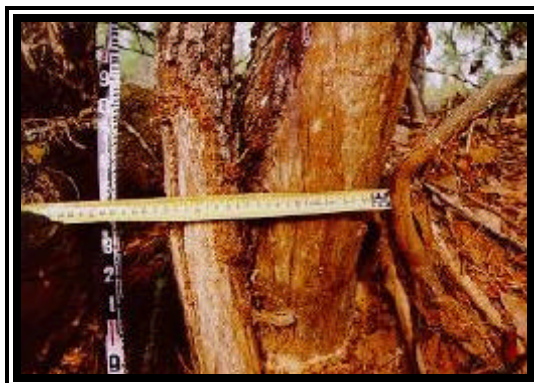
Figure 4. Close-up view of struck tree cluster.

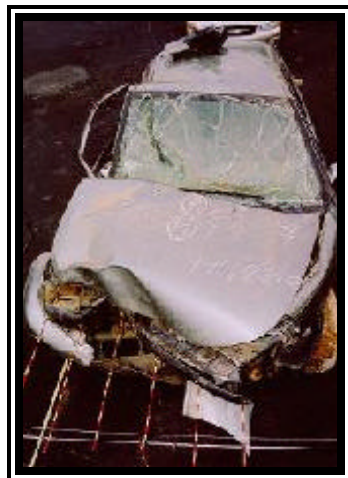
The 1999 Ford Contour Sport SE sustained severe frontal damage as a result of the impact with the tree cluster (**Figures 5 & 6**). The direct contact damage began 12.0 cm (4.7 in) right of the end plane centerline and extended 18.0 cm (7.1 in) outboard. The impact deformed the full frontal width resulting in a combined direct and induced damage length (Field L) of 116.0 cm (45.7 in). Six crush measurements were documented at the level of the bumper: C1= 4.5 cm (1.8 in), C2= 27.5 cm (10.8 in), C3= 47.5 cm (18.7 in), C4= 77.5 cm (30.5 in), C5= 63.5 cm (25.0 in), C6= 57.5 cm (22.6 in). The Collision Deformation Classification (CDC) for this impact to the Ford was 12-FZEN-4 with a principal direction of force of 0 degrees. The hood was deformed up and rearward from engagement against the trees. The bumper corners were pulled inward by the narrow contact damage as the end structure was displaced slightly to the right from the impact force. Tree bark was noted along the contact damage. The right fender was deformed rearward which restricted the right front wheel/tire (not

Figure 5. Front right damage to the 1999 Ford Contour Sport SE.

deflated) and jammed the right side doors. Induced contact damage also produced extensive longitudinal shifting of the right A-pillar which buckled the roof and right front window frame (tempered glazing disintegrated). The windshield was fractured from (exterior) impact forces and the (interior) front right passenger air bag deployment. Reduction in the right wheelbase measured 32.5 cm (12.8 in) as the left wheelbase was elongated 3.5 cm (1.4 in). Pre-existing damage was noted to the left rear tail light which was fractured and repaired with reflective tape.

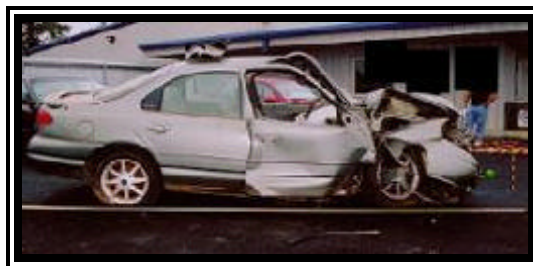
Figure 6. Right side view of the 1999 Ford Contour Sport SE.

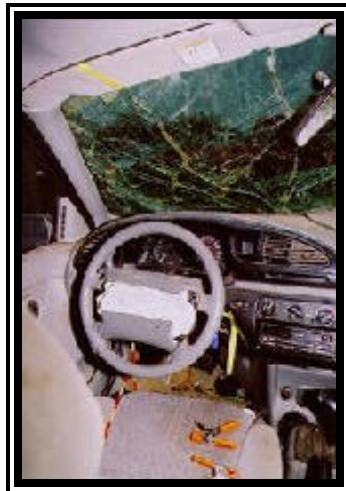
Interior damage to the Ford Contour was severe and attributed to component intrusions and occupant contact (**Figures 7 & 8**). The left knee bolster was deformed and scuffed. Steering wheel rim deformation measured 1.5 cm (0.6 in) along the top portion as sheer capsule movement measured 3.0 cm (1.2 in). The turn signal stalk separated from the steering column. Scuff marks, abrasions, and dark hair strands were identified on the left sunvisor. The rear view mirror was displaced to the right (not fractured). The center floor-mounted console was displaced to the right. The glove compartment door was deformed, scuffed and out-of-place. The front right seat back support was displaced rearward 25.0 cm (9.8 in) and attributed to passenger rebound. Indentations were identified on the right front door panel. Minor abrading and scuffs were also documented to the rear aspect of the front left seat back, which was attributed to cargo movement within the vehicle. *It should be noted that the right mid-instrument panel area, windshield header, and headliner were free of contact evidence.* Longitudinal intrusions into the front occupant space involved 15.0 cm (5.9 in) of right toe pan/instrument panel and 12.0 cm (4.7 in) of center instrument panel intrusion. Vertical intrusions into the front right passenger space involved 3.0 cm (1.2 in) of roof intrusion.

Figure 7. Interior view of the driver space.

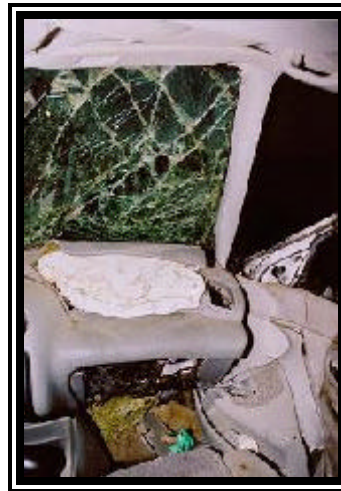
Figure 8. Interior view of the front right passenger space.

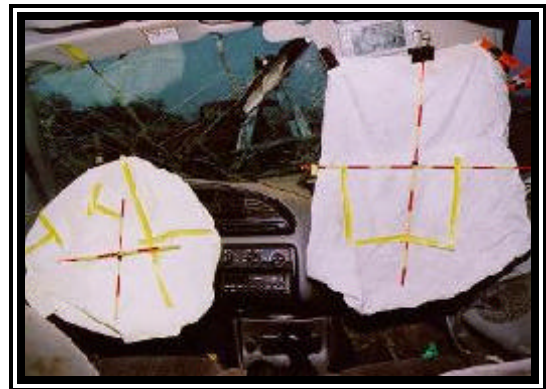
The 1999 Ford Contour Sport SE was equipped with redesigned frontal air bags for the driver and front right passenger positions. The air bags deployed as a result of the crash (**Figure 9**). The driver air bag was housed in the center of the steering wheel with a horizontally oriented flap tear seam (H-configuration). No contact evidence was identified on the exterior surface of the module cover flaps. The flaps were symmetrical in shape and measured 19.0 cm (7.5 in) in width and 9.0 cm (3.5 in) in height. The diameter of the driver air bag measured 56.5 cm (22.2 in) in its deflated state (**Figure 10**). Makeup transfers were documented to the upper right quadrant of the air bag face along with fabric transfers to the upper left quadrant. The bag was tethered by two internal straps and vented by two ports located at the 11 o'clock and 1 o'clock sectors on the rear aspect of the air bag.

Figure 9. 1999 Ford Contour Sport SE deployed redesigned frontal air bags.

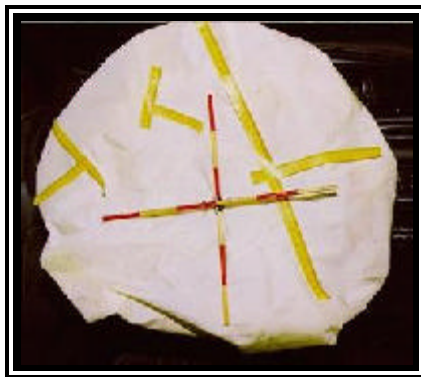
Figure 10. Contact evidence to the 1999 Ford Contour deployed redesigned driver air bag.

At impact, the driver initiated a forward trajectory in response to the 12 o'clock impact force and loaded the deployed redesigned driver air bag as evidenced by the makeup transfers documented to the upper right quadrant of the air bag face. Although driver injury information was limited, she sustained an abrasion to the left shoulder which probably was a result of air bag interaction, evidenced by the location of the injury relative to the fabric transfers documented to the left upper quadrant of the air bag face. The driver's torso loaded the deployed air bag and compressed the bag against the steering assembly. This loading of the steering column resulted in 3.0 cm (1.2 in) of sheer capsule movement. She subsequently impacted the knee bolster resulting in bilateral knee abrasions, evidenced by the deformation and scuff marks identified on this component. The driver continued the kinematic response pattern as her head struck the sunvisor as evidenced by the abrading and hair strands documented to this component, however, no resulting injury was reported. Following the crash, she exited the vehicle under her own power and was transported by private vehicle to the emergency room of a local hospital for treatment and released. The redesigned driver air bag provided adequate protection against contact to the steering wheel hub/rim, thus preventing serious injury.

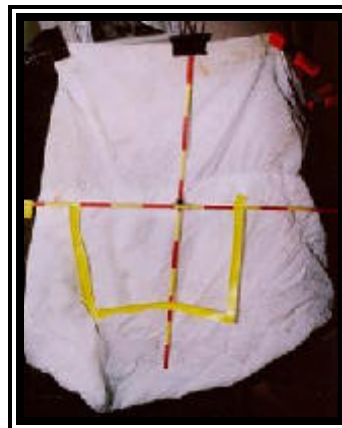
The front right passenger air bag deployed from the right top instrument panel area with a single cover flap design hinged at the forward aspect. The cover flap was rectangular in shape and measured 43.0 cm (16.9 in) in width along the top portion, 36.7 cm (14.4 in) in width along the lower portion, 26.0 cm (10.2 in) in height along the left edge and 22.0 cm (8.7 in) in height along the right edge. An indentation was noted along the aft edge of the flap from contact to the (fractured) right mid-windshield area. The passenger air bag measured 71.5 cm (28.1 in) in width and 69.5 cm (27.4 in) in height in its deflated state (**Figure 11**). Although heavily stained by mold from exposure to the environment post-crash, contact evidence consisted of dark fabric transfers to the lower left quadrant of the air bag face with heavy abrading surrounding the contact site. The top section of the air bag membrane was also abraded from engagement against the (fractured) right windshield. The bag was tethered by two internal straps and vented by one port located at the 10 o'clock sector on the side aspect of the bag. Rearward air bag excursion measured 53.0 cm (20.9 in) from the aft portion of the right instrument panel.

Figure 11. Contact evidence to the 1999 Ford Contour deployed redesigned passenger air bag.

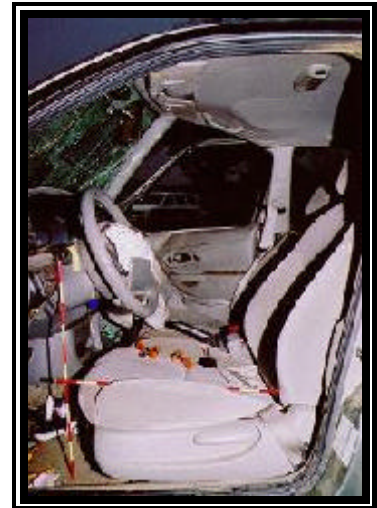
The 15 year old female driver of the 1999 Ford Contour Sport SE was unrestrained (3-point manual lap and shoulder belt system available) and presumed to be seated in an upright posture with the seat track adjusted to a middle position (**Figure 12**). The lack of belt usage was determined by the trajectory of the driver in conjunction with the absence of loading evidence on the restraint webbing or D-ring.

Figure 12. Interior view of the driver space.

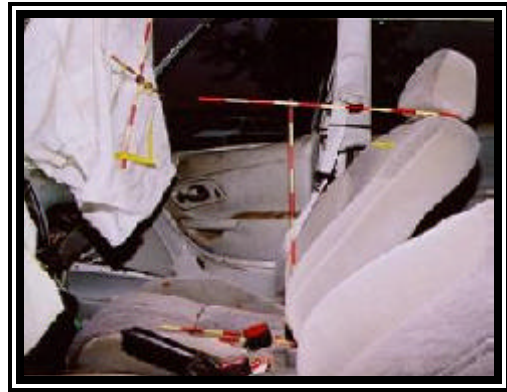
Figure 13. Deformation to the front right seat back support.

The child passenger was out-of-position forward due to the pre-crash braking actions of the driver. At impact, the child was forward within the path of the expanding air bag which struck her face/upper torso area and propelled her rearward into the front right seat back support. The combination of air bag expansion and rearward acceleration produced extensive injury. She sustained a nasal fracture and a multitude of underlying brain injury to the cerebral cortex and cerebellar regions. Cerebral trauma involved a parenchymal hemorrhage along with multiple contusions and acute edema. Cerebellar trauma involved a petechial hemorrhage and diffuse axonal injury in the left hemisphere. Soft tissue injury consisted of abrasions to the right anterior (lower) forearm and contusions to the right anterior (upper) forearm/shoulder. These injury mechanisms were evidenced by the occupant kinematic response pattern relative to the fabric transfers documented to the lower left quadrant of the passenger air bag face. In addition, occupant interaction with the expanding air bag re-directed the deployment path into the right mid-windshield area resulting in the noted abrasions to the top aspect of the air bag membrane. Loading of the glove compartment door was confirmed by the deformation documented to this component, however, no injury was reported as a result of this contact. At this point, the air bag membrane continued to expand against the child passenger which propelled her rearward into the front right seat back support. This trajectory was evidenced by 25.0 cm (9.8 in) of extensive loading deformation identified to the seat back (**Figure 13**). Loading of the seat back support resulted in a traumatic subarachnoid and petechial hemorrhage along with an underlying brain stem infarction (*an obstruction or interruption resulting in an inadequate flow of oxygen to the brain*).

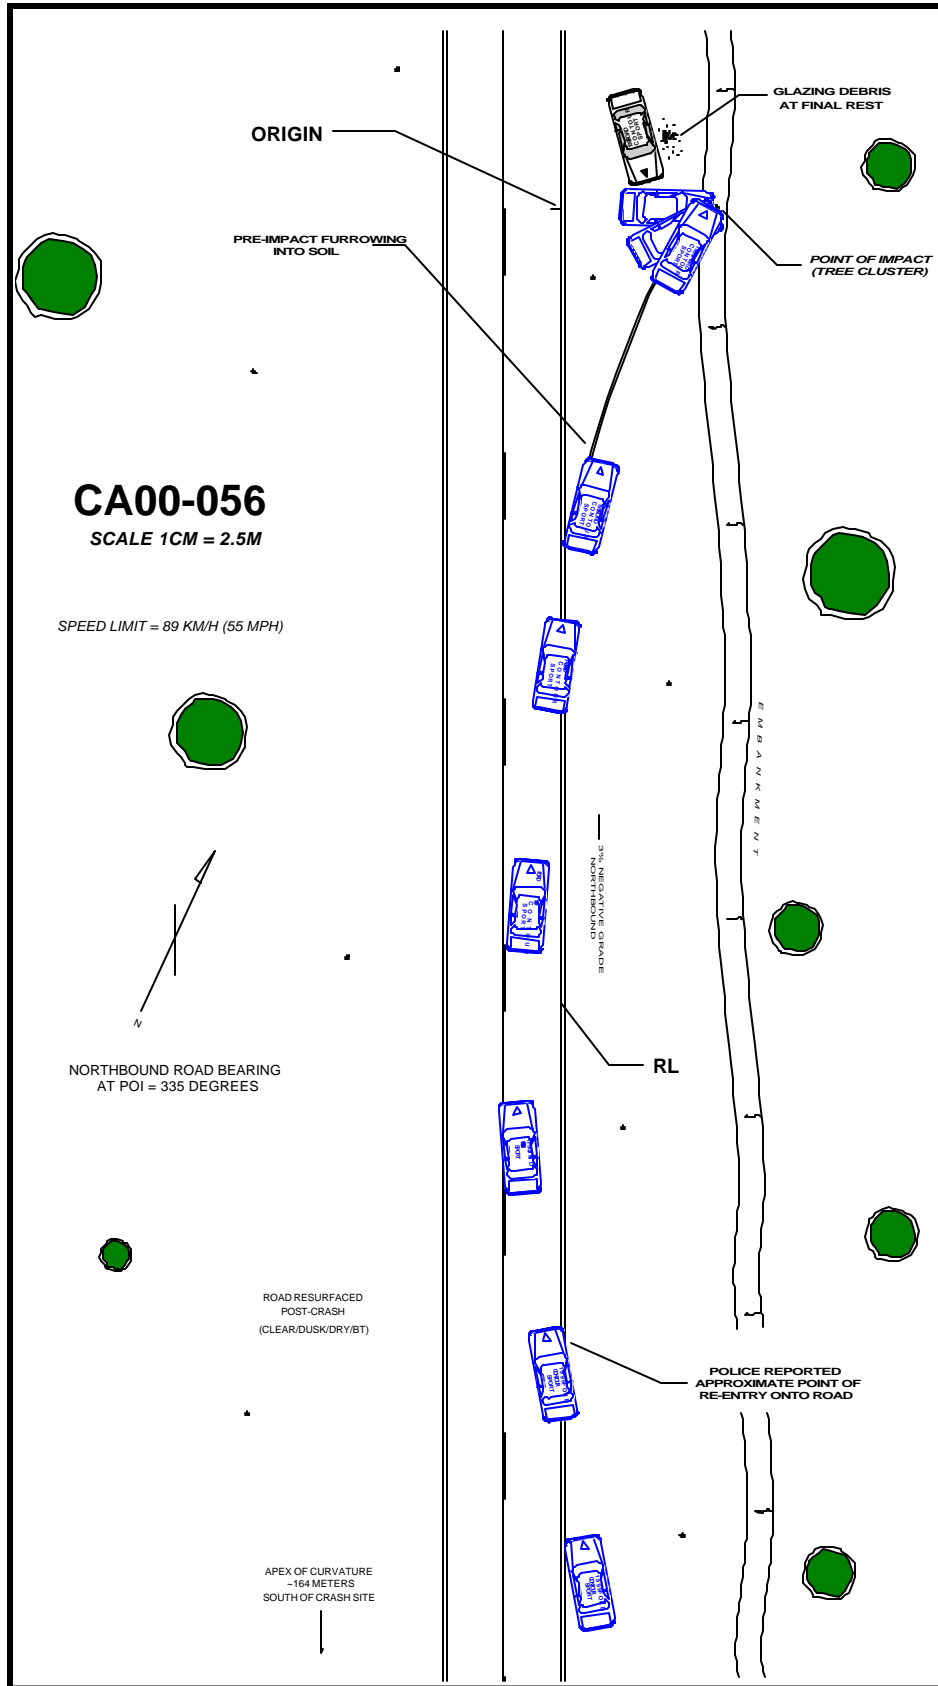
Figure 14. Scene Diagram.

This single vehicle crash occurred during the early evening hours of July, 2000. At the time of the crash, it was daylight (dusk) with no adverse conditions as the road was dry. The crash occurred off the east pavement edge of a two lane north/south rural roadway (see **Figure 14 - page 9**) which curved left for northbound traffic. A hillcrest was located approximately 130.0 meters (142.2 yards) south of the crash site with a negative grade for northbound traffic. *The asphalt roadway was re-surfaced prior to the SCI inspection.* Environmental features included a wooded area located approximately 8.0 meters (26.2 feet) off the east pavement edge with a 86.0 cm (33.9 in) high embankment surrounding the impacted trees. No curve warning signs were present at the crash site which had an (unposted) speed limit of 89 km/h (55 mph).
