**VERIDIAN ON-SITE AIR BAG RELATED DRIVER FATALITY INVESTIGATION
SCI TECHNICAL SUMMARY REPORT**

VERIDIAN CASE NO. CA00-060

SUBJECT VEHICLE - 1994 FORD F-150 4X2 PICKUP TRUCK

CRASH DATE - DECEMBER 2000

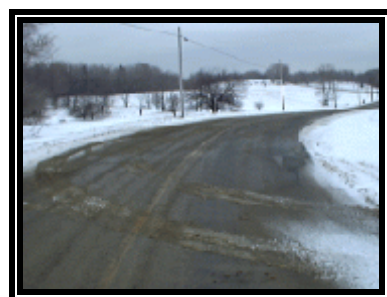
Figure 5. Approach #3 for the Ford pickup truck where it drifted across the centerline

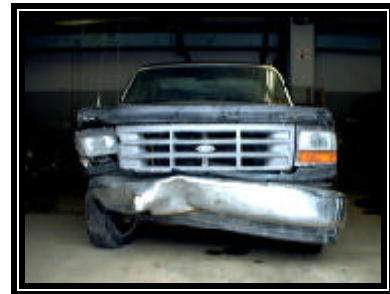
The 1994 Ford F-150 pickup truck sustained moderate frontal damage as a result of the impact with the Dodge Grand Caravan (**Figure 8**). The direct contact damage was concentrated on the front bumper and began 2.5 cm (1.0") left of the centerline, and extended 90.2 cm (35.5") to the right bumper corner. The combined direct and induced damage measured 180.3 cm (71.0") from bumper corner to bumper corner. The maximum crush was located at C6 and measured 19.0 cm (7.5"). The right aspect of the bumper was crushed rearward around the right frame rail, which caused the frame rail to project through the bumper 8.3 cm (3.3"). Based on an exemplar vehicle, the leading edge of the right frame rail was displaced laterally 7.6 cm (3.0") to the left (**Figure 9**). There was no movement of the left frame rail. The front right bumper corner was crushed against the right front wheel, which caused the wheel to be restricted. The right headlight assembly was displaced and the grille was fractured in multiple locations on the right side. The bottom right aspect of the grille was partially separated and longitudinal abrasions were noted on the bumper. The front aspect of the right fender was buckled rearward and outward, and the leading edge of the right door was deformed from being forced open against the displaced fender (**Figure 10**). The right side of the hood was slightly displaced rearward and upward. The box was shifted to the left 7.6 cm (3.0"). The distance between the cab and the box was elongated on the right side and measured 8.9 cm (3.5"). The distance on the left side was shortened and measured 1.2 cm (0.5"). The right wheel base was shortened 4.0 cm (1.6"). The Collision Deformation Classification (CDC) for this impact was 12-FZEW-1. Six crush measurements spaced 36.1 cm (14.2") apart were taken

Figure 8. Frontal damage to Ford F-150 pickup truck

at the level of the bumper and were as follows: C1 = 0.0 cm, C2 = 0.0 cm, C3 = 5.0 cm (2.0"), C4 = 18.0 cm (7.1"), C5 = 13.0 cm (5.1"), C6 = 19.0 cm (7.5").

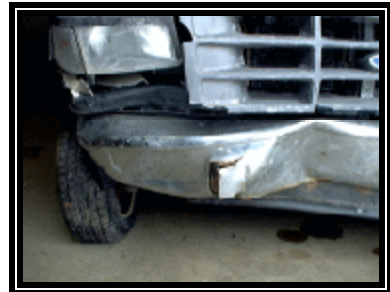
Figure 9. Displaced right frame rail protruding through bumper

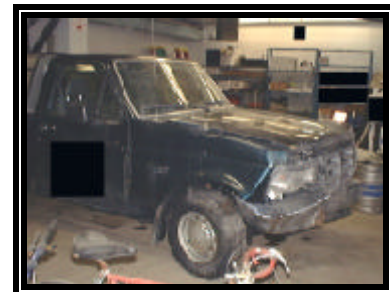
Figure 10. Left side view of damage

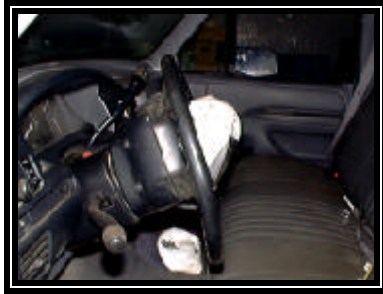
Interior damage to the 1994 Ford F-150 pickup truck was moderate and attributed to occupant contact. There was no glazing damage. The only intruded component was the right toe pan, which intruded 7.6 cm (3.0") longitudinally. The top half of the steering wheel rim was deflected forward 3.2 cm (1.3") from occupant loading (**Figure 11**). The steering column was uniformly compressed as evidenced by the displacement of the shear capsules. Both shear capsules were displaced 2.5 cm (1.0") from the brackets (**Figure 12**). The bend bracket located below the shear capsules was deflected forward 2.5 cm (1.0"). A scuff that measured 2.5 x 1.3 cm (1.0 x 0.5") was noted on the top aspect of the left instrument panel to the right of the steering wheel rim. Blood was noted on the bench seat cushion in the center and right positions.

Figure 11. Steering wheel deflection (note: rotated 180 degrees)

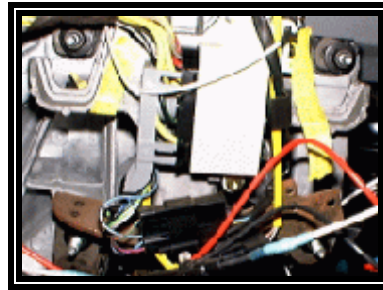
Figure 12. Shear capsules and bend bracket

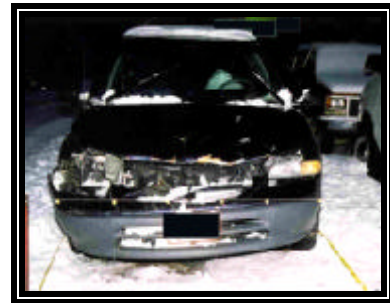
The 1997 Dodge Grand Caravan sustained moderate frontal damage as a result of the impact with the Ford F-150 pickup truck (**Figure 13**). The direct damage began 53.3 cm (21.0") left of the centerline and extended 132.1 cm (52.0") to the right bumper corner. The combined direct and induced damage involved the entire frontal width of the Grand Caravan and measured 151.8 cm (59.8"). The frontal damage was concentrated above the level of the bumper. The maximum crush was located 2.5 cm (1.0") right of C4 and measured 20.3 cm (8.0") to the center of the radiator core. The bumper fascia was fractured to the right of center and had numerous longitudinal abrasions on the top aspect. The bumper fascia was partially separated from the right front fender. The right headlight assembly and grille were separated from the vehicle. The leading aspect of the hood was abraded and the hood was buckled slightly at the designated

Figure 13. Frontal damage to 1997 Dodge Grand Caravan

fold points. The right front fender was displaced rearward and outward. The Collision Deformation Classification (CDC) for this impact was 12-FDEW-1. Six crush measurements spaced 30.4 cm (11.9") apart were taken at the level of the front bumper and were as follows: C1 = 2.0 cm (0.8"), C2 = 1.0 cm (0.4"), C3 = 5.0 cm (2.0"), C4 = 6.0 cm (2.4"), C5 = 6.0 cm (2.4"), C6 = 2.0 cm (0.8").

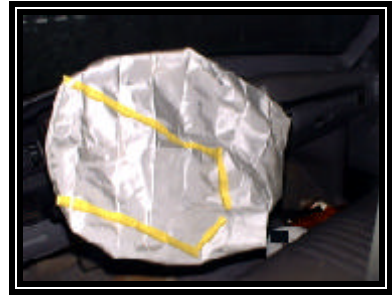
The 1994 Ford F-150 pickup truck was equipped with a frontal air bag for the driver's position only. The air bag deployed as a result of the frontal impact with the 1997 Dodge Grand Caravan. The driver's air bag was housed in the center of the steering wheel with asymmetrical H-configuration module cover flaps. The top flap measured 20.3 cm (8.0") in width and 12.7 cm (5.0") in height. The bottom flap measured 20.3 cm (8.0") in width and 3.8 cm (1.5") in height. There was no identifiable contacts or damage to the module cover flaps. The driver's air bag measured 56 cm (22") in diameter. Blood spattering was noted on the front air bag surface above the center aspect and continued at a downward angle toward the right side (**Figure 14**). The air bag was vented by two vent ports that measured 3.8 cm (1.5") in diameter at located at the 11 and 1 o'clock positions. The air bag was tethered by two internal straps that measured 6.4 cm (2.5") in width.

Figure 14. Driver's air bag (note: steering wheel rotated 180 degrees)

At impact, the driver's air bag deployed and the expansion of the air bag against the driver's face resulted in a left and right conjunctiva injuries, a forehead abrasion, a nose abrasion, irregular left and right facial abrasions, and an upper lip contusion. According to the Medical Examiner, the driver's facial trauma caused bleeding from the mouth and nose. The smooth surface of the vinyl bench seat made it easy for the unrestrained driver to slide forward. The driver initiated a forward trajectory in response to the 12 o'clock crash force and loaded through the top aspect of air bag. He deflected the upper half of the steering wheel rim forward 3.2 cm (1.3") which resulted in bilateral chest contusions. The combined forward momentum of the driver and impeded deployment of the air bag compressed the steering column approximately 2.5 cm (1.0") as evidenced by shear capsule displacement. The air bag expansion accelerated the driver's head rearward. The air bag induced acceleration of the driver's head resulted in brain swelling/edema and bilateral uncus grooving and tonsillar coning. The air bag expansion projected the driver's right hand into the left instrument panel, as evidenced by a scuff that measured 2.5 x 1.3 cm (1.0 x 0.5"), although there was no soft tissue injury identified on the right hand to confirm this contact. The expansion of the air bag resulted in a contusion of the medial aspect of the right upper arm. He rebounded rearward and came to rest face-up lying laterally on the bench seat with his legs still in the driver's floor area.
