## SCI/NASS COMBINATION CASE REPORT

CASE NUMBER - NASS-2001-49-014K  
LOCATION - Texas  
VEHICLE - 1996 PLYMOUTH VOYAGER  
CRASH DATE - February 2001

1. <i>Report No.</i> NASS-2001-49-014K		2. <i>Government Accession No.</i>		3. <i>Recipient's Catalog No.</i>	
4. <i>Title and Subtitle</i> SCI/NASS Combination Child Safety Seat Investigation Vehicle - 1996 Plymouth Voyager Location - Texas			5. <i>Report Date:</i> March 6, 2002

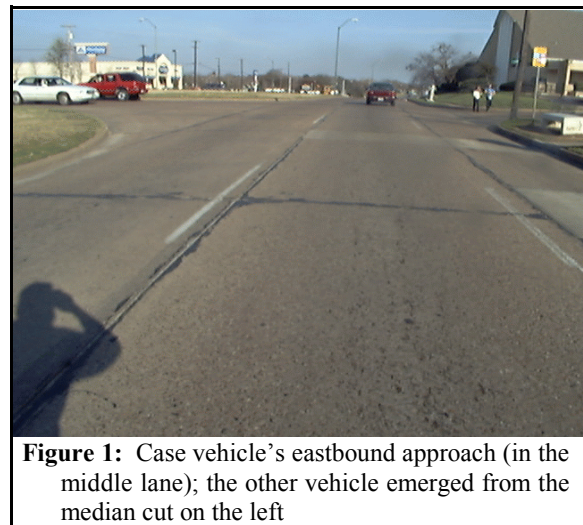
The case vehicle was traveling east in the center eastbound lane of a three-lane, one-way roadway that was part of a divided, six-lane trafficway, approaching a four-leg intersection and intending to continue east (**Figure 1**). The other vehicle had exited a parking lot on the north side of the divided roadway and was traveling south, intending to cross the divided roadway and continue southbound. The other vehicle had crossed the westbound lanes and was in the median cut intending to continue south across the eastbound lanes. The weather was clear, it was daylight, both roadways were of concrete construction, dry and without defects. The grass median was over 10 meters [30 feet] wide, with no longitudinal barrier. The speed limit for the case vehicle was 56 km.p.h. [35 m.p.h.], with the roadway straight and a negative slope to the east. The speed limit for the other vehicle was 48 km.p.h. [30 m.p.h.], with the roadway straight and level.

**Figure 1:** Case vehicle's eastbound approach (in the middle lane); the other vehicle emerged from the median cut on the left

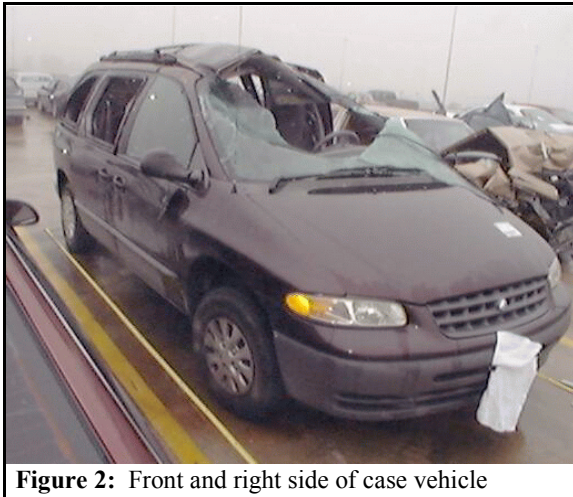
The case vehicle sustained direct contact damage on the left side from the impact with the other vehicle (event 1). The case vehicle began rotating counterclockwise and rolled to the right three quarter-rolls (event 2), coming to rest on its left side and sustaining direct damage from contact with the ground on the right, top and left sides (**Figures 2 and 3**).

**Figure 2:** Front and right side of case vehicle

For event 2, the heaviest damage was on the roof at the junction of the left A-pillar, windshield header and the left roof rail (**Figures 2 and 3**). The left A-pillar was crushed inward and downward, pulling the adjacent structures with it and causing the roof to buckle on the right. There was light scratching on the right and left sides, along the upper right A-pillar and the right roof rail, and on the mid-door area along the left side. There was also heavy abrading across the forward half of the roof, heavier on the left. The CDC for the rollover (second event) was determined to be **00-TZDO-3 (non-horizontal)**. The crash severity for the rollover was judged to be moderate.

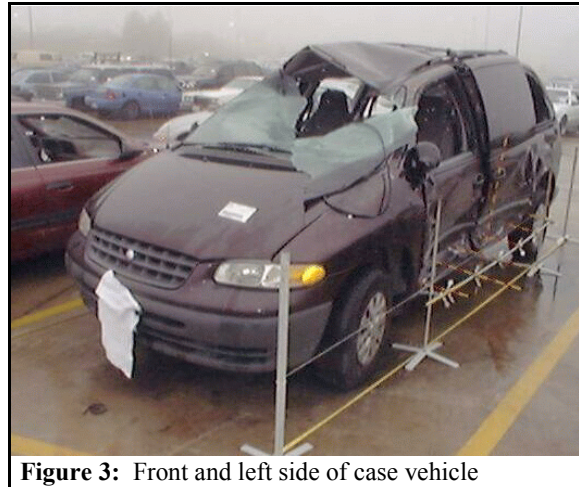
**Figure 3:** Front and left side of case vehicle

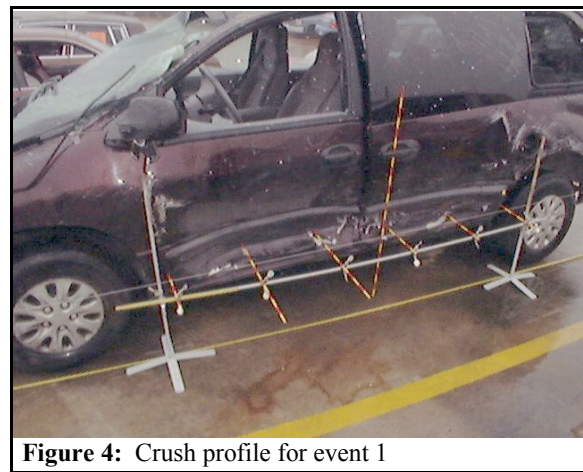
For event 1, direct damage extended from the left A-pillar along the driver's door and the left sliding side door to the left rear wheel well (**Figure 4**). The CDC for the first event was determined to be **12-LZEW-3 (350)**. Maximum crush was 19 centimeters [7.5 inches] at C4, near the center of the driver's door. The first event was judged to be the most severe and the WinSMASH reconstruction program was executed, based on the damage-only algorithm using the measured crush profiles from both vehicles. The Total, Longitudinal and Lateral DeltaVs for the case vehicle were, respectively: 11 km.p.h. [6.8 m.p.h.], -11 km.p.h. [-6.8 m.p.h.] and +2 km.p.h. [+1.2 m.p.h.].

**Figure 4:** Crush profile for event 1

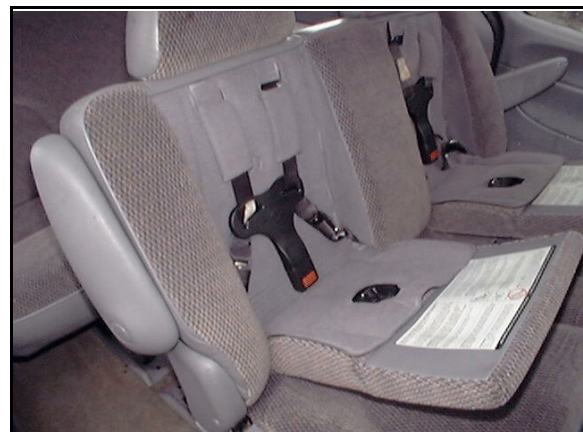
The case vehicle's second row bench seat was manufactured with two integral child safety seats (**Figure 5**). At the time of the crash, the left integral child safety seat (CSS) was open and in use (**Figure 6**) while the right integral CSS was folded away with no occupant in the second row right seat position.

**Figure 5:** Case vehicle's second row bench seat with two integral child safety seats folded open

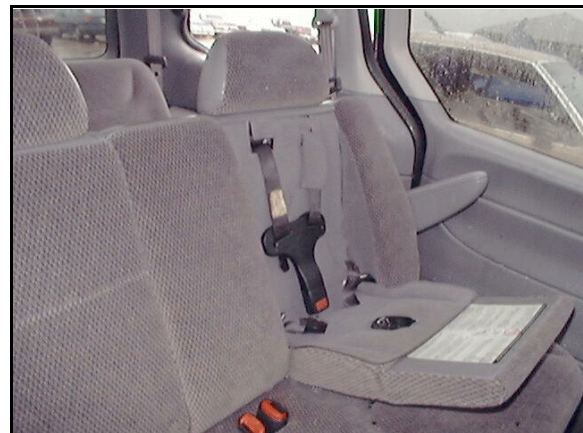
Prior to the left side impact with the other vehicle, the child was seated in the open integral CSS (**Figure 6**), restrained by the integral seat's five-point harness with the T-Bar in use. She was sitting upright, with her back against the integral CSS's seat back and her legs forward in front of her. The case vehicle driver braked immediately prior to the impact and the child moved slightly forward, but her movement was restricted by the harness. When the other vehicle struck the case vehicle's left side, the child moved further forward and slightly to the left, toward the 350 degree direction of force, loading the harness. The interior surface of the left sliding door intruded as a result of the impact (**Figure 7**), probably compressing the bench seat cushion and possibly contacting the child. As the case vehicle began to rotate counterclockwise, she moved slightly to the right but was probably held in place by the harness. As the case vehicle rolled over (i.e., rotated about the longitudinal axis) to the right, she moved first to the right, then upwards and then back to the left, but was held essentially in place by the harness, although her legs may have flailed and contacted the intruded door surface. The case vehicle rolled three quarter rolls onto its left side. Her posture at final rest is

**Figure 6:** Second row left CSS folded open and in use at the time of the crash; right CSS closed

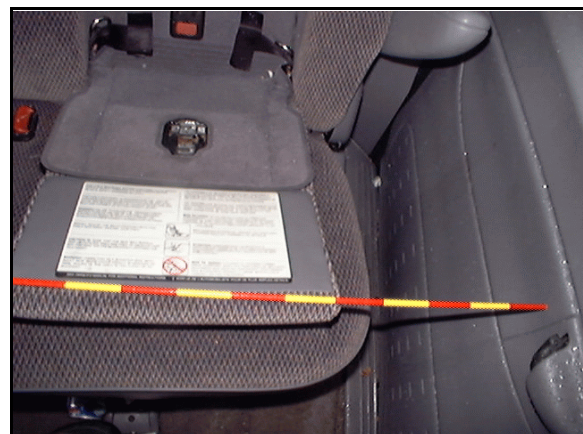
Inspection of the interior revealed numerous areas of intrusion on the left side and the top. In the second row left seat area, intrusion by the left door panel (due to the impact with the other vehicle) was measured as 13 centimeters [5.1 inches]. Note, however, the left side door apparently had been forced opened and could not be closed completely, and the intrusion during the crash was probably somewhat greater. The left roof rail intruded 24 centimeters [9.4 inches] laterally into the second seat row as a result of the rollover. In the driver's seat position, the roof intruded 12 centimeters [4.7 inches] and the windshield header intruded 10 centimeters [3.9 inches] vertically, as a result of the rollover. Other components also intruded laterally or vertically, with lesser magnitude, into the left side seating areas in all three seat rows.

**Figure 7:** Second row left CSS cushion open on bench seat cushion, showing door panel intrusion

not known, but she was probably held in the recessed seating area by the CSS harness, leaning toward the intruded left side interior surface as the vehicle slid to final rest on its left side. The child suffered a fracture of the left femur in the area of the lesser trochanter, probably as a result of contacting the left side interior surface. No other injuries were reported for this occupant. Whether the fracture was caused by the impact with the other vehicle and the resulting intrusion, or from being thrown against the door during the rollover and/or slide to rest, is not known.

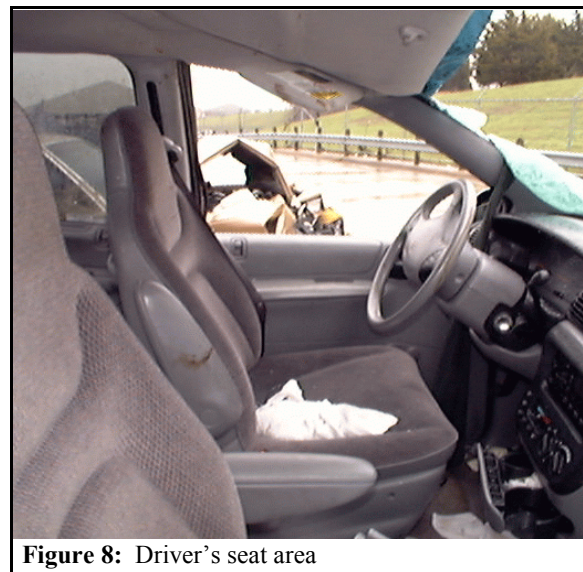
Prior to the impact with the other vehicle, the driver was seated in a van-type box-mounted bucket seat, in an upright posture with her back against the seat back, both hands on the steering wheel, her left foot on the floor and her right foot on the foot controls. Immediately prior to the left side impact, the driver braked, causing her to move slightly forward. Upon impact, she moved further forward and slightly upward and to the left, toward the 350 degree direction of force, loading the safety belt webbing. As the case vehicle began to rotate counterclockwise, she moved slightly to the right. As the case vehicle rolled over (i.e., rotated about the longitudinal axis) to the right, she moved first to the right, then upwards and then back to the left. Her head probably struck the left roof rail and she sustained a laceration on her scalp and a non-anatomic brain injury resulting in loss of consciousness. Her posture at final rest is not known, but she was probably laying against the left side interior surface as the vehicle lay on its left side following the rollover.

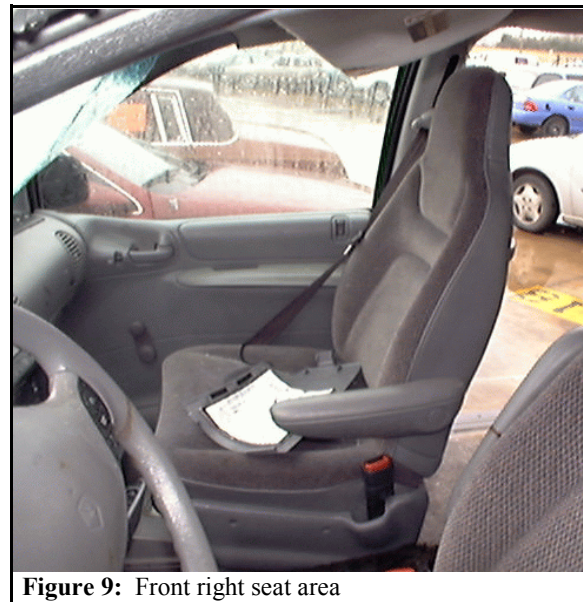
**Figure 9:** Front right seat area

Prior to the impact with the other vehicle, the front right passenger was seated in a van-type box-mounted bucket seat, in an upright posture with his back against the seat back, his hands in an unknown position and his legs hanging down in front of the seat. Immediately prior to the left side impact, the driver braked, causing him to move slightly forward. Upon impact, he moved further forward and slightly upward and to the left, toward the 350 degree direction of force, loading the safety belt webbing. As the case vehicle began to rotate counterclockwise, he moved slightly to the right. As the case vehicle rolled over (i.e., rotated about the longitudinal axis) to the right, he moved first to the right, then upwards and then back to the left, but was held essentially in place by the safety belt. His posture at final rest is not known, but he was probably hanging to the left, held by the safety belt. He did not sustain any injuries.

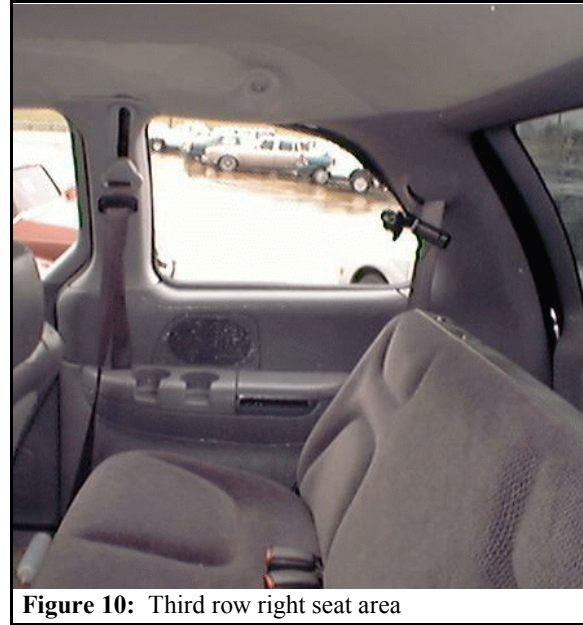
Figure 10: Third row right seat area

Prior to the impact with the other vehicle, the third row right passenger was seated in the right portion of the three-position bench seat, in an upright posture with her back against the seat back, her hands in an unknown position, her knees bent and her feet on the floor. Immediately prior to the left side impact, the driver braked, causing her to move slightly forward. Upon impact, she moved further forward and slightly upward and to the left, toward the 350 degree direction of force. As the case vehicle began to rotate counterclockwise, she moved back to the right. As the case vehicle rolled over (i.e., rotated about the longitudinal axis) to the right, she was thrown against the right side interior surface and window sill, causing a contusion of her lungs. The window glazing shattered as a result of the rollover contact and she essentially fell out through the window opening as the vehicle continued to roll, leaving her on the ground. Her face and head contacted the ground, causing a non-anatomic brain injury resulting in unconsciousness, a displaced nasoseptal fracture, and a fracture of the alveolar ridge with loosened teeth. The contact by her face and head on the ground caused hyperextension of her cervical spine, resulting in subluxation of the 5th and 6th cervical vertebrae. She also sustained lacerations, abrasions and contusions from contact with the ground.

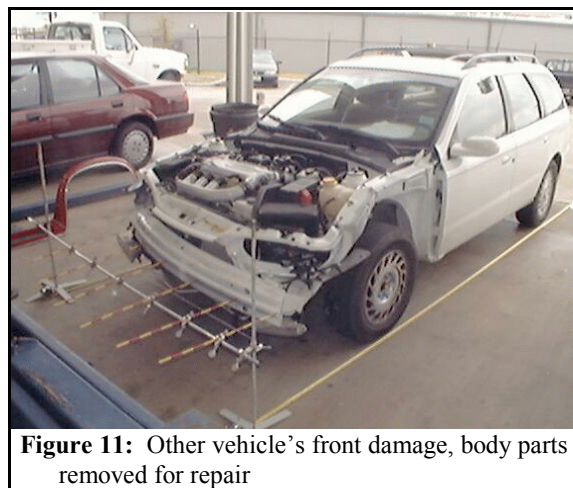
The Saturn sustained direct contact damage across the entire front plane, with maximum crush 15 centimeters [5.9 inches] at the front right corner. The vehicle was under repair at the time of inspection, with the hood, grille, bumper cover and the two front fenders removed and not available. The bumper was pushed leftward and rearward, with bending of the radiator support bracket and the fender support brackets on both sides, heavier on the left. The post-crash wheelbase was shortened by 7 centimeters [2.8 inches] on both sides. The CDC was determined to be **03-FDEW-1 (80)**. The WinSMASH reconstruction program, damage-only algorithm

**Figure 11:** Other vehicle's front damage, body parts removed for repair
