SCI/NASS COMBINATION CASE REPORT

CASE NUMBER - NASS-2001-74-010J

VEHICLE - 2001 Volvo V70

CRASH DATE - January 2001

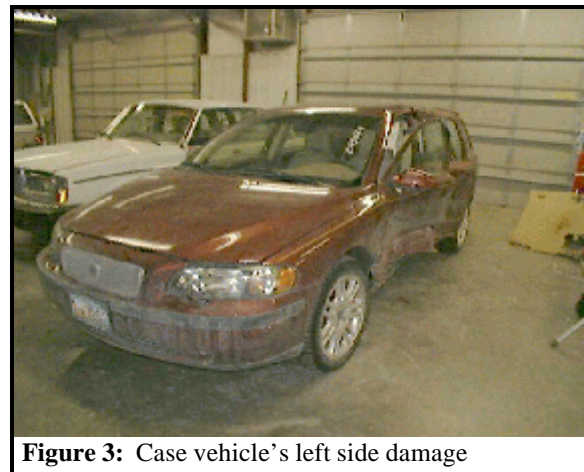
The case vehicle had been altered by rescue personnel and was under repair at the time of the inspection, such that complete inspection data could not be acquired. The Volvo's impact with the Nissan involved the left side from the A-pillar rearward (**Figure 3**). Field L began 40 centimeters [15.7 inches] rearward of the front axle and extended 199 centimeters [78.3 inches] to the leading edge of the rear wheel well. Both left doors sustained direct contact damage and were jammed shut, but were subsequently forced open, altering the area of the crush profile (**Figure 4**). The PSU measured the crush along the sill and maximum crush was 11 centimeters [4.3 inches], at the base of the left B-pillar. Because the measured crush at the sill did not reflect the actual crush and the other vehicle was repaired such that no crush profile could be obtained, none of the available reconstruction programs could be used. The CDC for the case vehicle's most severe impact was determined to be **11-LPAW-3 (340)**. The researcher's visual estimate of delta V for this impact was between 25 and 40 kmph [16 - 25 mph]. The case vehicle rotated counterclockwise and sustained a second, minor impact when it struck a traffic signal pole with its right rear quarter panel. The quarter panel had been removed by the repair shop, but a partial CDC for this impact was determined to be **03-RBAE-99 (090)**.

Figure 3: Case vehicle's left side damage

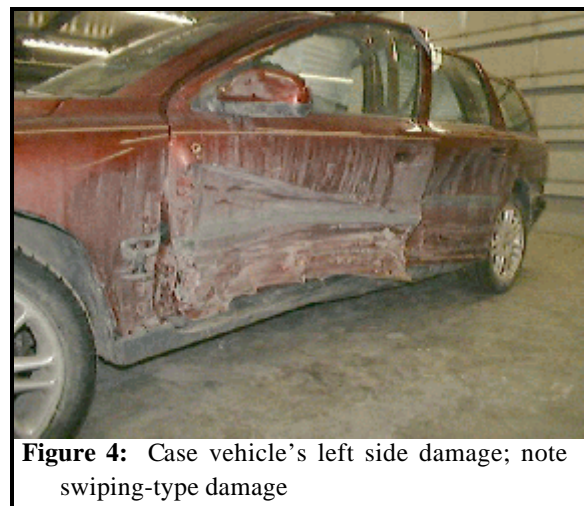
Figure 4: Case vehicle's left side damage; note swiping-type damage

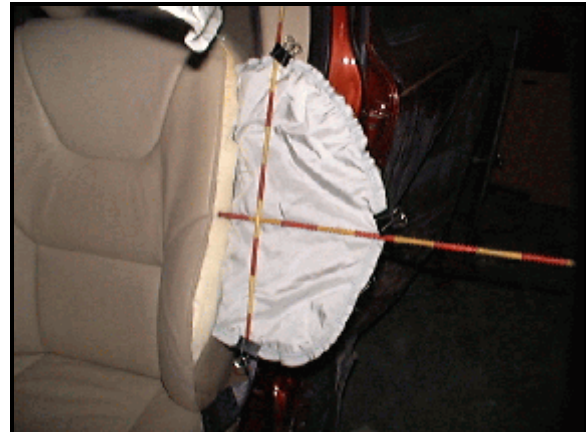
The driver's seat back-mounted side air bag deployed through a pre-stressed seam along the forward edge on the outboard side of the seat back (**Figure 5**). There was no evidence that the air bag module cover or the air bag was damaged. The air bag was shaped like an elongated half-circle and measured 38 centimeters [15.0 inches] vertically and 25 centimeters [9.8 inches] horizontally. There were no tethers and there was one vent port on the outboard surface near the top. There was no visible evidence of occupant contact, nor any other marks, on the seat back-mounted side air bag, the module or the adjacent interior components (**Figure 6**).

Figure 5: Deployed driver's seat back-mounted side air bag, showing inboard surface

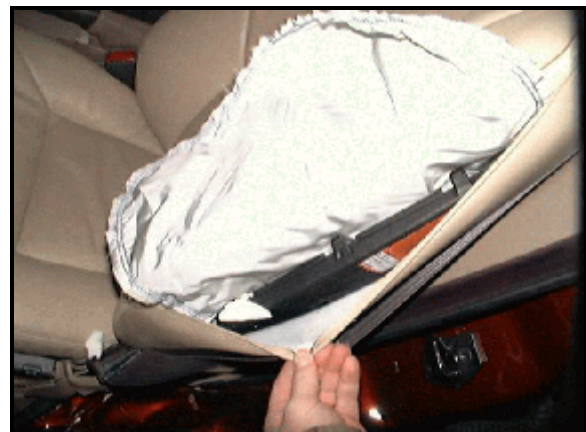
Figure 6: Deployed driver's seat-back mounted side air bag, showing module and outboard surface

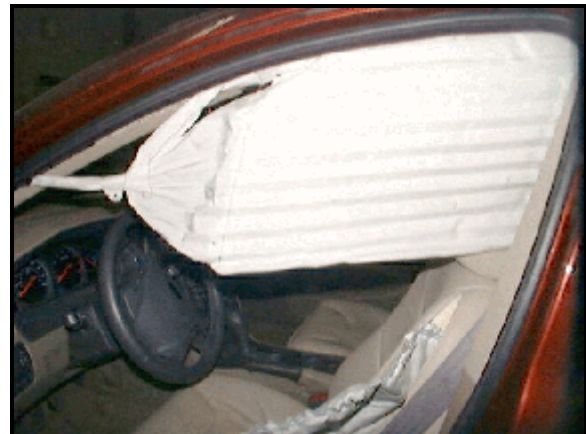
The left side roof rail-mounted inflatable curtain air bag deployed through a pre-stressed seam where the headliner joins the side rail. This inflatable curtain is designed to protect both the driver and the second row left seating position (**Figures 7, 8 and 9**). The curtain air bag measured 130 centimeters [51.2 inches] horizontally by 29 centimeters [11.4 inches] vertically. There were no tethers or vent ports. There was no visible evidence of occupant contact, nor any other marks on the inflatable curtain. There was some tearing of the headliner in the second seat area (**Figure 9**).

Figure 7: Left roof rail-mounted inflatable curtain, forward portion viewed from outside

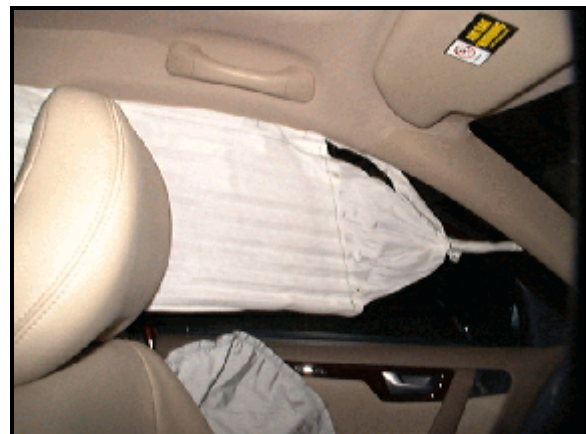
Figure 8: Interior view of left roof rail-mounted inflatable curtain, forward portion

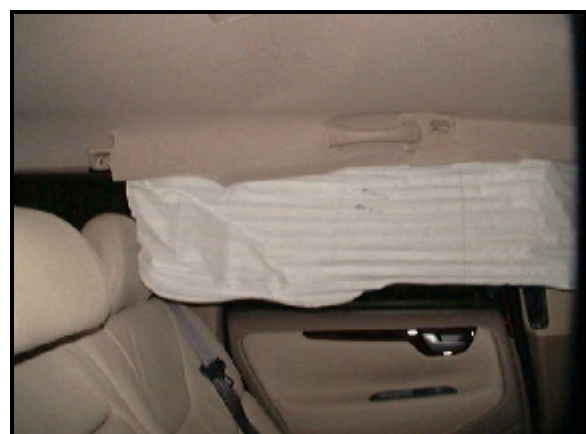
Figure 9: Inflatable curtain, rearward portion

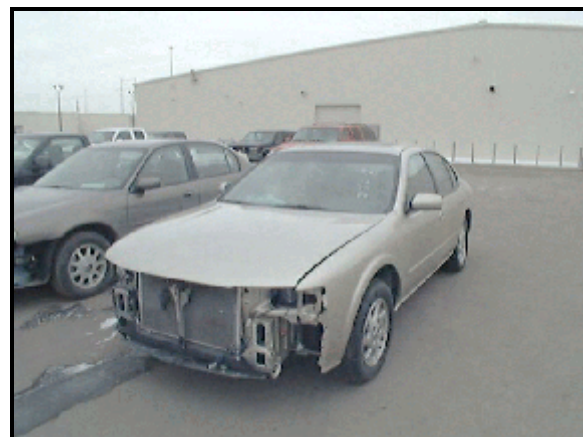
Figure 10: Other vehicle, front components removed

The Nissan had been partially disassembled for repair, with the front bumper, grille, headlight assemblies and other front components removed. No crush profile was measured, the CDC is unknown and NASS estimated severity is coded unknown. The Nissan was equipped with front and side air bags and the front air bags did deploy. This contractor estimates that the impact was of low severity (14 - 23 km.p.h. [9 - 14 m.p.h.]).
